# Performance Evaluation of Arizona's LTPP SPS-1 Project: Strategic Study of Flexible Pavement Structural Factors

Final Report 396-1  
February 2012

Nichols Consulting Engineers  
1885 South Arlington Avenue  
Suite 111  
Reno, Nevada 89509

Arizona Department of Transportation  
In cooperation with  
U.S. Department of Transportation  
Federal Highway Administration

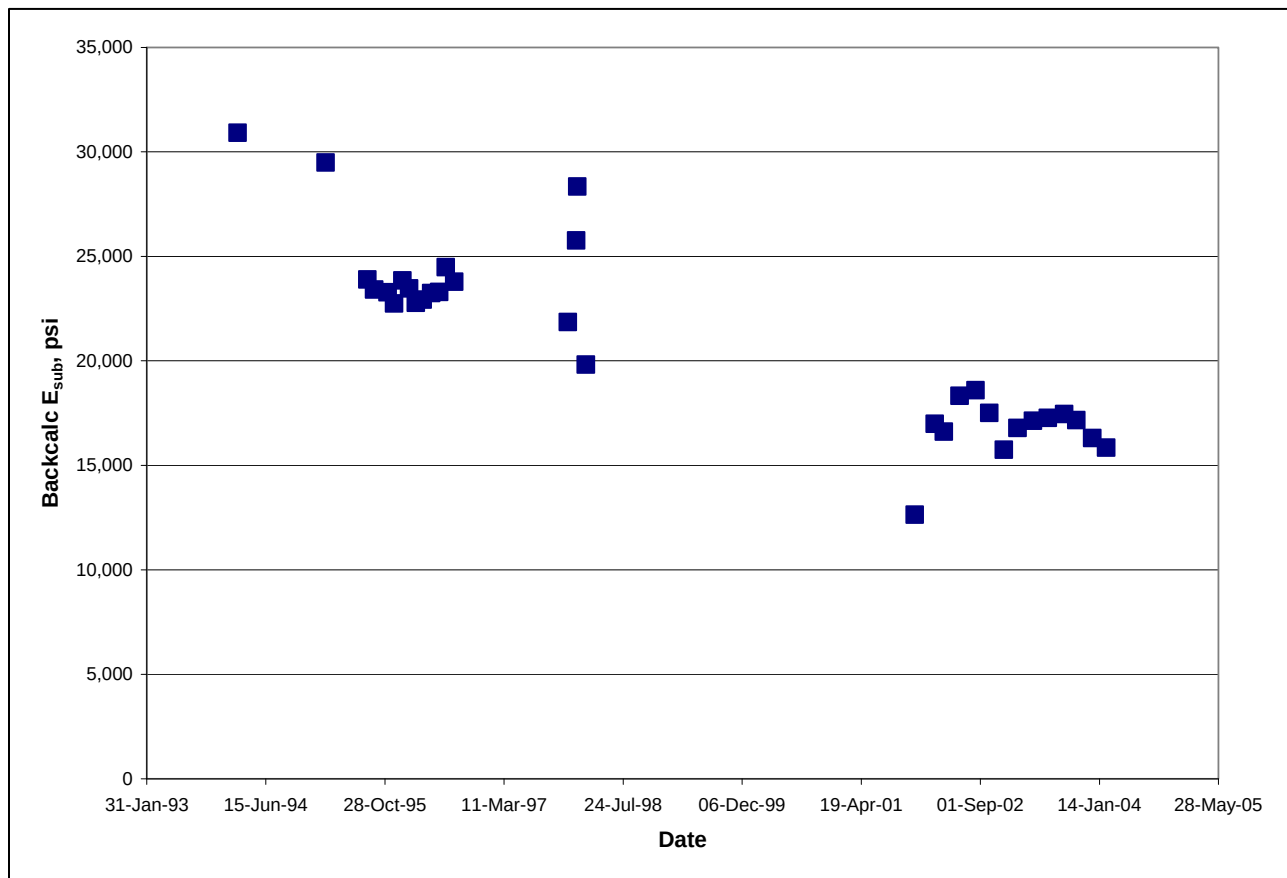
Figure 5. Backcalculated subgrade modulus decrease over time, section 0113.

This decrease in subgrade modulus over time is presumed to be due to a gradual increase and leveling off of the subgrade moisture content after construction. The fairly steady trend in decreasing subgrade moduli over time is illustrated by the values backcalculated for SMP test section 0113, shown in Figure 5 and Table 6.

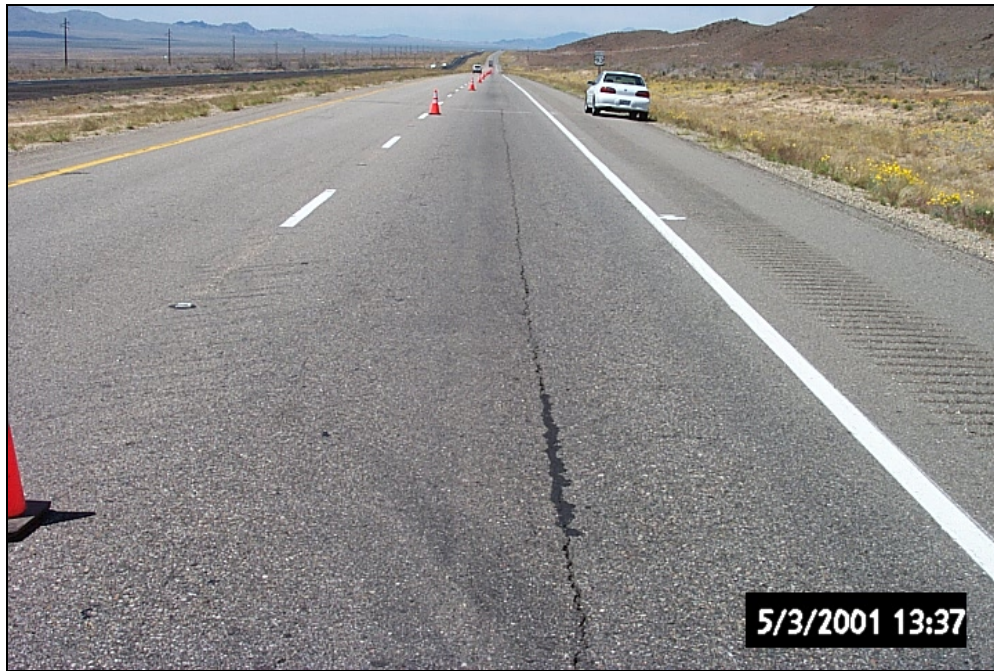
Figure 10. Photograph of paving seam.

Unfortunately, much of the longitudinal and fatigue cracking was a result of surface cracking that seemed to be associated with a construction joint located within the right wheel path on the final paving course. The deflection data indicates that most of the pavement sections remained structurally competent through the life of the study.

contribution of the paving seam and will be described in subsequent sections of this report.

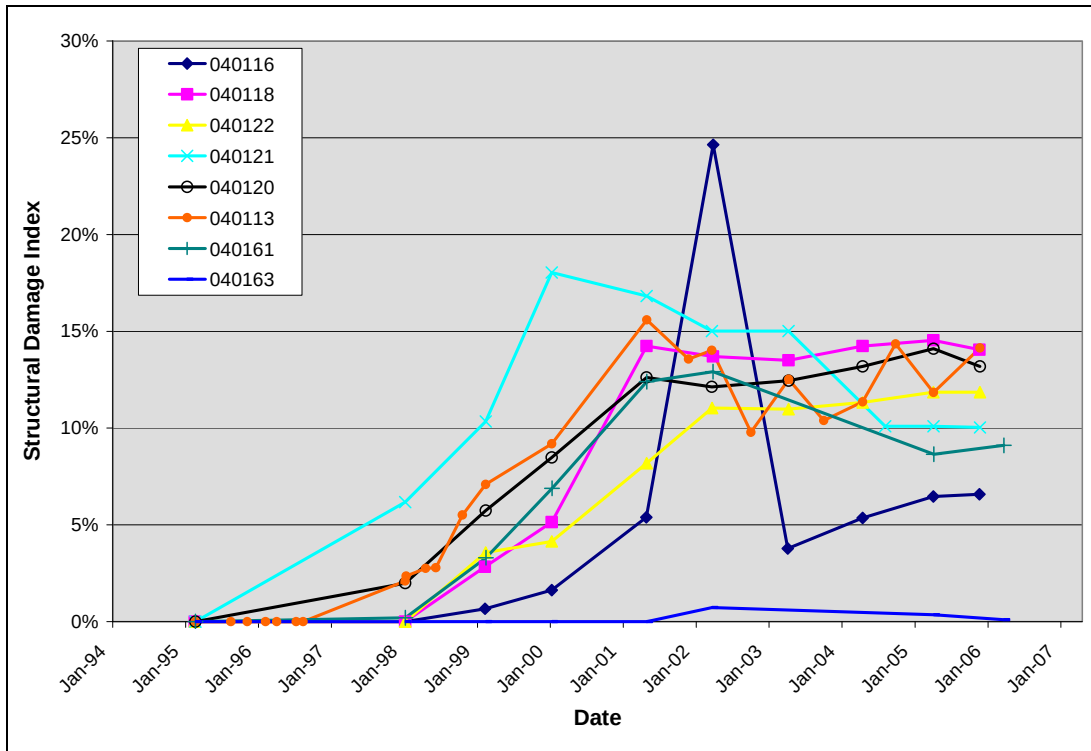
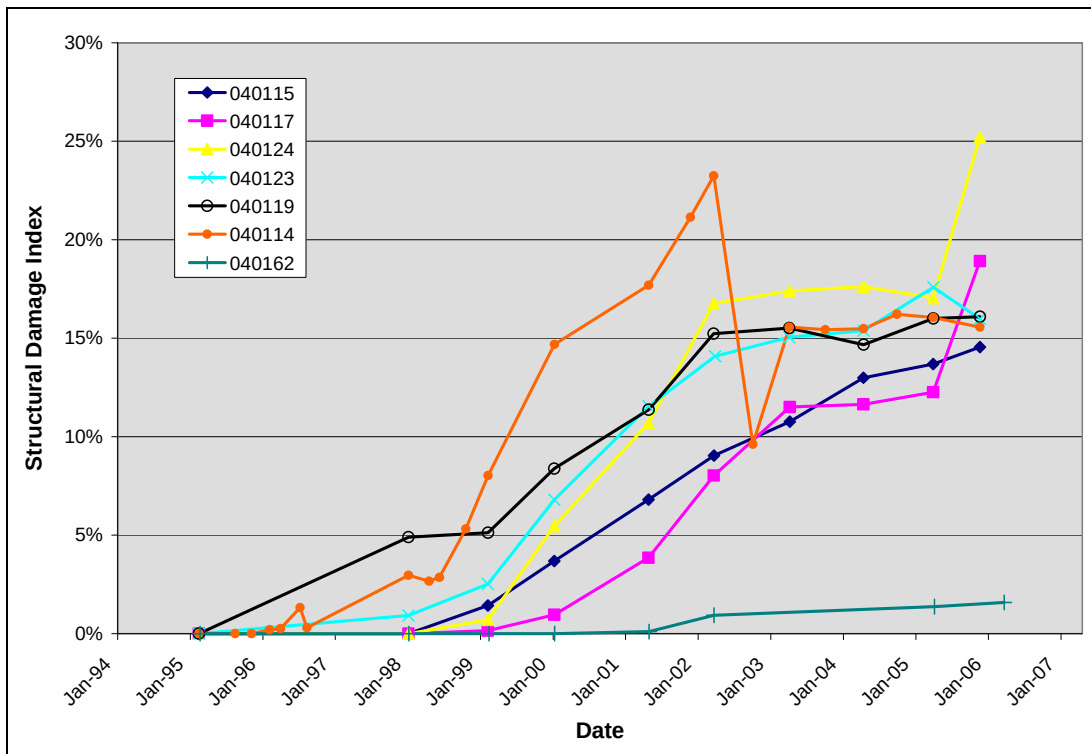
The overall structural damage trends for each section can be found in Figures 11 and 12. The performance trends are relatively consistent and within the expected range of variation. The drop in damage after May 2002 is indicative of the slurry seal masking the underlying deterioration.

All sections (except 0162 and 0163) showed a rapid accumulation of structurally related distresses approximately 9 to 10 years after construction. The accumulation typically slowed in later years.

In comparison with the rest of the SPS-1 project, sections 0162 and 0163 exhibit significantly smaller amounts of structural damage accumulation. The pavement structure for section 0162 is composed of 200 mm asphalt concrete placed directly on the subgrade. Section 0163 has a pavement structure consisting of an asphalt concrete friction course over roller compacted concrete.

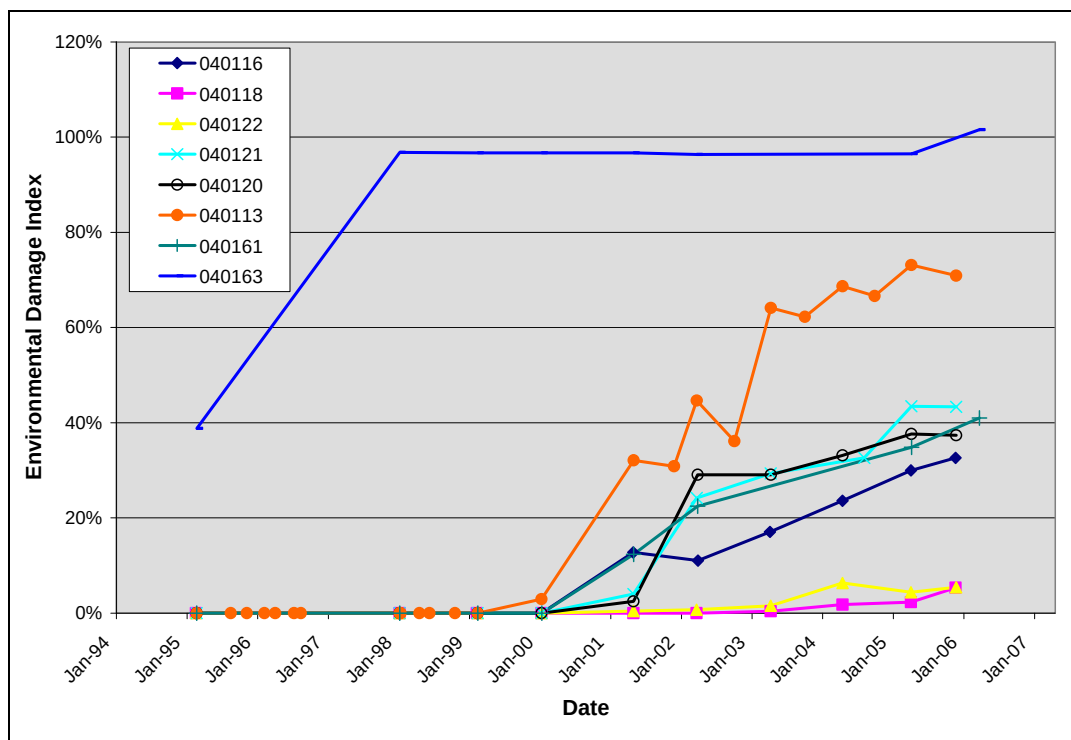
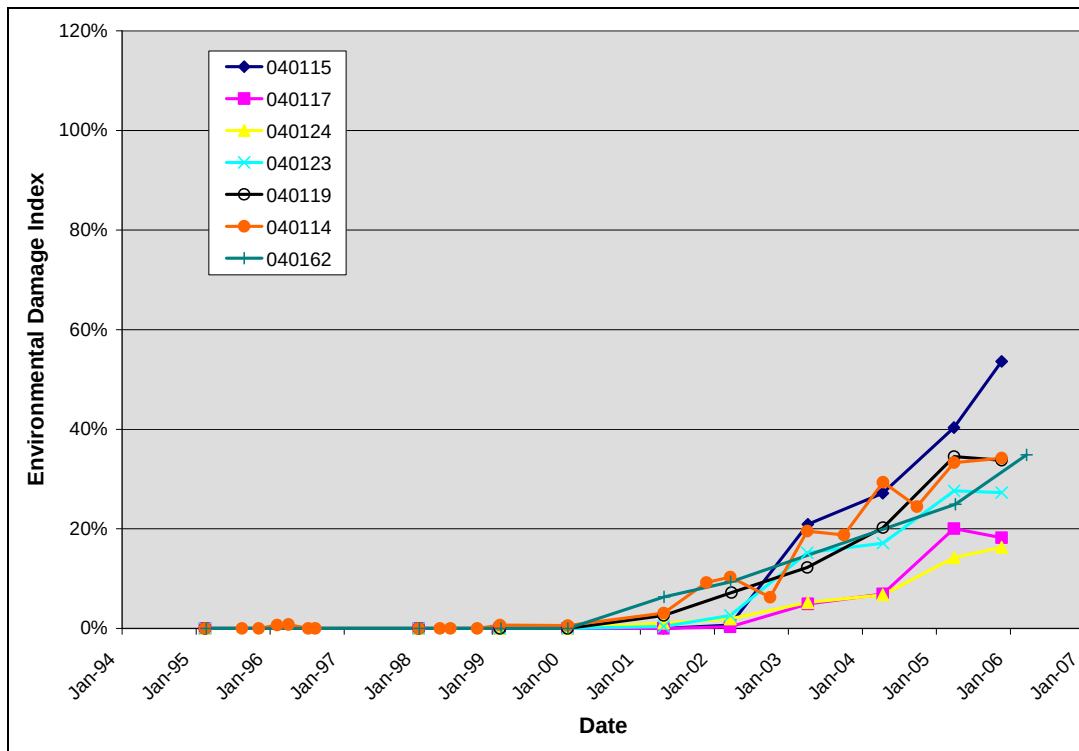
The overall environmental damage trends for each section can be found in Figures 13 and 14. The performance trends are relatively consistent and within the expected range of variation. Although slight decreases were somewhat discernible for surveys within a year of the slurry seal, environmental distresses clearly increased in magnitude approximately 10 years after construction, and there is not a clear indication that the slurry seal provided any abatement to environmental distress. In fact, environmental damage was observed reflecting through the slurry seal on some sections approximately seven months after placement.

The slurry seal did improve the surface characteristics of the road and eliminated the raveling surface. However, the seal was applied after cracking was present, which was too late to be effectively used as a preventative maintenance treatment. The purpose of such application is to slow crack initiation by reducing oxidation and weathering. Oxidation of the asphalt binder increases the brittleness of the binder and promotes raveling and cracking. Slurry seals do not increase the structural capacity of the pavement and are not thick enough to prevent existing cracks from reflecting through the treatment. If cracks are present in the existing pavement, a slurry seal will quickly reflect this cracking, thereby diminishing the expected resistance to oxidation and weathering.

Timing of surface applications is critical to the effectiveness of the treatments. Figures 4 through 7 indicate that the majority of sections had very little cracking in 1998 and the cracking that was present was likely to be of low severity. Applying the slurry seal in 1998 may have resulted in slower deterioration and improved effectiveness of the treatment.

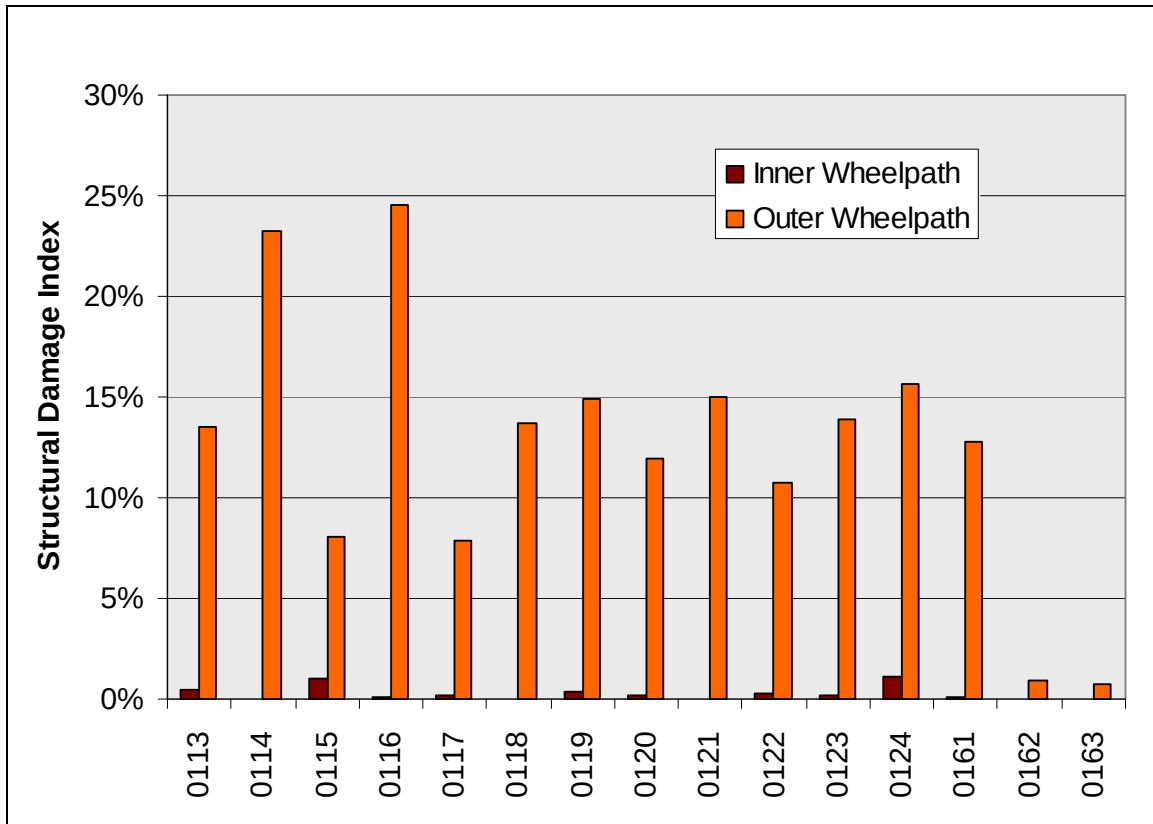
Figure 18. Structural Damage Index separated by wheel path.

As mentioned previously, the paving seam present throughout the SPS-1 project has contributed to the damage accumulated; however, the extent of the seam's influence on performance cannot be completely determined and isolated from deterioration that would have occurred naturally due to environment and traffic. To provide a complete picture of the deterioration, Figure 18 provides structural damage index values for each wheel path. Figure 18 does not isolate construction issues from natural deterioration, but it is expected that the paving seam will have a greater influence on the deterioration of the outer wheel path as compared to the inner wheel path, due to the proximity of the outer wheel path and the paving seam.

From Figure 18, it is apparent that the outer wheel path—largely governed by the paving seam—has driven the overall structural damage. The outer wheel path of every section contains significantly more deterioration as compared to the inner wheel path.

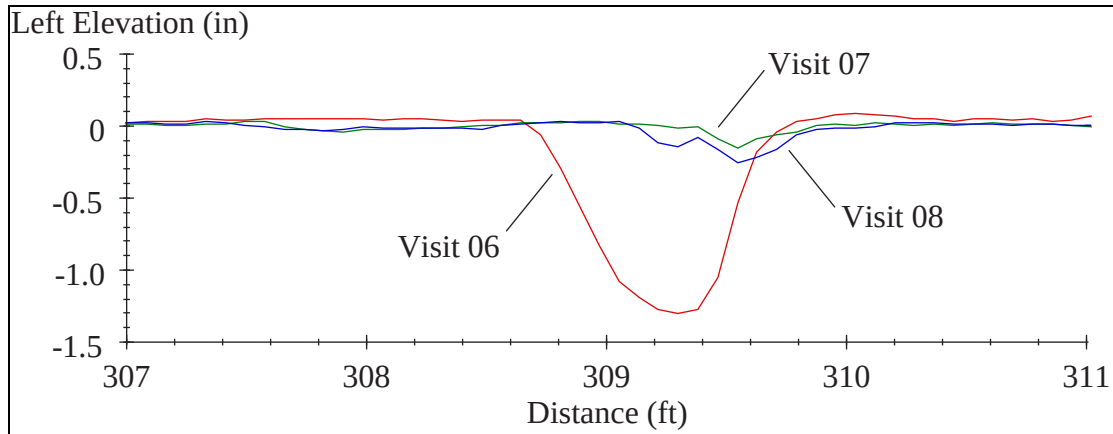
Figure 39. Filtered profile of section 0122.

Although the raw profile plots in Figure 20 provide very useful information about the nature of the roughness on section 0122, a filtered plot may provide a more detailed look at short-duration features of interest, such as the dip at 309 ft. Figure 39 shows a small segment of the profile after it has been high-pass filtered. In this case, a moving average (smoothing) filter with a base length of 20 ft was applied to the profile, and the result was

subtracted from the raw profile. Without the filter, the large changes in elevation along the profile may have masked the dip in visits 07 and 08, such that they may have been ignored. When the profile is filtered, the dip and its shape are much easier to evaluate.

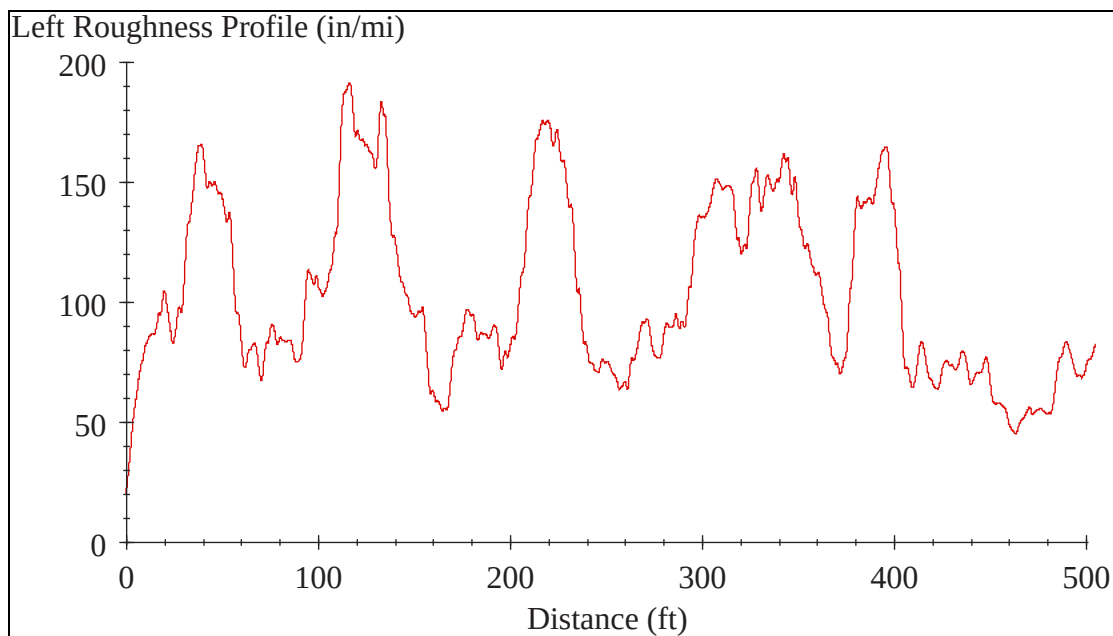
Figure 41. Roughness profile of section 0160, 25-ft base length.

Figure 41 shows an example of a roughness profile for visit 08 of section 0160. The roughness profile was generated using a base length of 25 ft. That means that every point in the plot shows the IRI of a 25-ft long segment of road, starting 12.5 ft upstream and ending 12.5 ft downstream. The plot shows several areas of elevated roughness over the first 400 ft. The smoothest 100 ft segment appears from 400 ft to 500 ft from the start of the section, but it is no smoother than the areas between isolated rough spots over the first 400 ft. Note that isolated roughness is absent over the last 100 ft of the section because it was diamond-ground to smooth the section for an approach to a weigh-in-motion scale just downstream of the section.

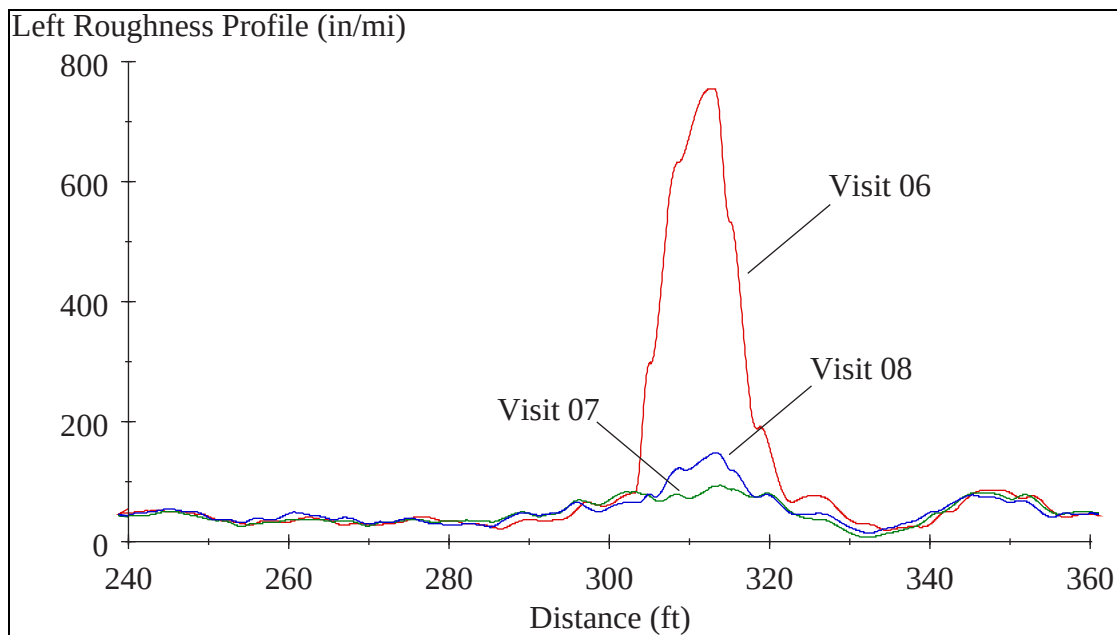
Figure 42. Roughness profile of section 0122, 10-ft base length.

Figure 42 shows how a roughness profile can help find and quantify isolated roughness. The figure shows the roughness profile of section 0122 using a 10 ft base length for visits 06, 07 and 08. With a 10 ft base length, isolated roughness is easy to identify. In visit 06, the peak roughness at the dip is about 755 in/mi. In the same location, the roughness is 88 in/mi. This is a difference of 667 in/mi over 10 ft. Since that value represents the roughness over just one fiftieth of the segment, it suggests that the single dip contributes about 13 in/mi to the overall IRI of the section. This is most of the difference between the IRI in visits 06 and 07.

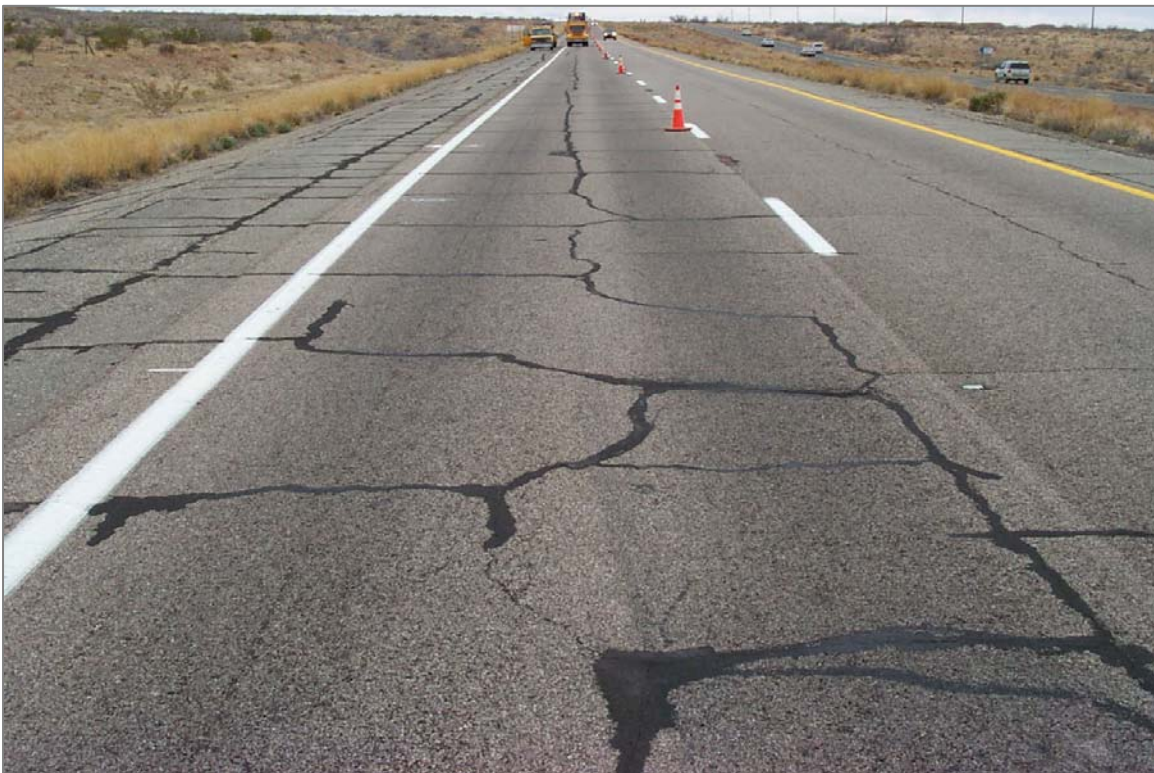
Figure 45. Section 0163 showing long dip in last 100 ft.

The long dip in the last 100 ft of the section appears clearly in Figure 45 below. This is certainly considered a rough feature by passing vehicles.
