## **TECHNICAL MEMORANDUM 3 – CONCEPTUAL DRAINAGE REPORT**

# Yuma Parkway Corridor Feasibility Study – Salome Highway to Palo Verde Road

## FINAL Technical Memorandum 3 Conceptual Drainage Report

August 2011  
091337133

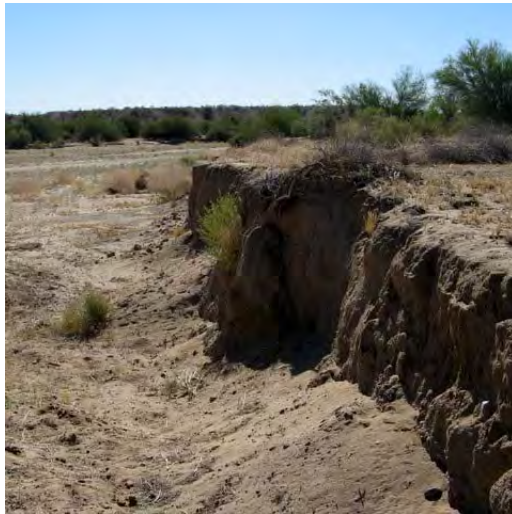
**Vertical cutbanks**

Vertical cutbanks within the limits of the study area, evidence of lateral migration, varied between two to eight feet at the time of the LHWMP field investigation. Cutbanks were typically located on the outside of large bends in the active channel. Bank materials in cutbanks were found to be composed of non-cohesive, highly erodible fine-grained alluvium. Photos 662 and 663 in **Appendix TM3-05** show wash banks in the study area that have recently eroded into near vertical cut banks. These banks are unstable and may continue to erode during successive flood events until a more resistant soil layer is encountered.

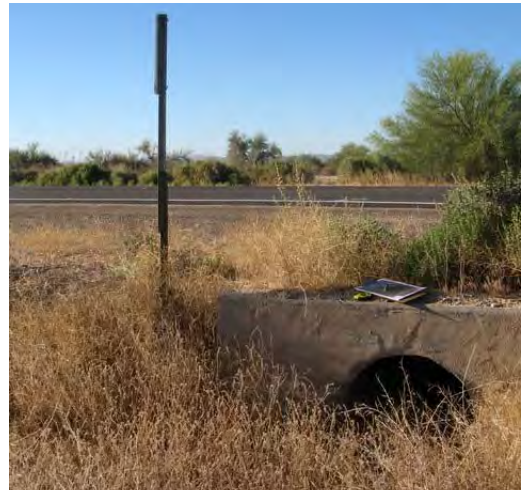
**Culvert near Palo Verde Road**

East of the Hassayampa River, the existing paved Yuma Road contains numerous cross culverts. These culverts are typically corrugated metal pipe (CMP) with concrete headwalls. The design storm of these culverts is not known, but based on field observations they are only capable of containing relatively small flows. Erosion protection at outlets was not observed; however, little evidence of inlet or outlet scour was seen in the field.

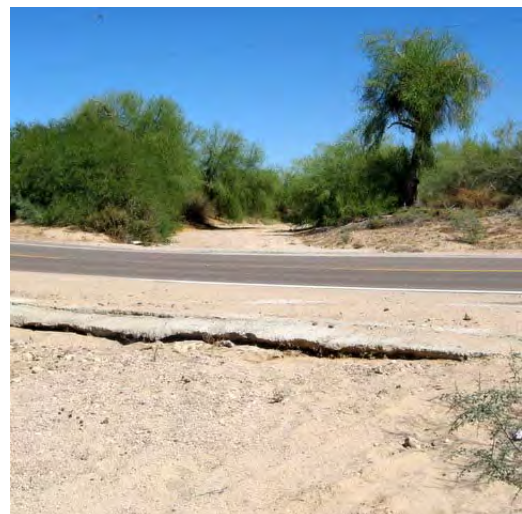
**Dickey Wash crossing**

The existing Buckeye Road features at-grade dip crossings instead of culverts at the eight study crossing locations west of the Hassayampa River. The larger washes have concrete aprons on the upstream and downstream sides of the at-grade crossings. Evidence of downstream undercutting of this apron, as shown in the photo at right, was found at the Dickey Wash crossing.

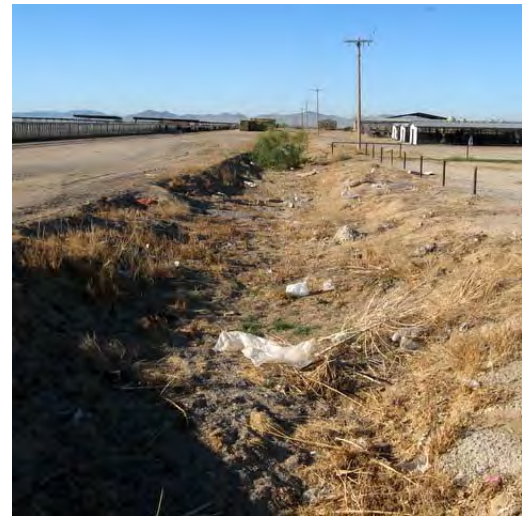
**Stotz Dairy channel**

The only drainage channels observed during the field visit were at Stotz Dairy and Phillips Wash. An earthen channel has been constructed south of Yuma Road through the dairy property. This channel likely has been designed to convey both offsite flows and local onsite runoff from the dairy land. As with all the drainages east of the Hassayampa River, little offsite flow is expected due to the Buckeye FRS #1.

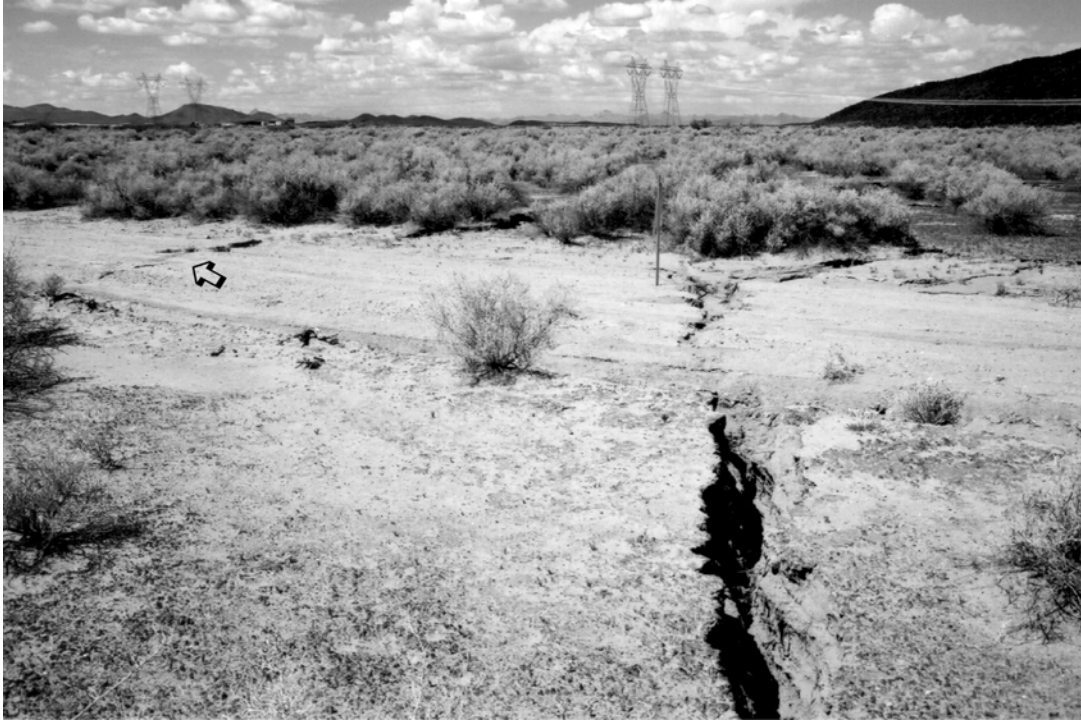
Figure 5. En echelon section of earth fissure crossing Baseline Road, looking NW. Fissure is 6-12 inches wide here. Second earth fissure crosses road at far left (arrow).

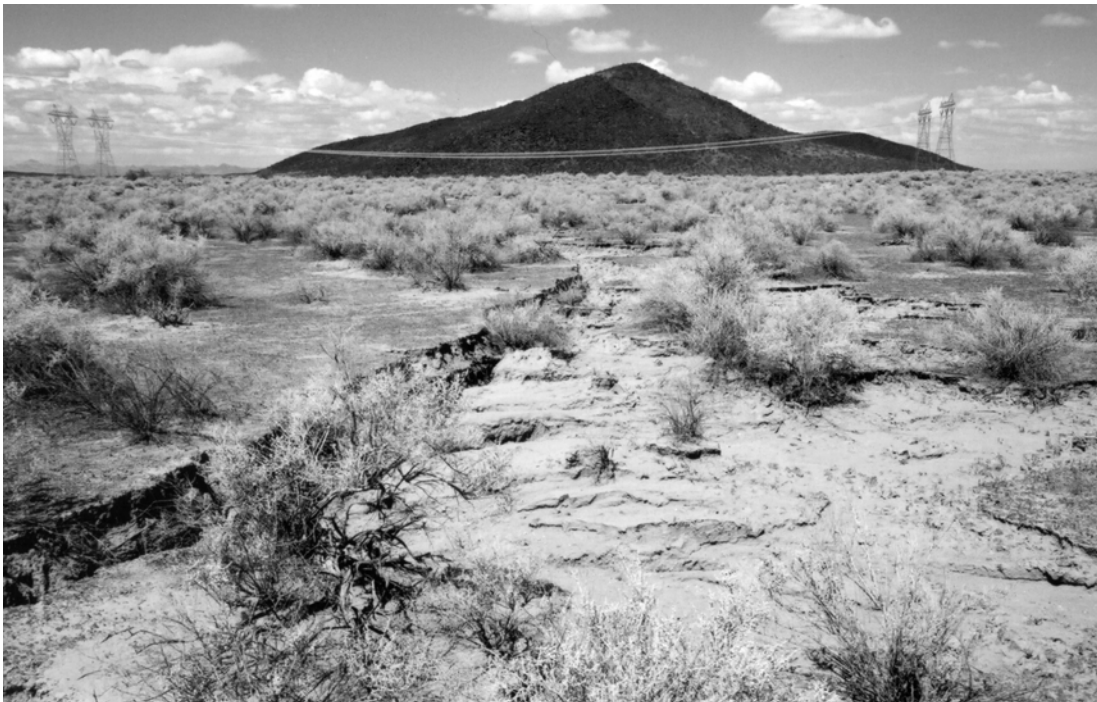
Figure 6. Section of earth fissure north of Baseline Road, showing erosion on uphill (east) side. Fissure is 12-18 inches wide, 1-6 feet deep in this section.

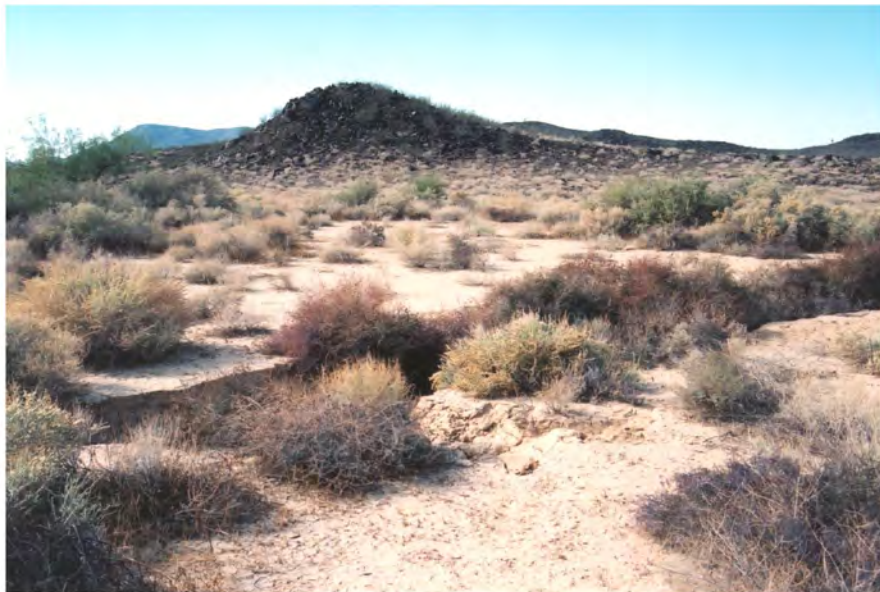
Figure 8. Crack near outcrop at northern end of main cluster, Winter 2002. This crack has multi-stage history, as shown by older vegetation in renewed crack.

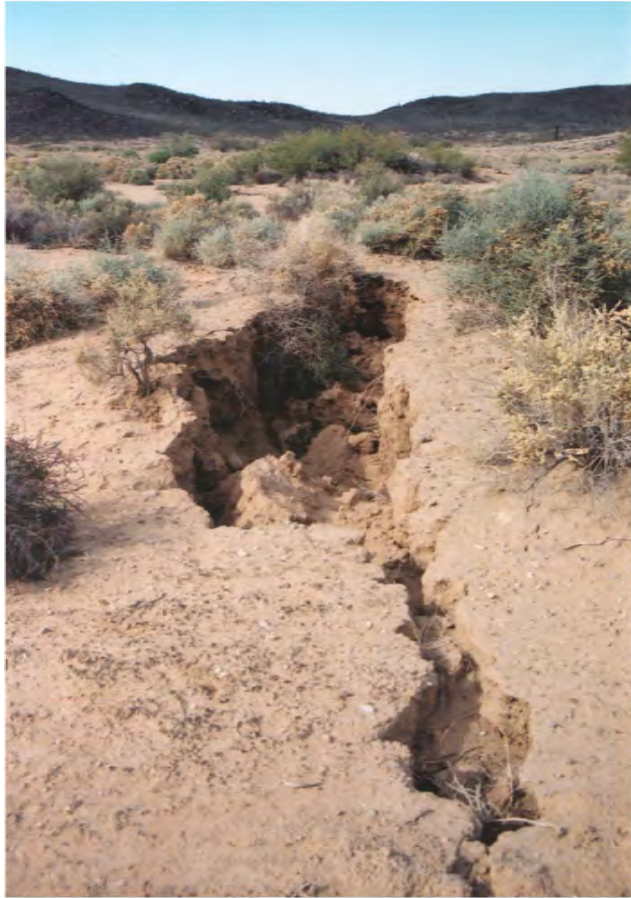
Figure 9. Crack near northwestern end of main cluster displays highly variable width and depth along its course.

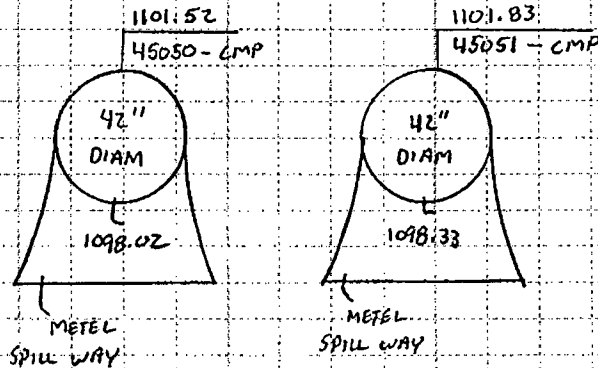
Photo Taken (UPSTREAM) NORTH

SPILLWAYS ARE 6' FROM INVERT TO END OF SPILLWAY

General Condition of Structure GOOD

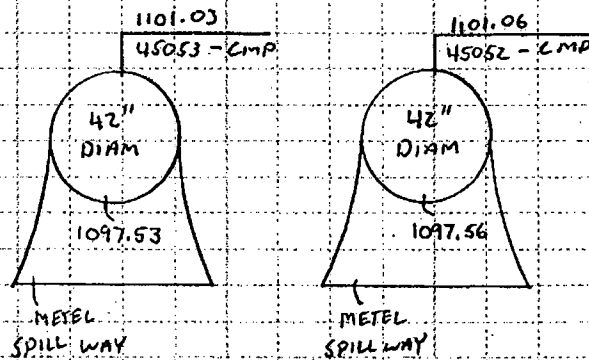
Photo Taken (DOWNSTREAM) SOUTH

SPILLWAYS ARE 6' FROM INVERT TO END OF SPILLWAY

General Condition of Structure GOOD

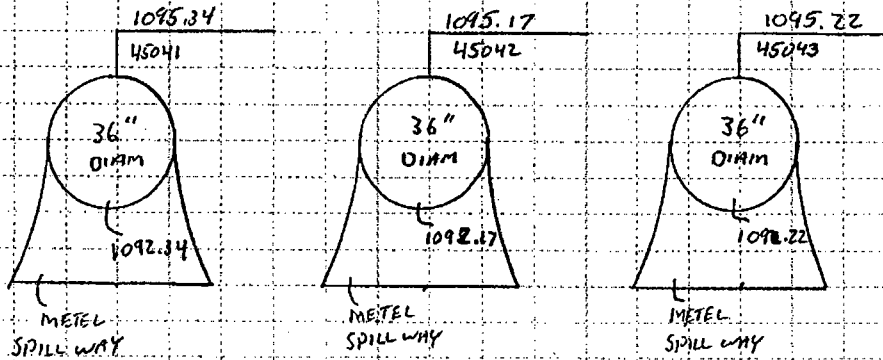
Photo Taken (UPSTREAM) NORTH

ALL SPILL WAYS ARE 5' FROM INVERT TO END SPILL WAY.

General Condition of Structure GOOD

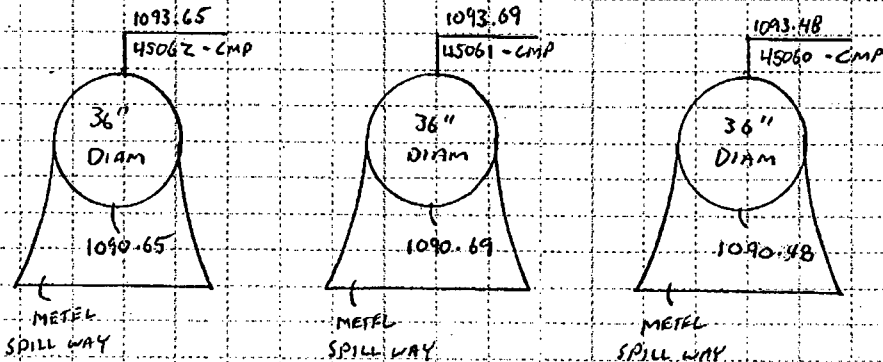
Photo Taken (DOWNSTREAM) SOUTH

ALL SPILL WAYS ARE 5' FROM INVERT TO END SPILL WAY.

General Condition of Structure GOOD

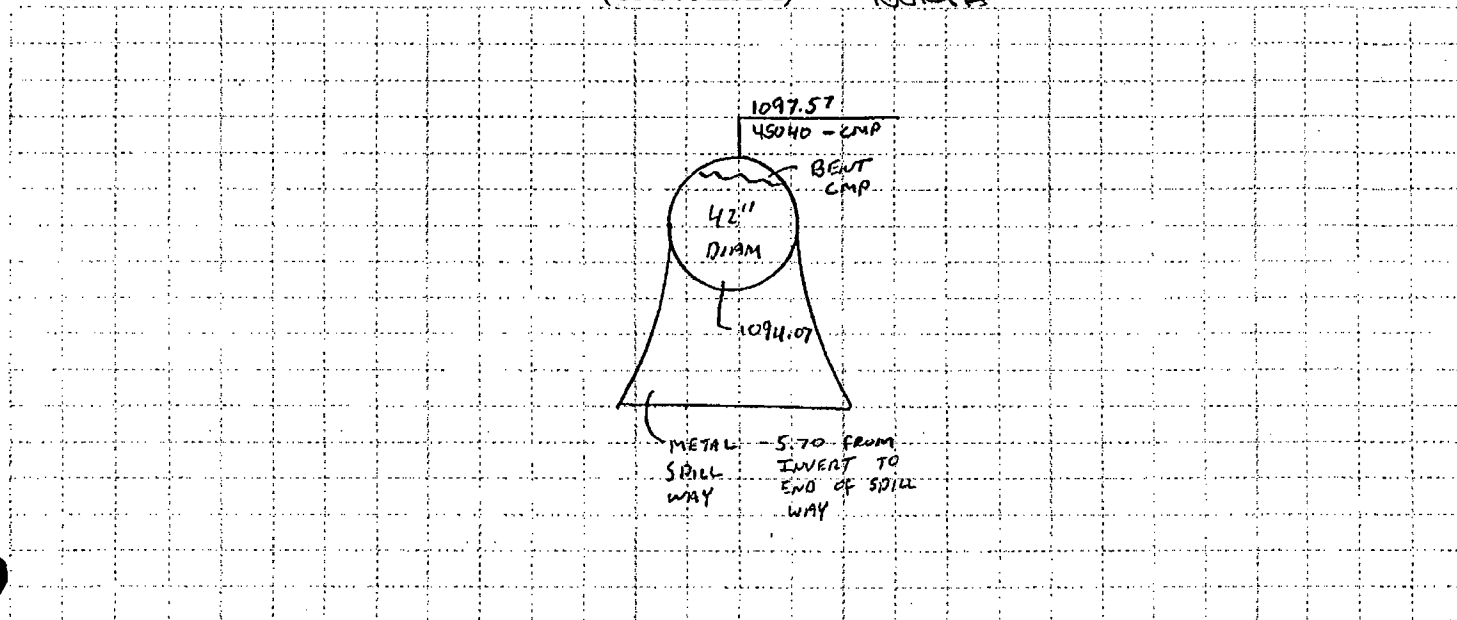
Photo Taken (UPSTREAM) NORSTA

General Condition of Structure TOP OF CMP BENT
