Geomorphic Analysis Report for the Lee Moore Wash Basin Management Study in Pima County Arizona

Prepared for and in cooperation with the
Pima County Regional Flood Control District

August 2008

By Ian P. Sharp, P.E., CFM
JE Fuller Hydrology & Geomorphology Inc.

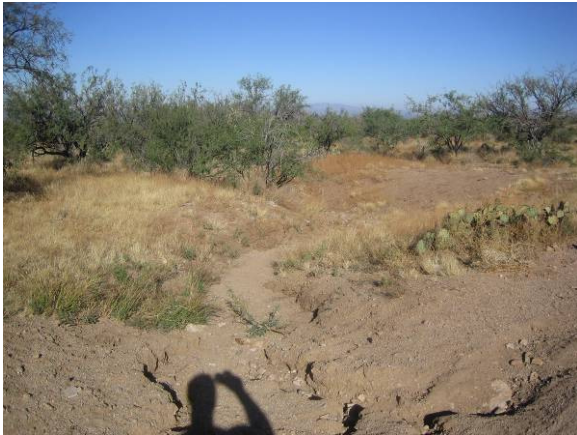
Following are a couple representative locations where scour was greater downstream of a road crossing. The first example (Figure 4) is a case of scour downstream of a road crossing with no significant flow path or scour upstream of the road crossing. The observation occurred in the upper basin, away from the significant headcutting found nearest the Santa Cruz River. The second observation (Figure 5) is of a more significant wash lower in the basin. The banks downstream of the road are vertical while upstream of the road they are sloped and vegetated. The bed material is visibly coarser downstream of the road. This location is close to the Incised Zone where the headcutting is most active and the observation is most likely of a headcut terminated by a road in association with local scour generated by the road crossing.

Scour extends some distance downstream of road (LM01-09-02)

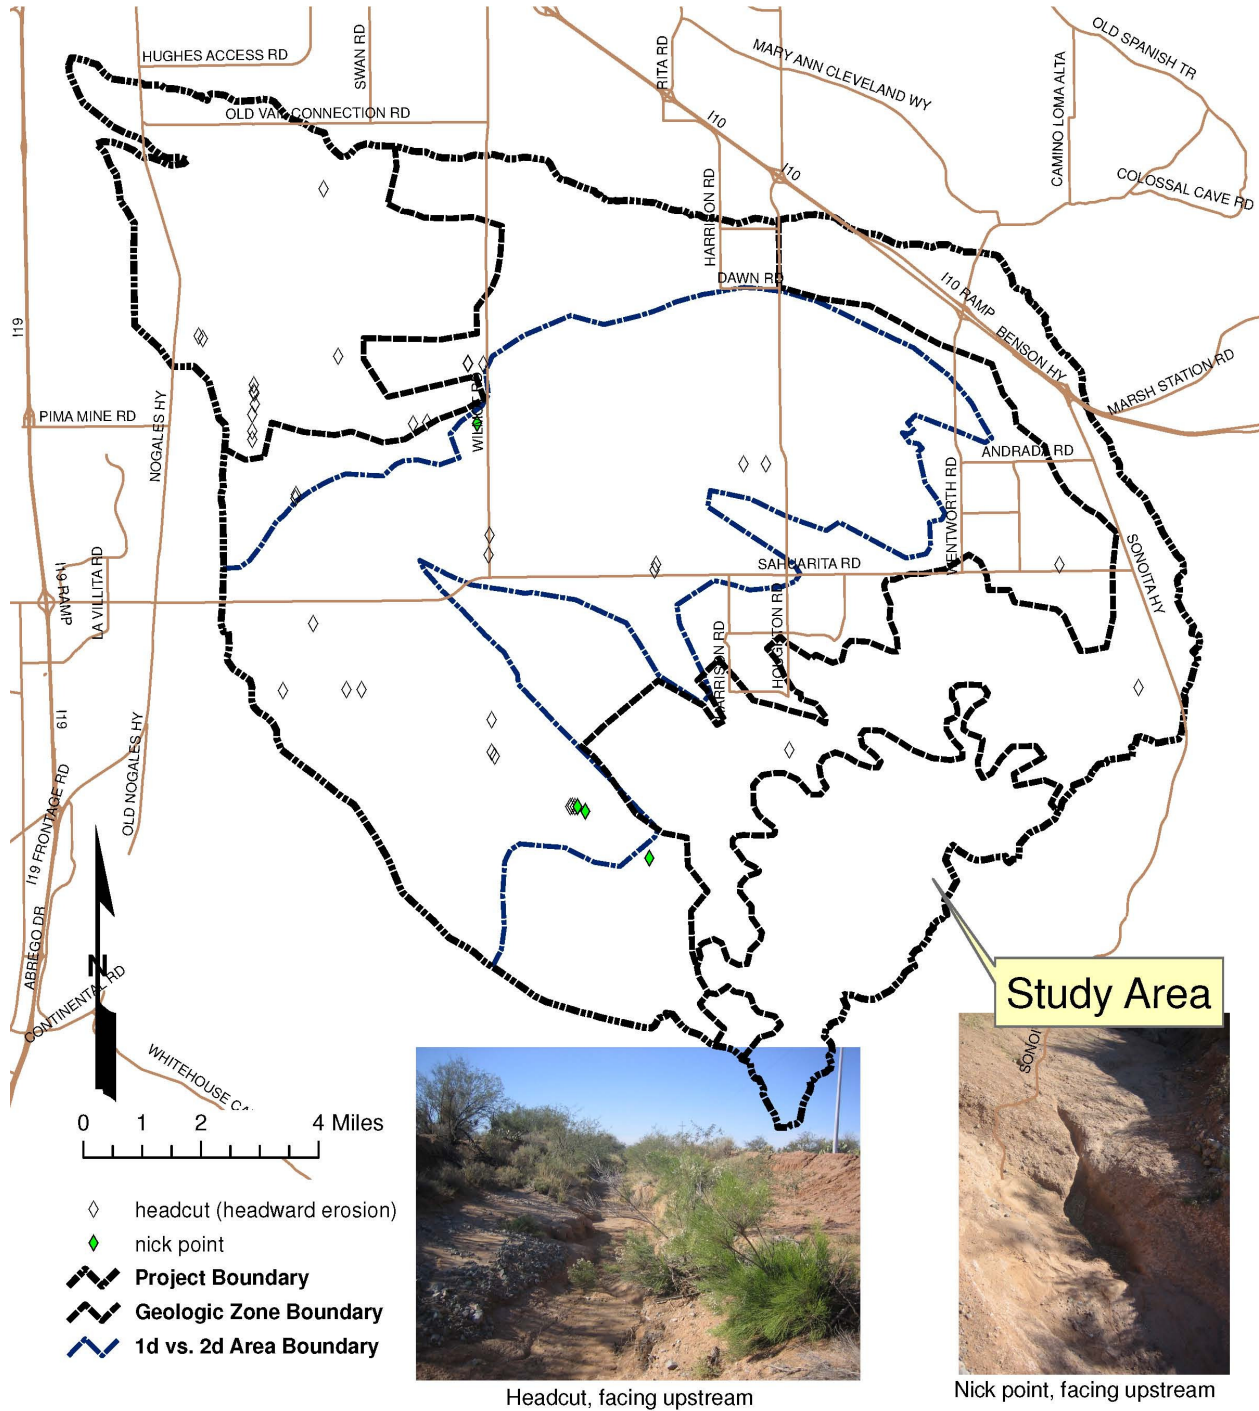
Figure 7 shows the locations where headward erosion (this term may be considered synonymous with headcut within this report) and nick points (where a headcut meets a resistant material) were observed. Locations of headward erosion refer to areas where channel incision was observed and the inferred cause was headcutting. Section 6.3.2 provides more explanation of these terms and provides some example photographs of headward erosion.

Figure 7 - Observed locations of headward erosion

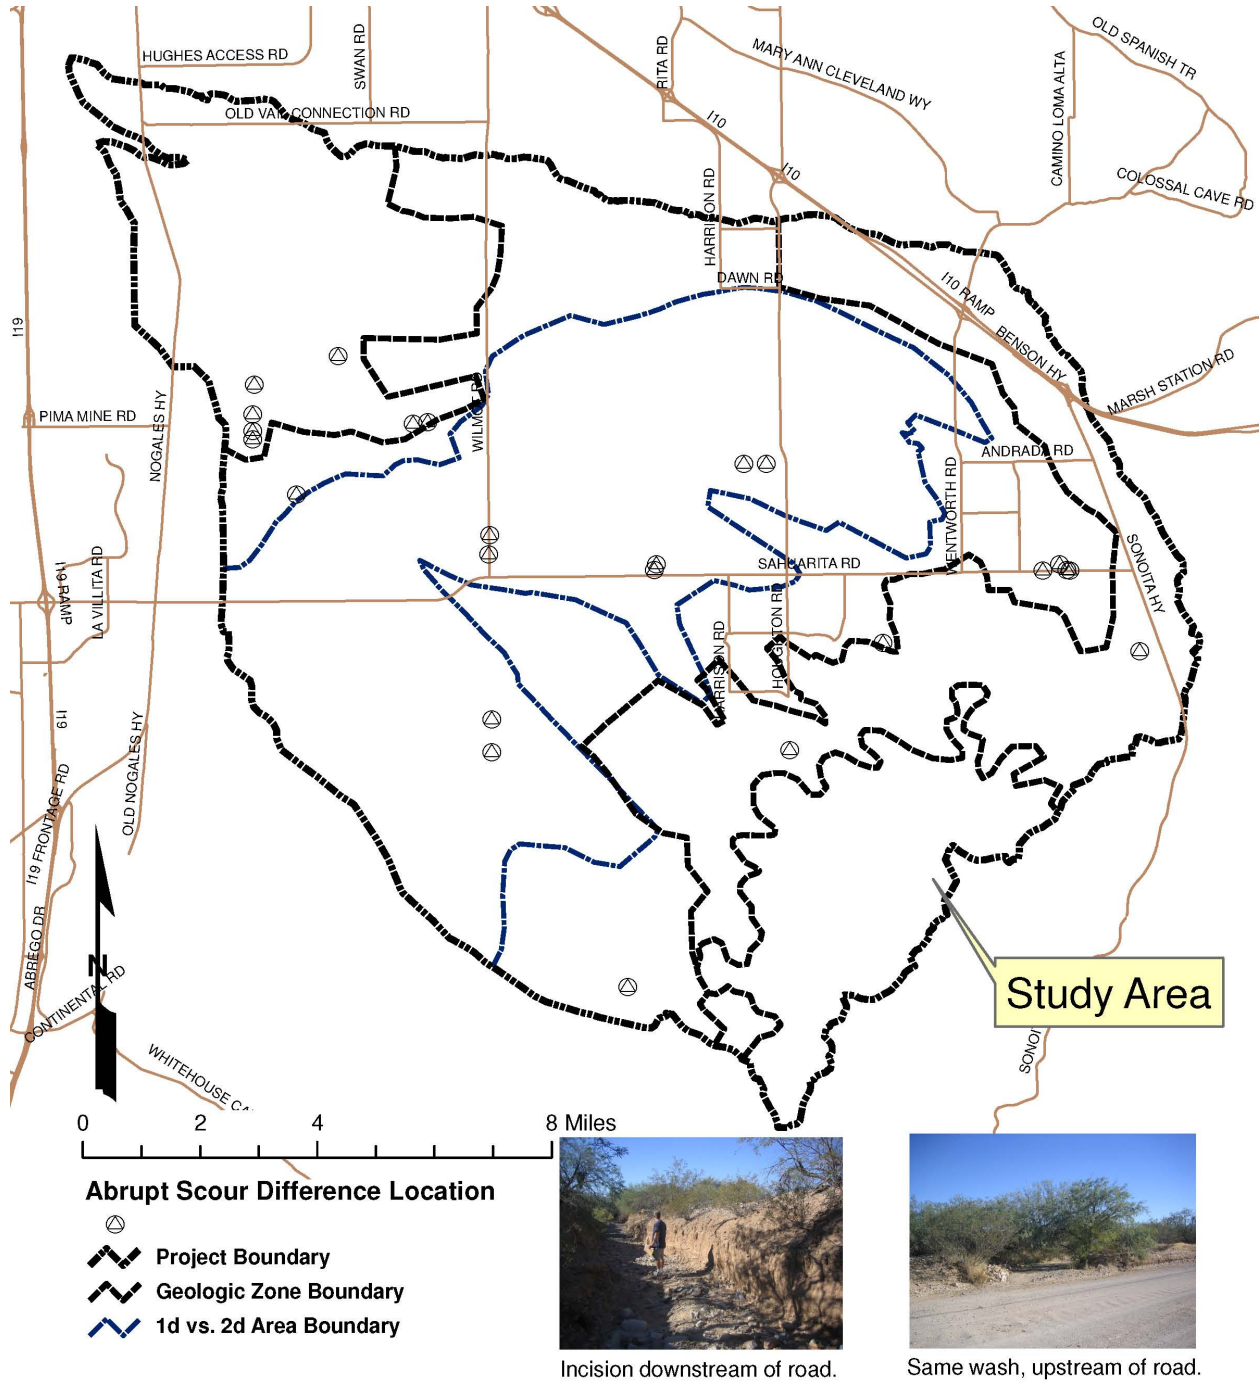
Figure 8 shows the locations where scour was observed downstream of the point of interest but not upstream, typically at dip road crossings. These locations were labeled ‘abrupt scour difference’ locations.

Figure 8 - Observed locations of abrupt scour differences

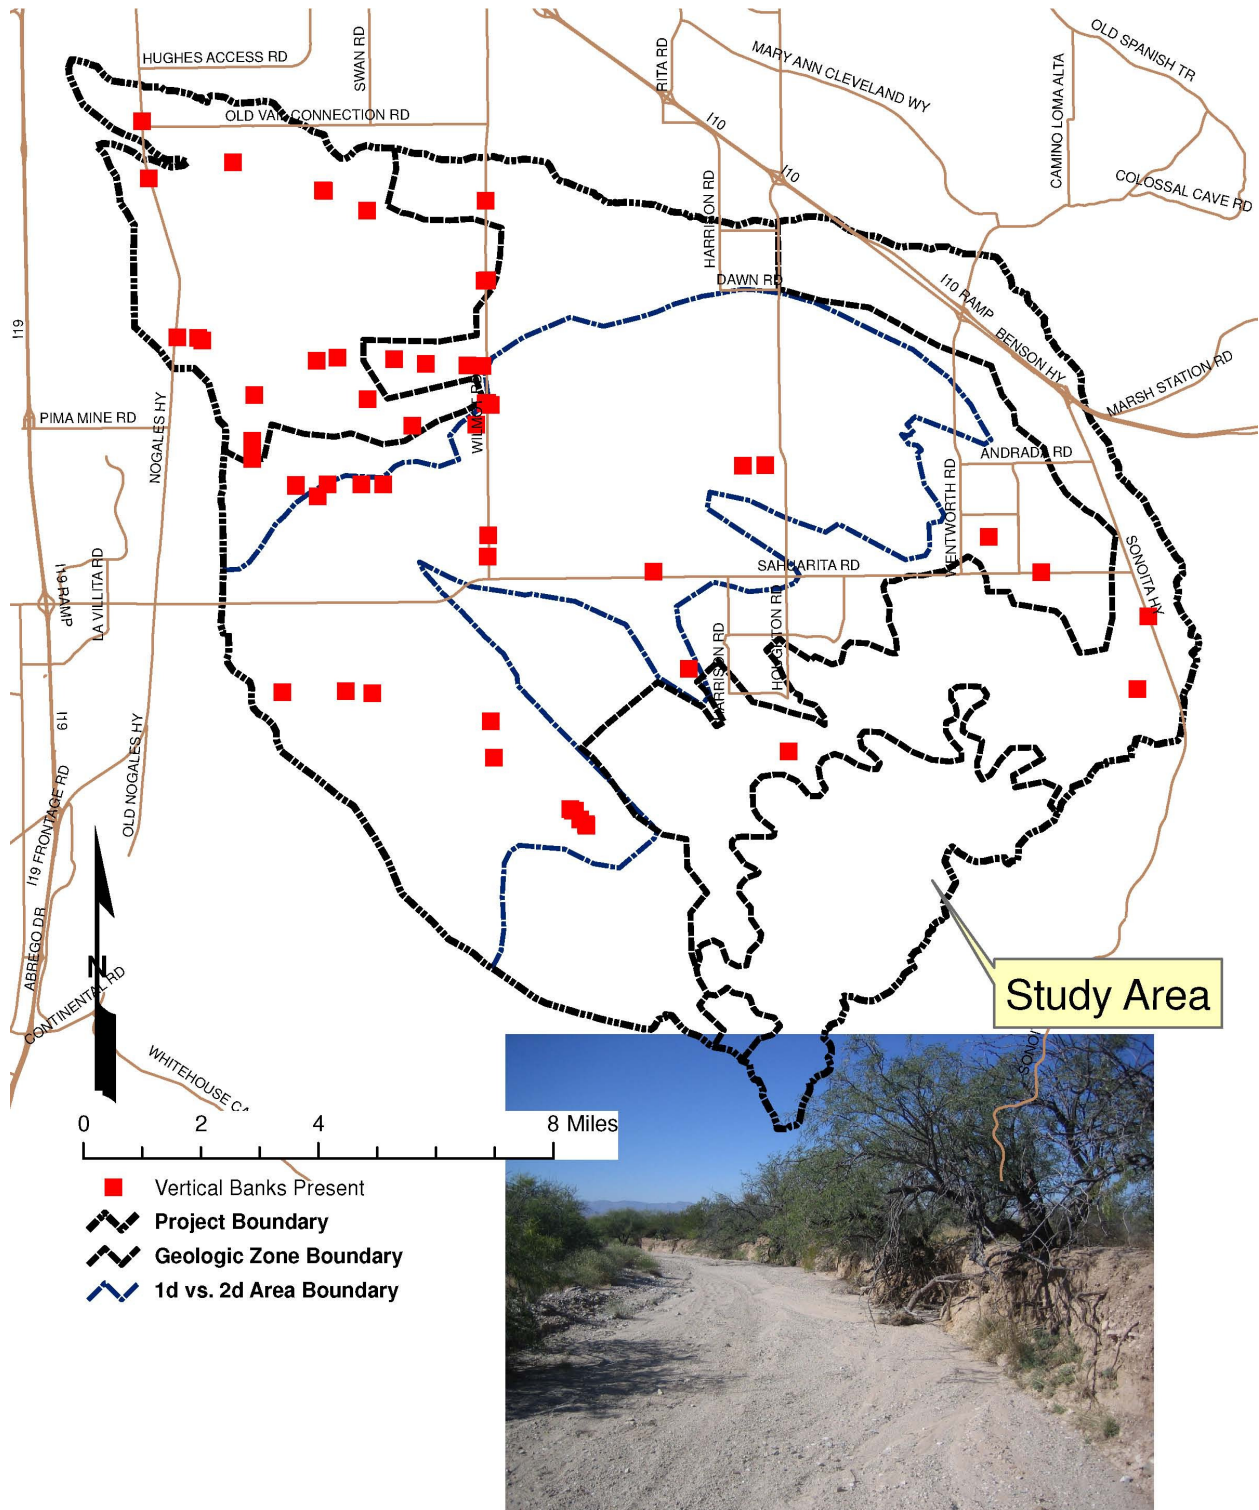
Figure 9 shows the locations where vertical banks were observed.

Figure 9 - Observed locations of vertical banks as found in field reconnaissance

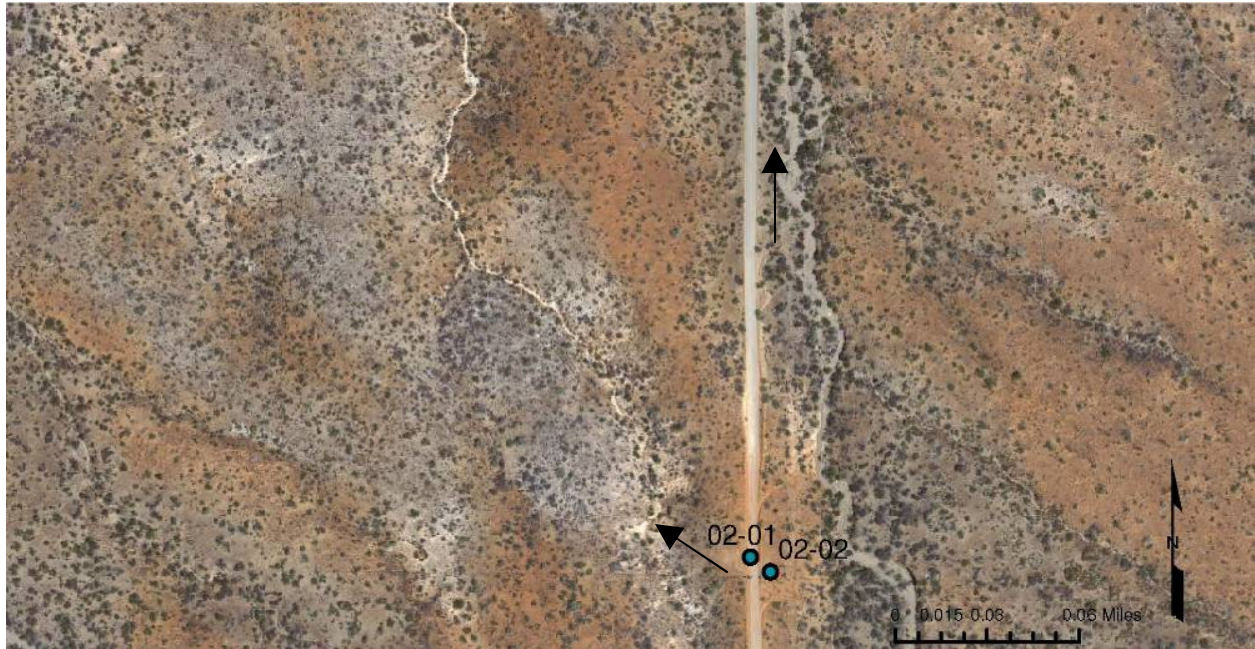
Localized Headcutting along south Houghton Road

Figure 46 shows the location of a headcut observed along south Houghton Road. The flow direction is to the northwest at this location and flow crosses the road to drain to the wash located west of the road. The wash west of the road is not highly incised and is not impacted by headcutting. However, the wash is at an elevation below the road, and concentrated flow which crosses the road at this location and drains to the wash has caused a headcut to develop from the wash to the road. Only minor scour was noted upstream of the road (LM02-02-01) in association with almost no channel development. LM02-02-02 shows the downstream view where an incised wash has developed with vertical banks. The road has terminated the headcut.

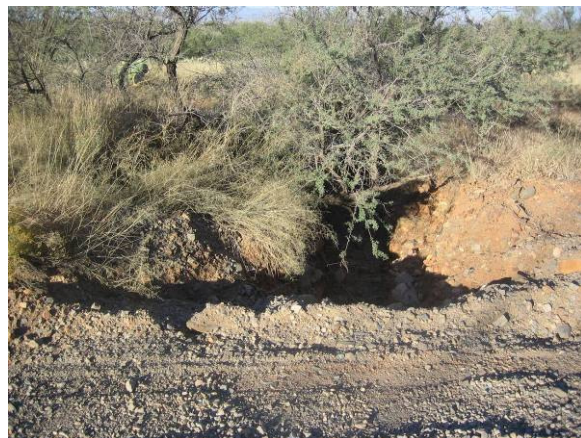
View downstream of drainage across south Houghton Road, headcutting observed below road (LM02-02-02)

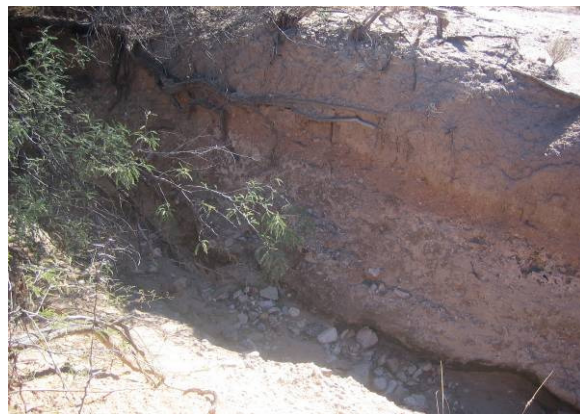
Visible soil horizons below Ql/Qm surface found on recently eroded bank (LM01-47-01)

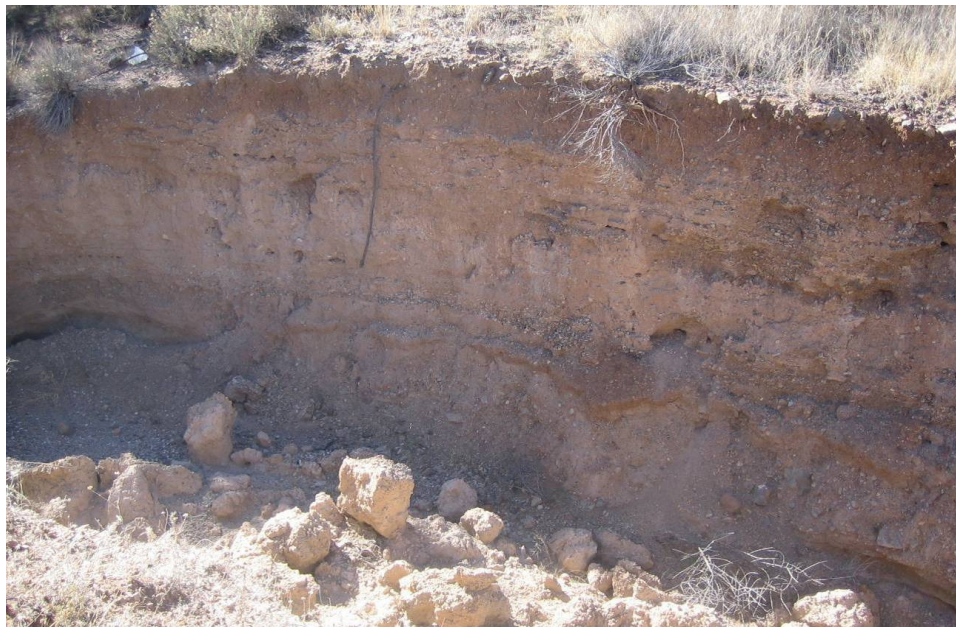
Visible soil horizons below Qm surface found on recently eroded bank (LM02-46-03)

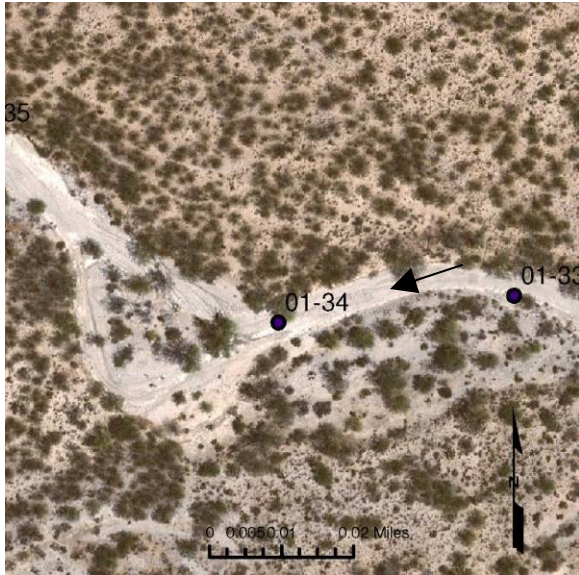
Lateral erosion and avulsion occur within this zone. Figure 53 shows a channel that has cut a path towards the inside of the channel bend. Several instances of vertical banks, specifically along outside bends, were noted. Vertical banks are typically about 4 feet high with exposed roots. Vertical cutbanks exceeding 250 feet in length were found.

Aerial view of avulsion on Qy surface

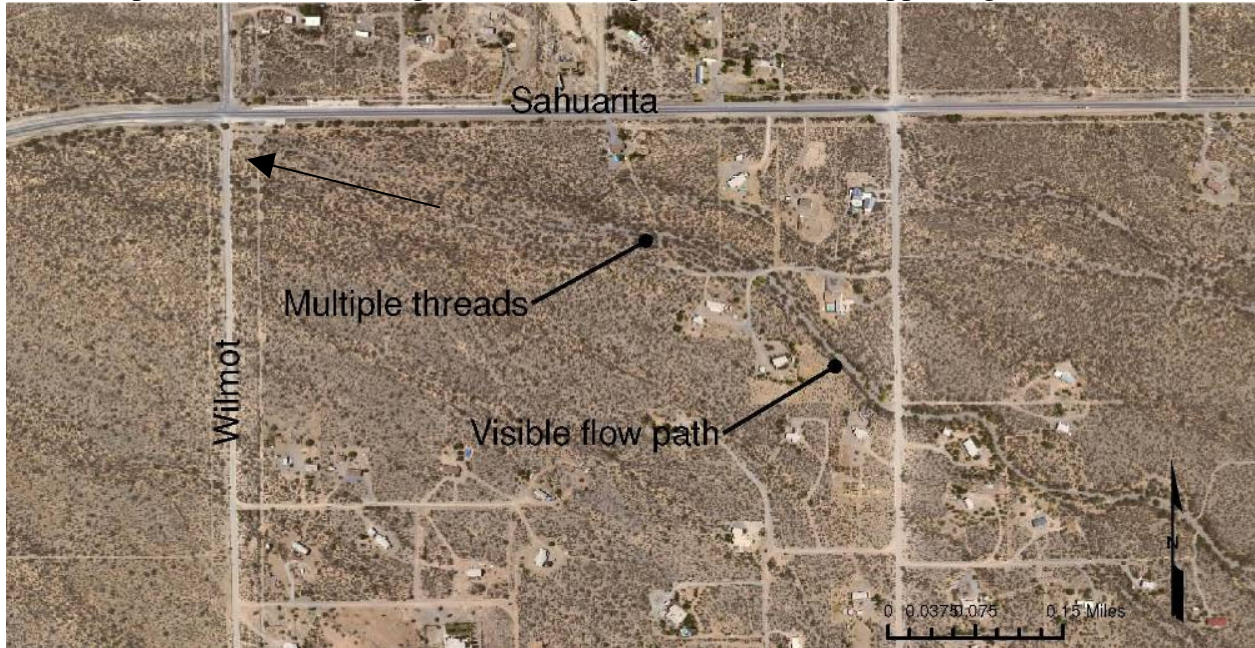
All of the identified disappearing washes are found within the Distributary Piedmont Zone. The cause of this phenomenon is most likely the deposition of sediment. As the gradient decreases, the energy necessary to convey the sediment within the channel diminishes and sediment is deposited. A transition to sheet flow ultimately occurs as flow is forced out of a main channel into multiple threads. Following are a few example locations of disappearing washes.

Disappearing washes, southeast of Sahuarita Road and Wilmot Road intersection

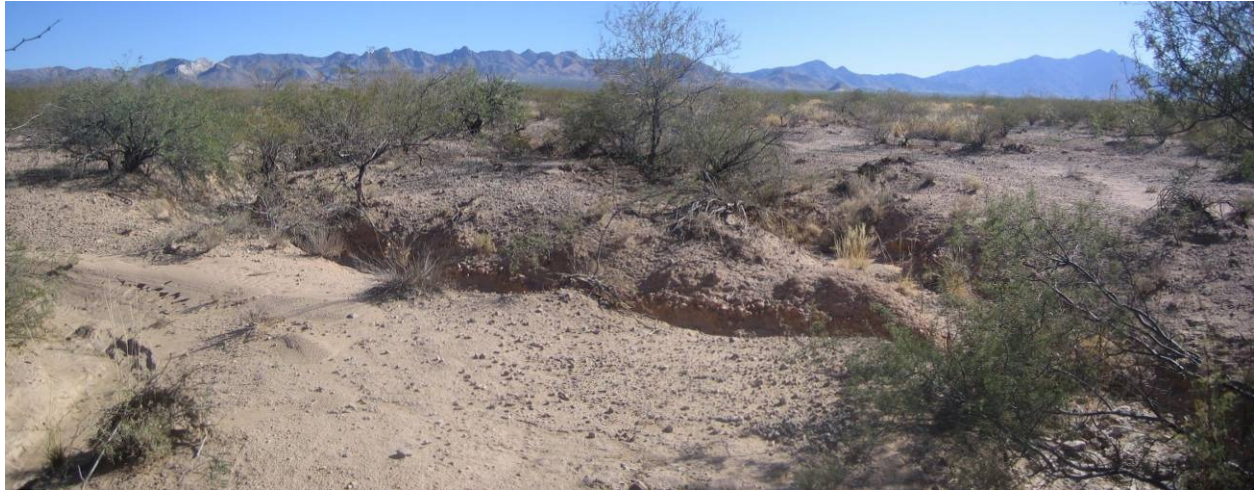
Gullies are forming in several of the flow paths shown in the above aerial images. An example is shown in Figure 60. The gullies are relatively young, narrow, and v-shaped with no gravel or sandy bed material. The primary cause of the gully development is headcutting. The bottom right image (LM03-61-02) within Figure 60 is a view of the same channel network over 2 miles downstream. The channel at this location is incised. In addition to the headcutting which is migrating upstream to this point, local scour has been introduced by the road crossing and is also progressing upstream near photo point 01-47.

Headcutting on M1/M2 surface (panorama of LM01-48-01 and 02)

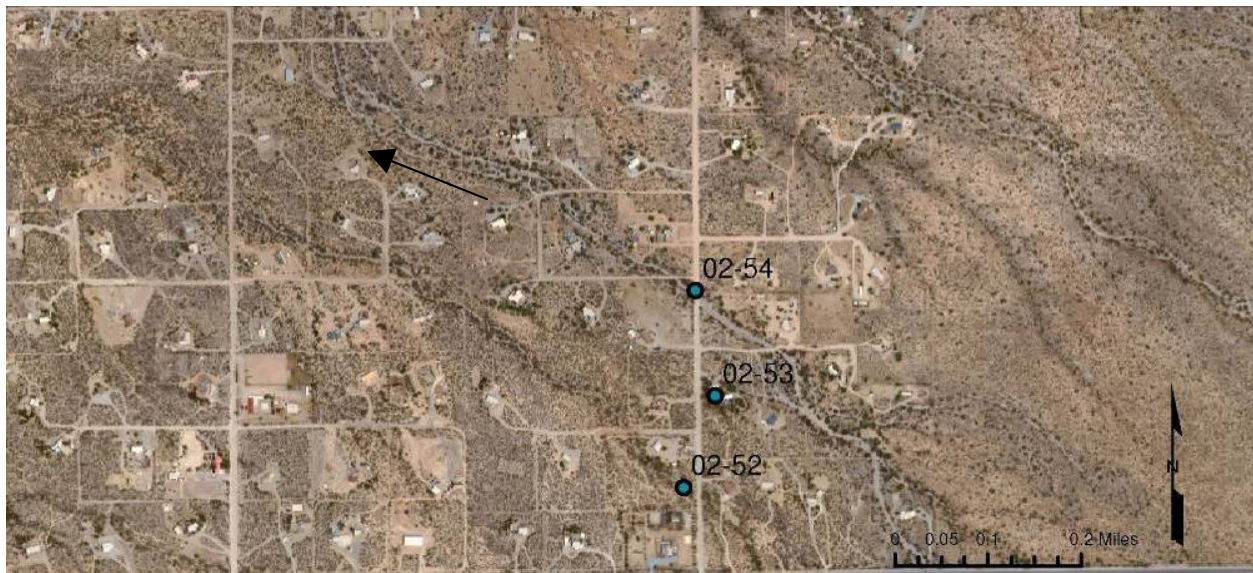
Another location of headcutting was found along Salero View Road, north of Sahuarita Road, see Figure 63. The crossing is a simple crossing; the profile of the road does not dip down into a channel. Both ground images were obtained from the same location. The channel is not much lower than the adjacent landscape and it appears that some sediment deposition has occurred upstream of the road with the channel aggrading to the elevation of the road. Vertical scour downstream of the road has cut a significant trench with the channel banks extending up approximately 6-feet. This is a location identified as an abrupt scour difference, and the observed scour downstream of the road is primarily a result of headcutting. A small, local contribution to the scour may be due to concentration of flow at the crossing and scour introduced by weir flow over the road. Headward erosion is mitigated by the placement of a concrete spillway.

Aerial view of headcutting washes crossing Salero View Road

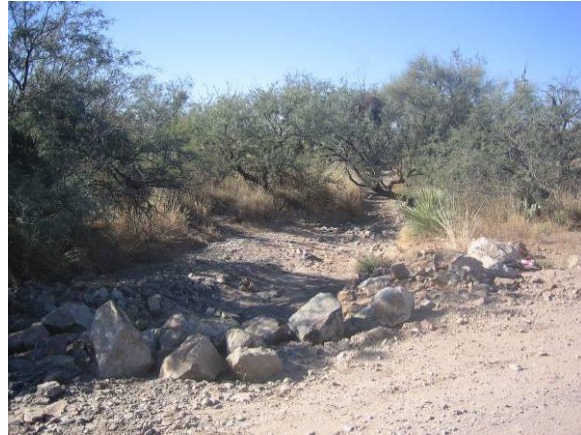
Rip rap along Salero View Road, north of Toro Bronco, Qy surface (LM02-55-01)

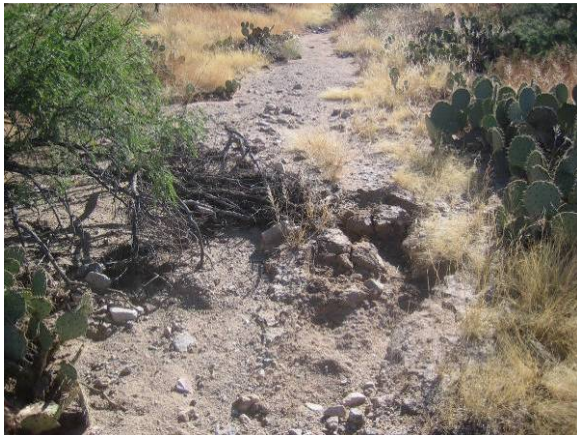
Figure 65 shows two locations where possible nick points were found along minor headcuts. The scour shown in the first photo is also associated with the debris lodged within the channel. The nick point shown in the second photo is along a seemingly abandoned flow path.

Nick point, facing upstream (LM01-13-01)

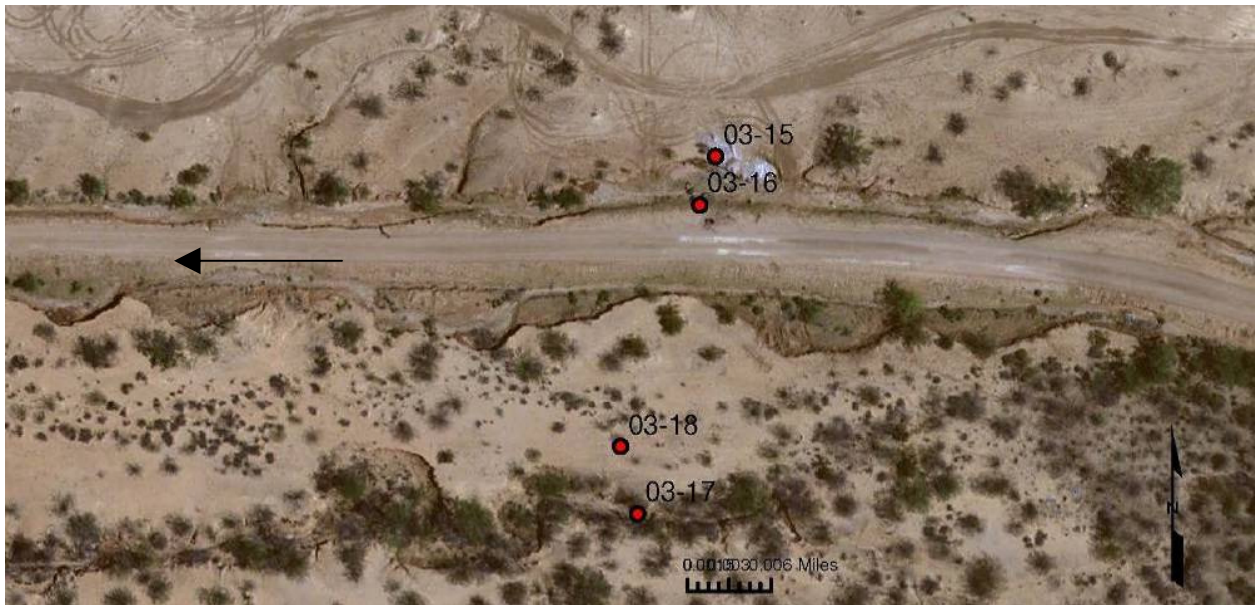
Figure 67 shows aerial views of flow paths within the Distributary Piedmont Zone that run parallel to roads. Multiple geomorphic processes seem to have caused the observed erosion. Note that in the top photo of Figure 67 the wash at the bottom of the frame is cutting into the floodplain terrace. This wash (LM03-17-01) is not impacted locally by the road, indicating that the roads are not entirely responsible for the scour and that headcutting and system wide scour is occurring. Furthermore, this area is tributary to the Cuprite Wash. A downstream reach of this tributary was observed to be incising as shown on LM03-26-01 (within the upper limit of the Incised Zone). Furthermore, it was observed elsewhere that the Fagan Wash, which Cuprite Wash is tributary to, is incised downstream of this location.

Aerial view of erosion along flow paralleling dirt road

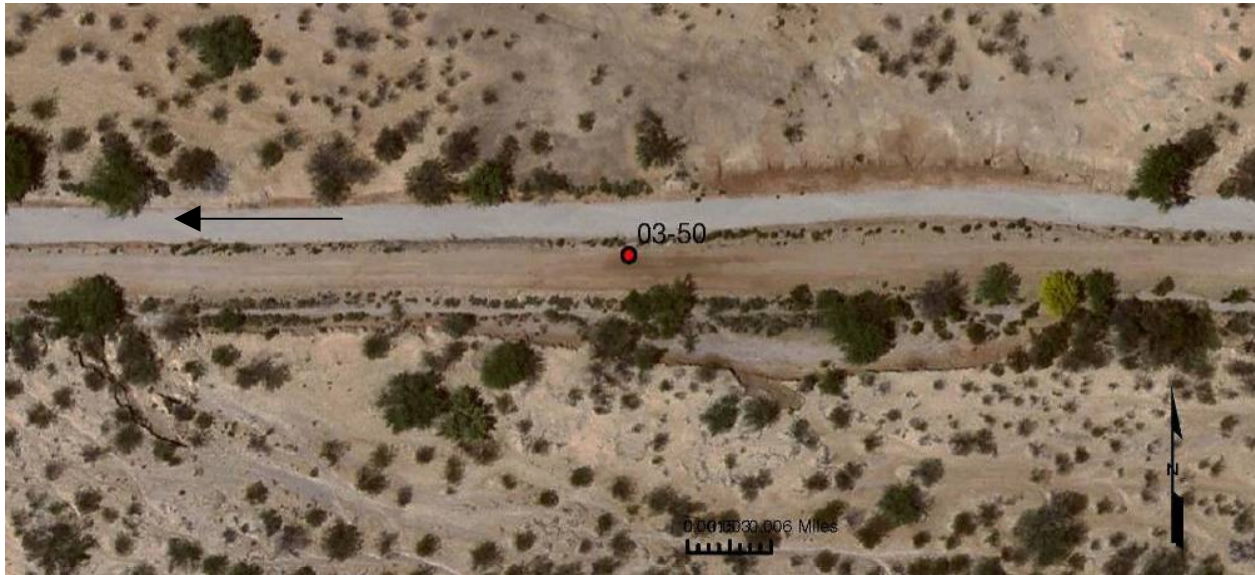
Another aerial view of a flow path parallel to a road is shown in Figure 68. The observed erosion is similar at this location to that of Figure 67.

Another aerial view of erosion along flow paralleling dirt road

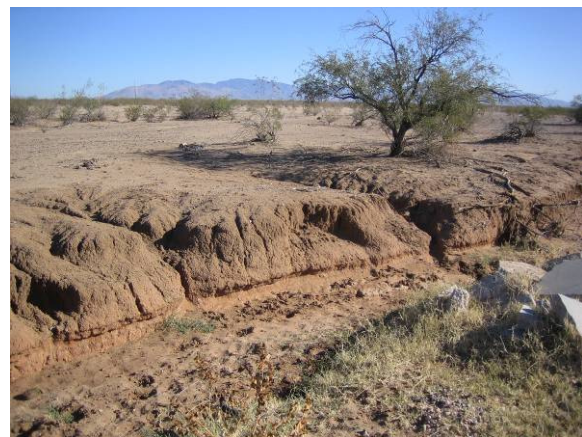
Headward erosion from flow spilling into roadside drainage, Qyd surface (LM03-15-02)

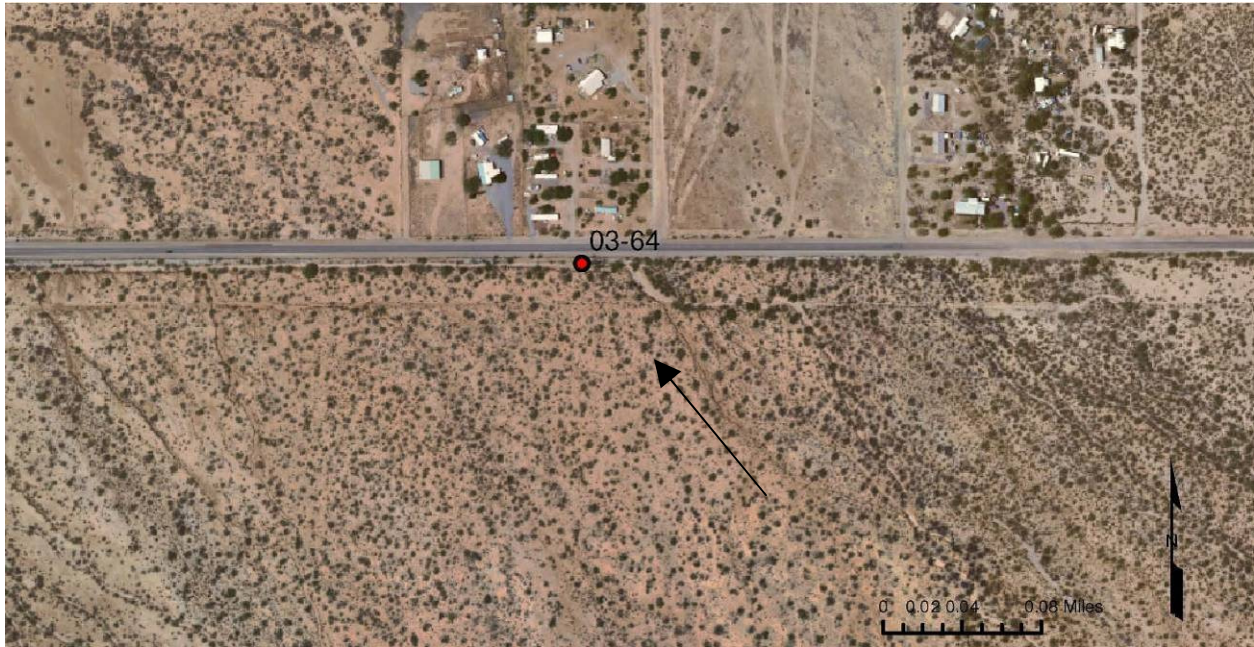
Other areas where roads are parallel to flow paths and with similar, yet less severe scour problems were found in areas such as along the south side of Dawson Road within the southwest portion of the Distributary Piedmont Zone (Figure 70) and south of Sahuarita Road, west of Houghton Road. The natural flow paths do not parallel the roads, but the flow paths have been redirected by the roads and therefore parallel the road for some distance.

Flow path altered at Dawson Road, west of Alvernon Road

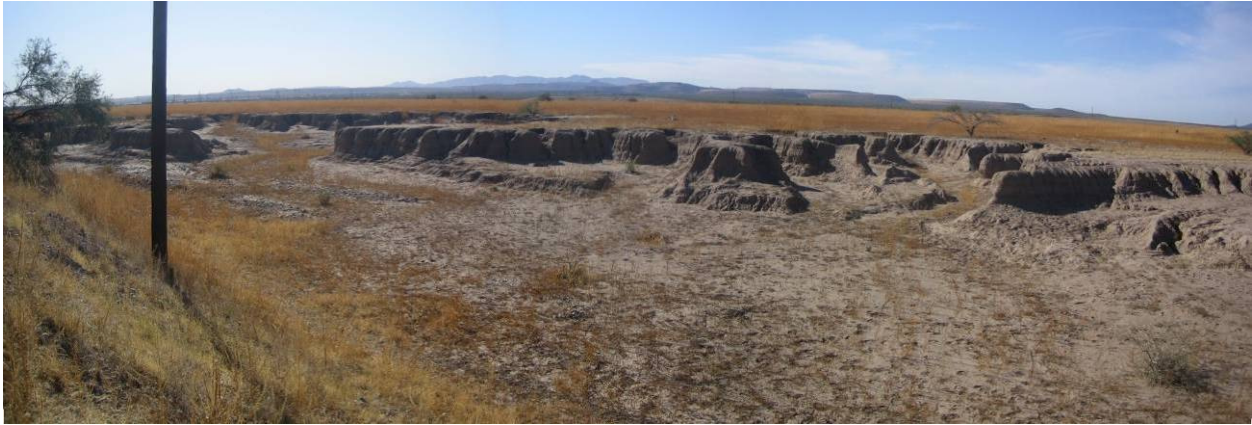
Widespread erosion on T2 surface west of Nogales Highway. (Panorama of LM03-65-01, 02, and 03)

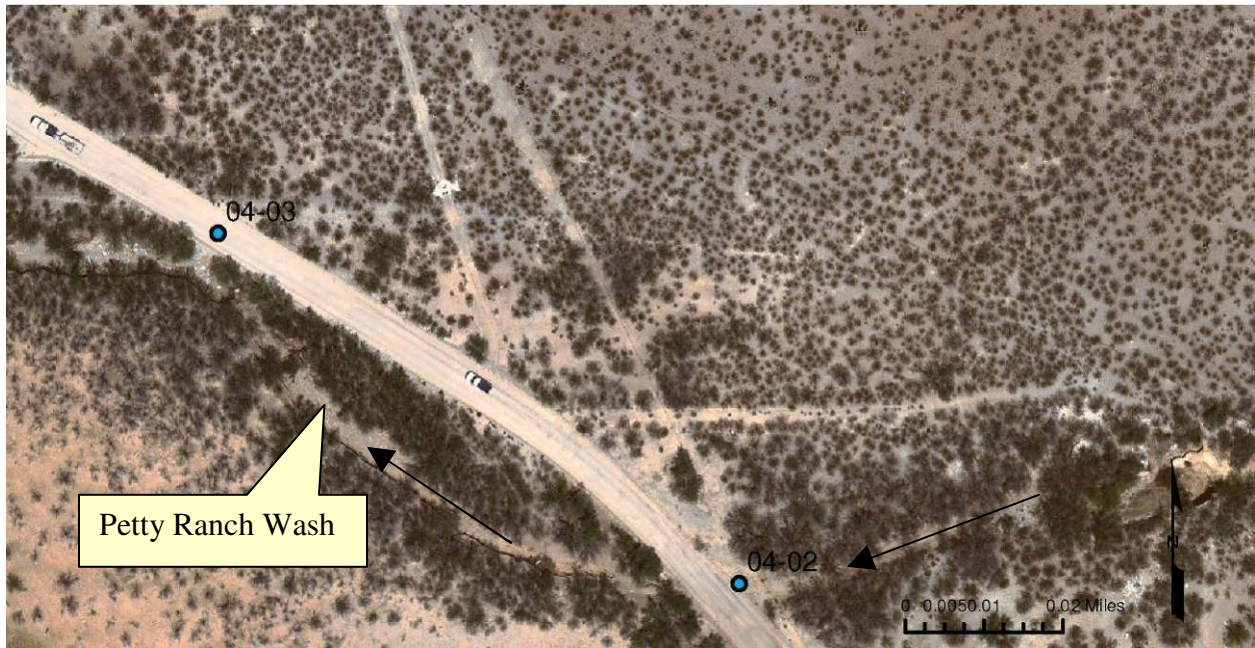
Headcutting and an abrupt scour difference were found along the Petty Ranch Wash ford crossing of the Old Nogales Highway, shown in Figure 93. The wash upstream of the road is highly incised with semi stable banks while the banks are less stable downstream of the road. The channel downstream of the road has scoured right up to the edge of the road which might wash away during a significant event. Reworking of the channel upstream of this location may have reduced sediment supply to this area, further encouraging scour.

Aerial view of Petty Ranch Wash crossing of Old Nogales Highway

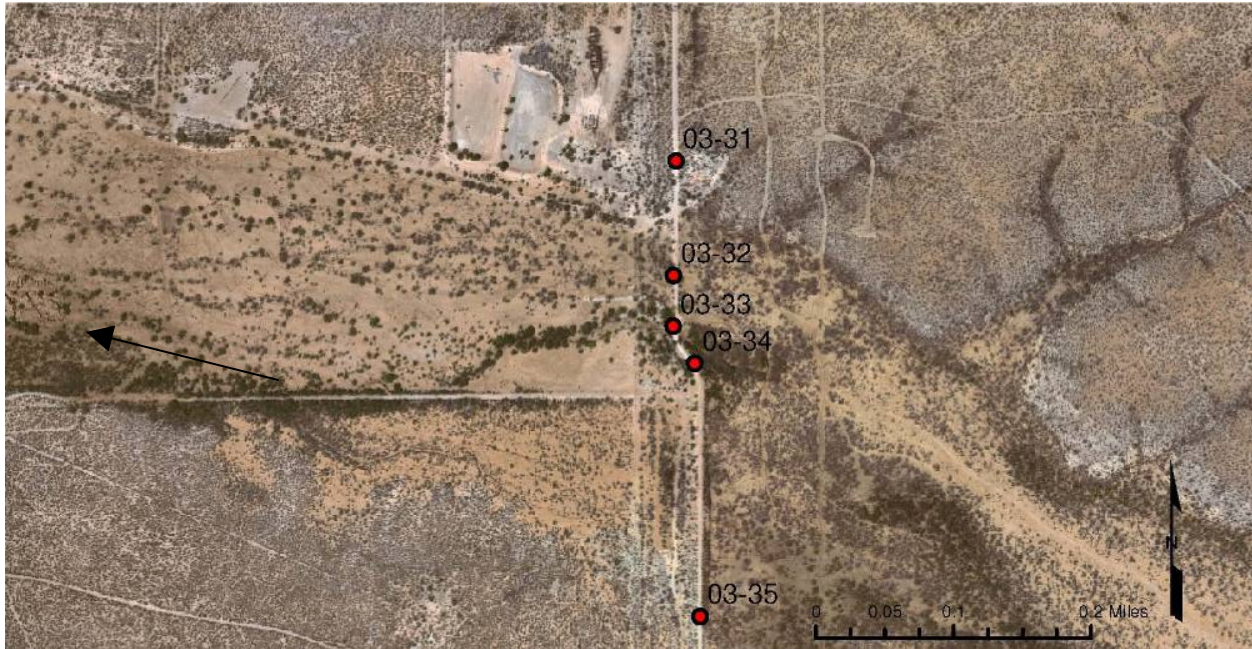
Aerial view

Headcutting along the Fagan Wash was observed along the Country Club Road alignment. The headward erosion extends up minor flow paths such as was observed at field point 03-31; see LM03-31-01. The main channel of the Fagan wash is scarred by headcutting as shown in LM03-33-02. Dumped rip rap has been placed downstream of the road, impounding the water observed in the photograph.

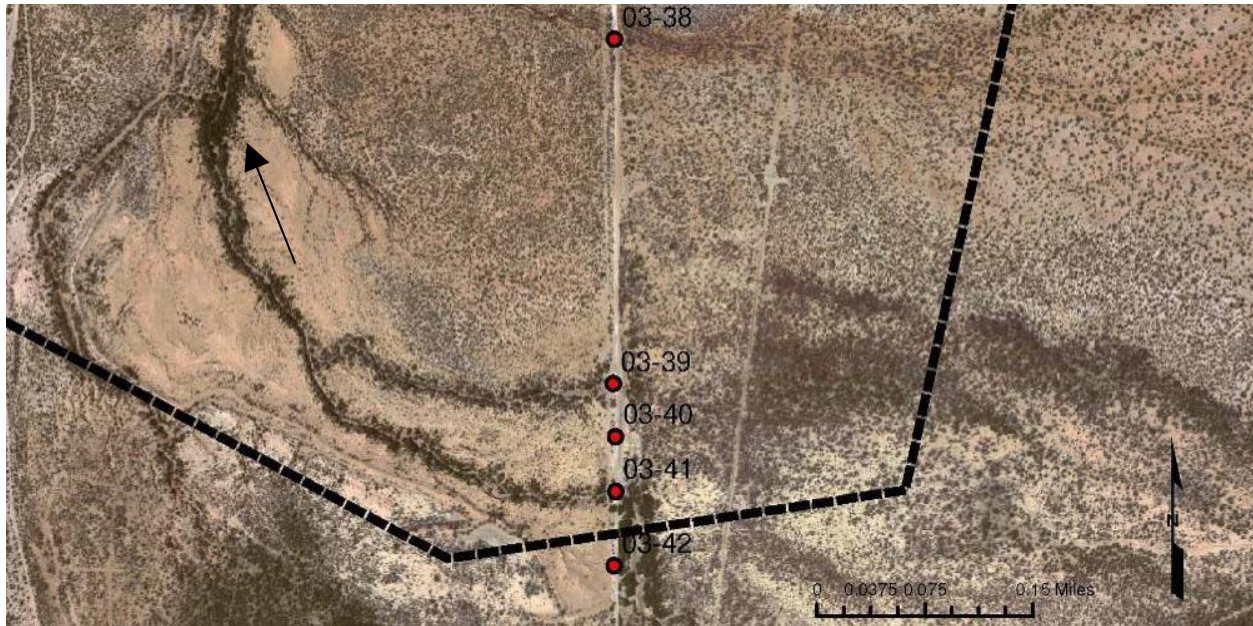
Figure 96 shows observed headcuts along the Lee Moore Wash and local tributaries.

Aerial view of Lee Moore Wash at Country Club Road alignment

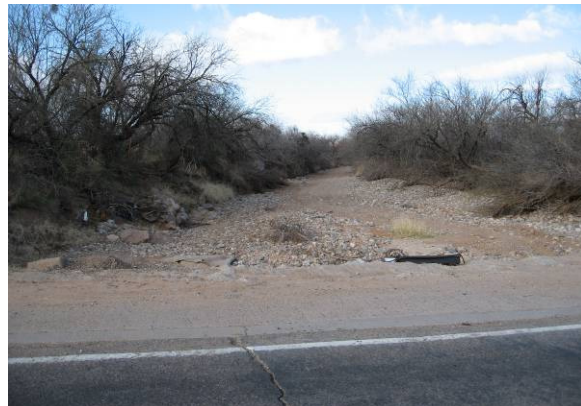
Degradation downstream of Highway, T2 surface (LM04-04-01)

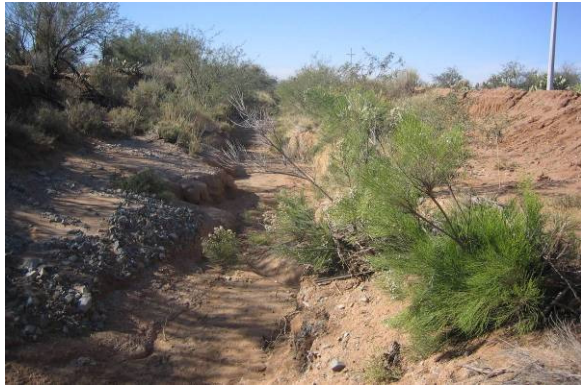
A - Incised channel bottom (LM03-39-03)
