**HIDDEN WATERS PARKWAY NORTH
CORRIDOR FEASIBILITY STUDY
INTERSTATE 10 TO STATE ROUTE 74
CONTRACT NUMBER: 2010-054**

**TECHNICAL MEMORANDUM NO. 3
CONCEPTUAL DRAINAGE REPORT**

June 2011

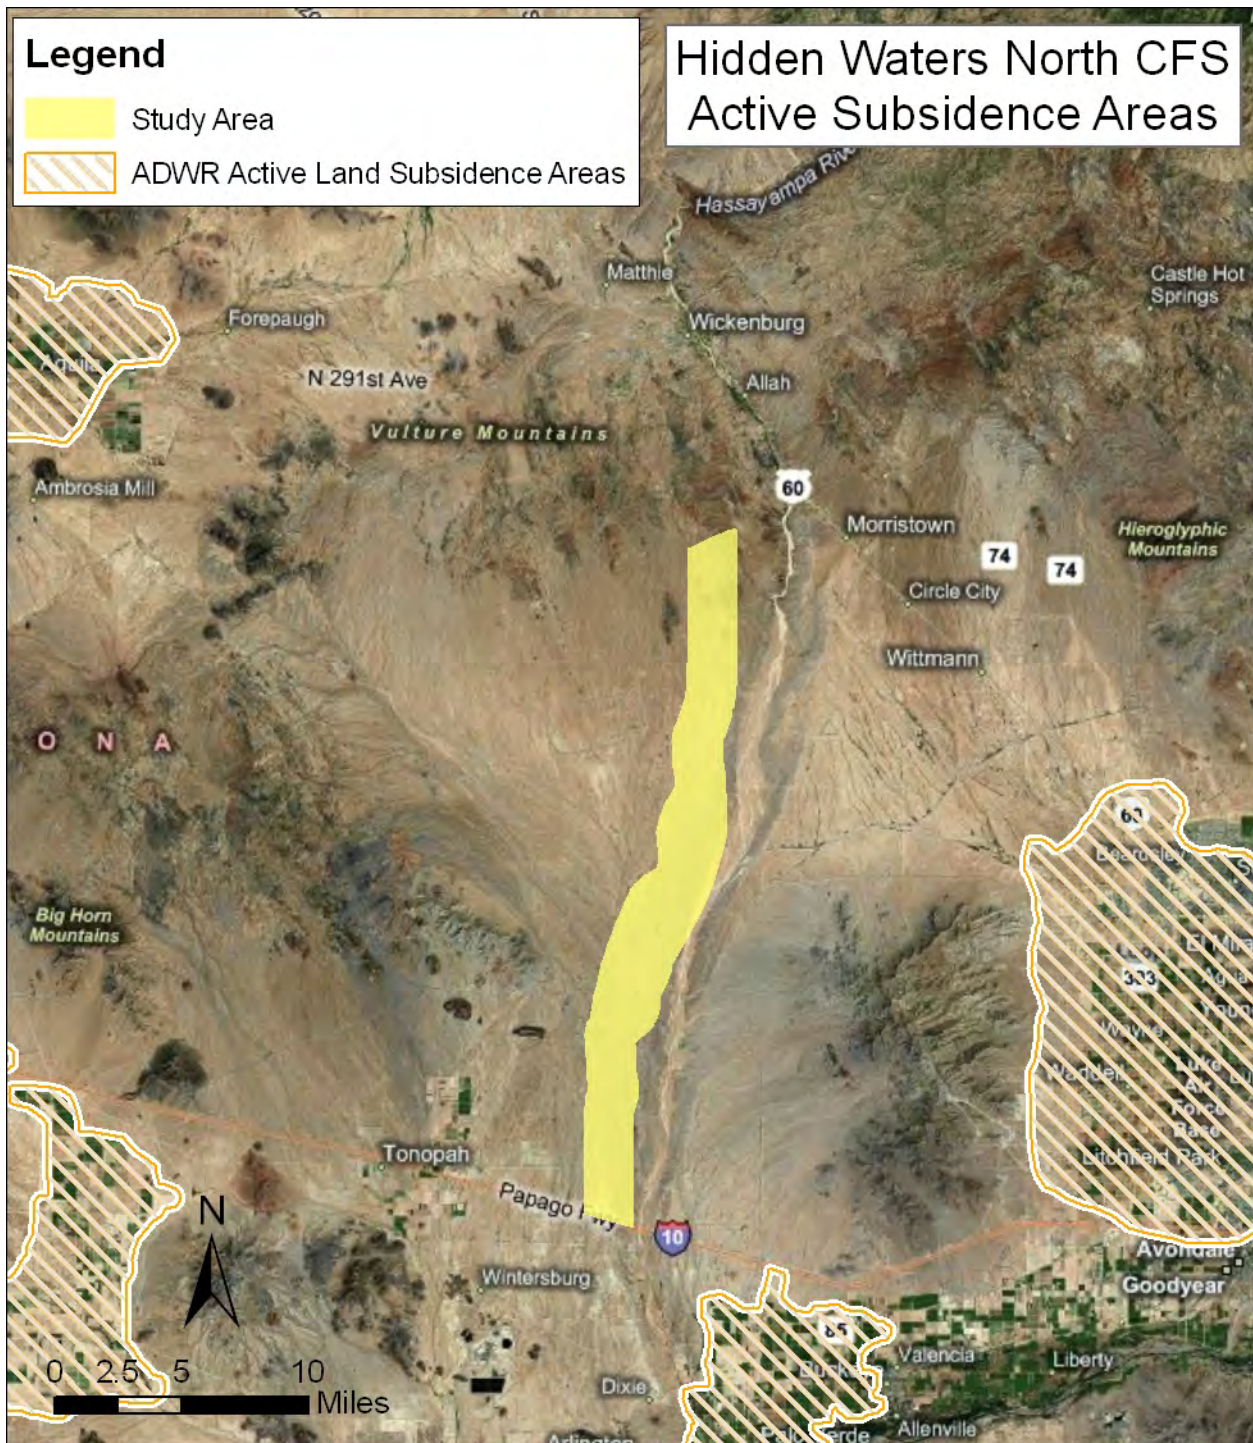
Figure 4. ADWR active land subsidence areas map

The Arizona Department of Water Resources (ADWR) has conducted satellite monitoring of subsidence throughout the state. Figure 4 shows a map of active land subsidence area in the vicinity of the Hidden Waters Parkway North study area. Note that none of the identified areas are within close proximity of the study area.
