Geomorphic Analysis Report for the Lee Moore Wash Basin Management Study in Pima County Arizona

Prepared for and in cooperation with the
Pima County Regional Flood Control District

August 2008

By Ian P. Sharp, P.E., CFM
JE Fuller Hydrology & Geomorphology Inc.

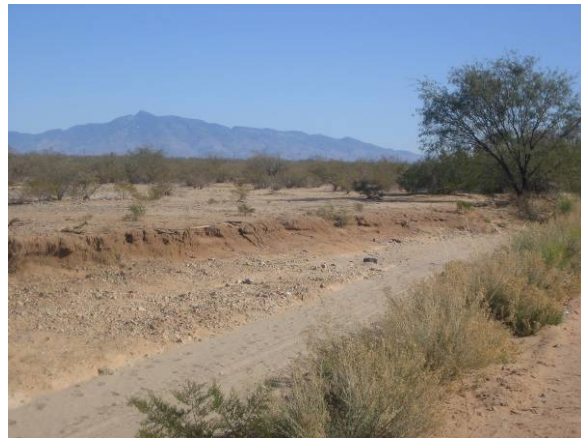
Lateral erosion (LM03-50-02)

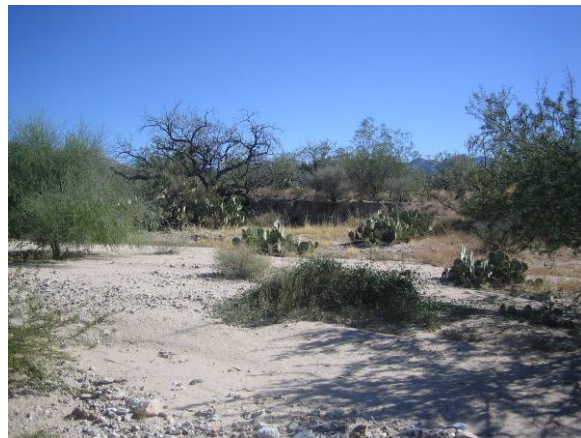
Avulsion (LM01-34-04)

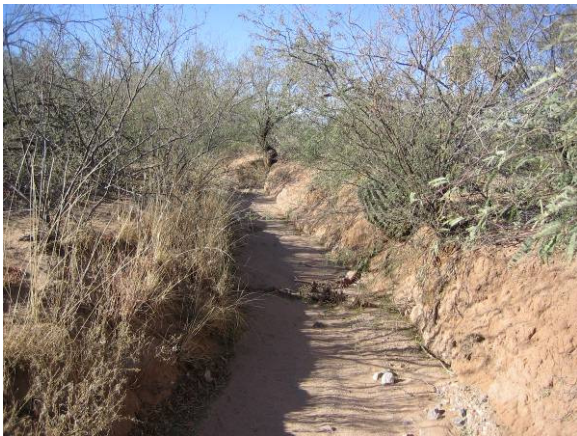
Incision (LM03-11-01)

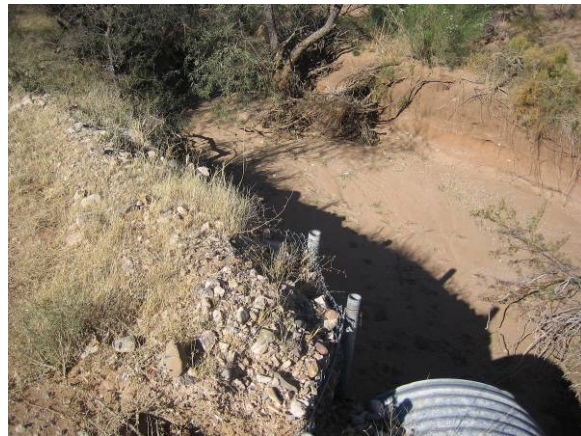
Scour (LM03-23-06)

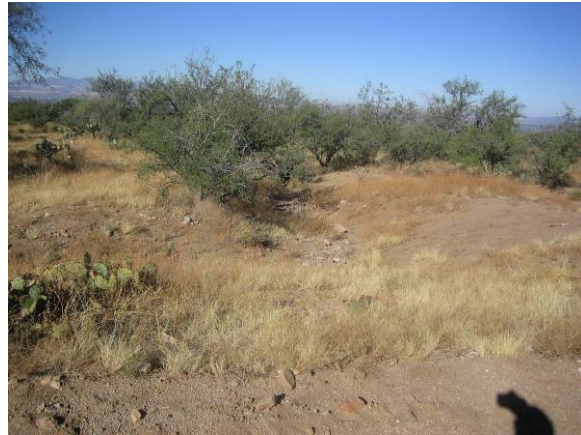
Following are a couple representative locations where scour was greater downstream of a road crossing. The first example (Figure 4) is a case of scour downstream of a road crossing with no significant flow path or scour upstream of the road crossing. The observation occurred in the upper basin, away from the significant headcutting found nearest the Santa Cruz River. The second observation (Figure 5) is of a more significant wash lower in the basin. The banks downstream of the road are vertical while upstream of the road they are sloped and vegetated. The bed material is visibly coarser downstream of the road. This location is close to the Incised Zone where the headcutting is most active and the observation is most likely of a headcut terminated by a road in association with local scour generated by the road crossing.

No scour or significant drainage upstream of road (LM01-09-03)

Figure 4 - Representative abrupt scour difference location 1

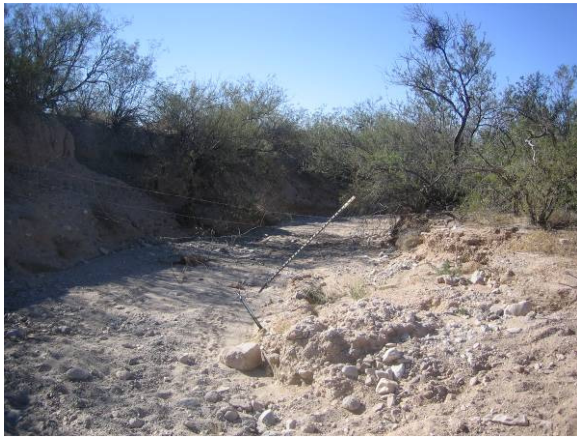
Incision and vertical banks downstream of road are significant (LM01-49-02)

Figure 5 - Representative abrupt scour difference location 2

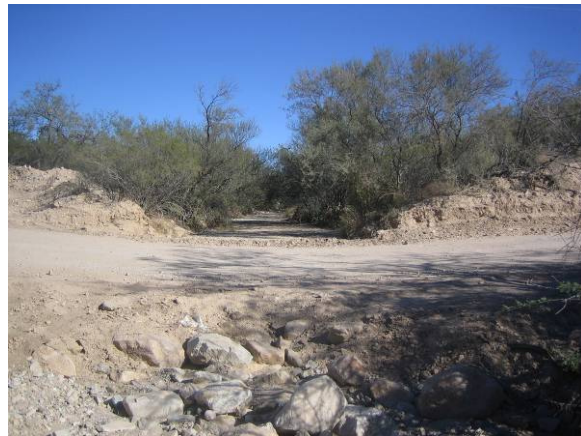
Well vegetated, sloped banks upstream of road (LM01-49-01)

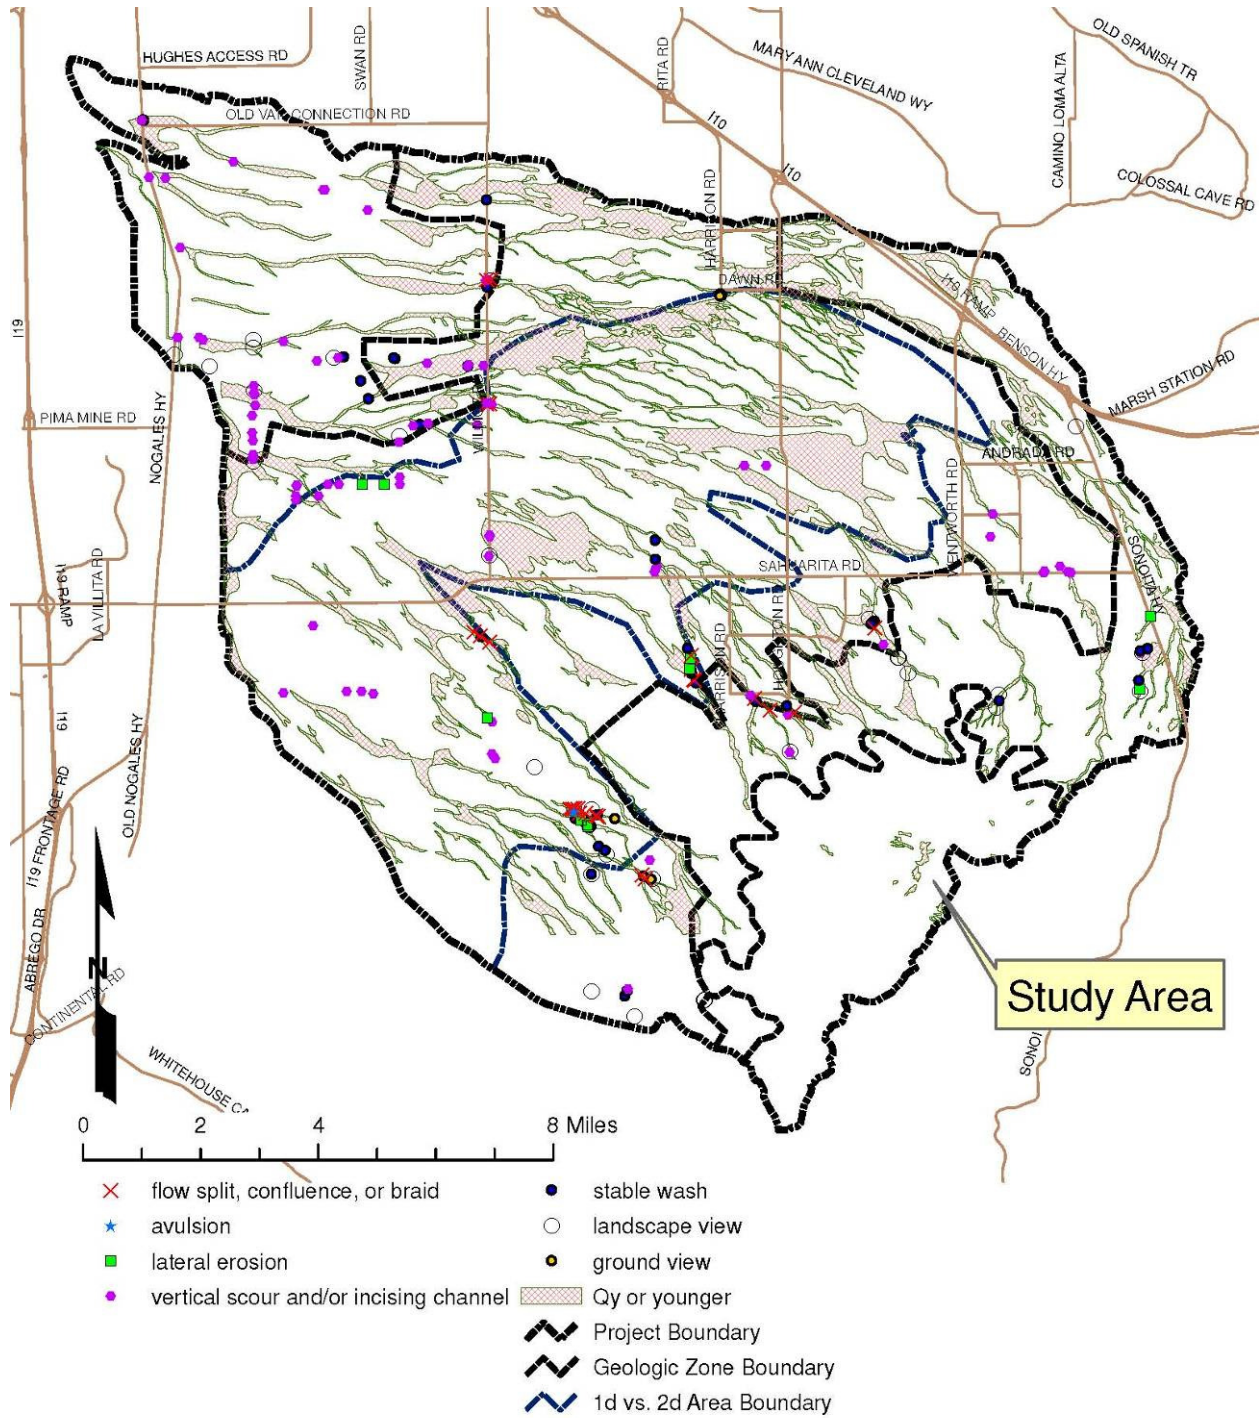
Figure 6 - Generalization of observed geomorphic conditions

Five figures are included to give visual representation of Appendix C. Figure 6 shows the locations of the broadly categorized geomorphic processes, excluding the locations of aggradation or sedimentation as these were limited and generally occurred in areas with other geomorphic processes. This figure also shows the limits of Holocene era or younger deposits (shown as Qy or younger); note the correlation between observed geomorphic activity and the limits of these younger deposits.

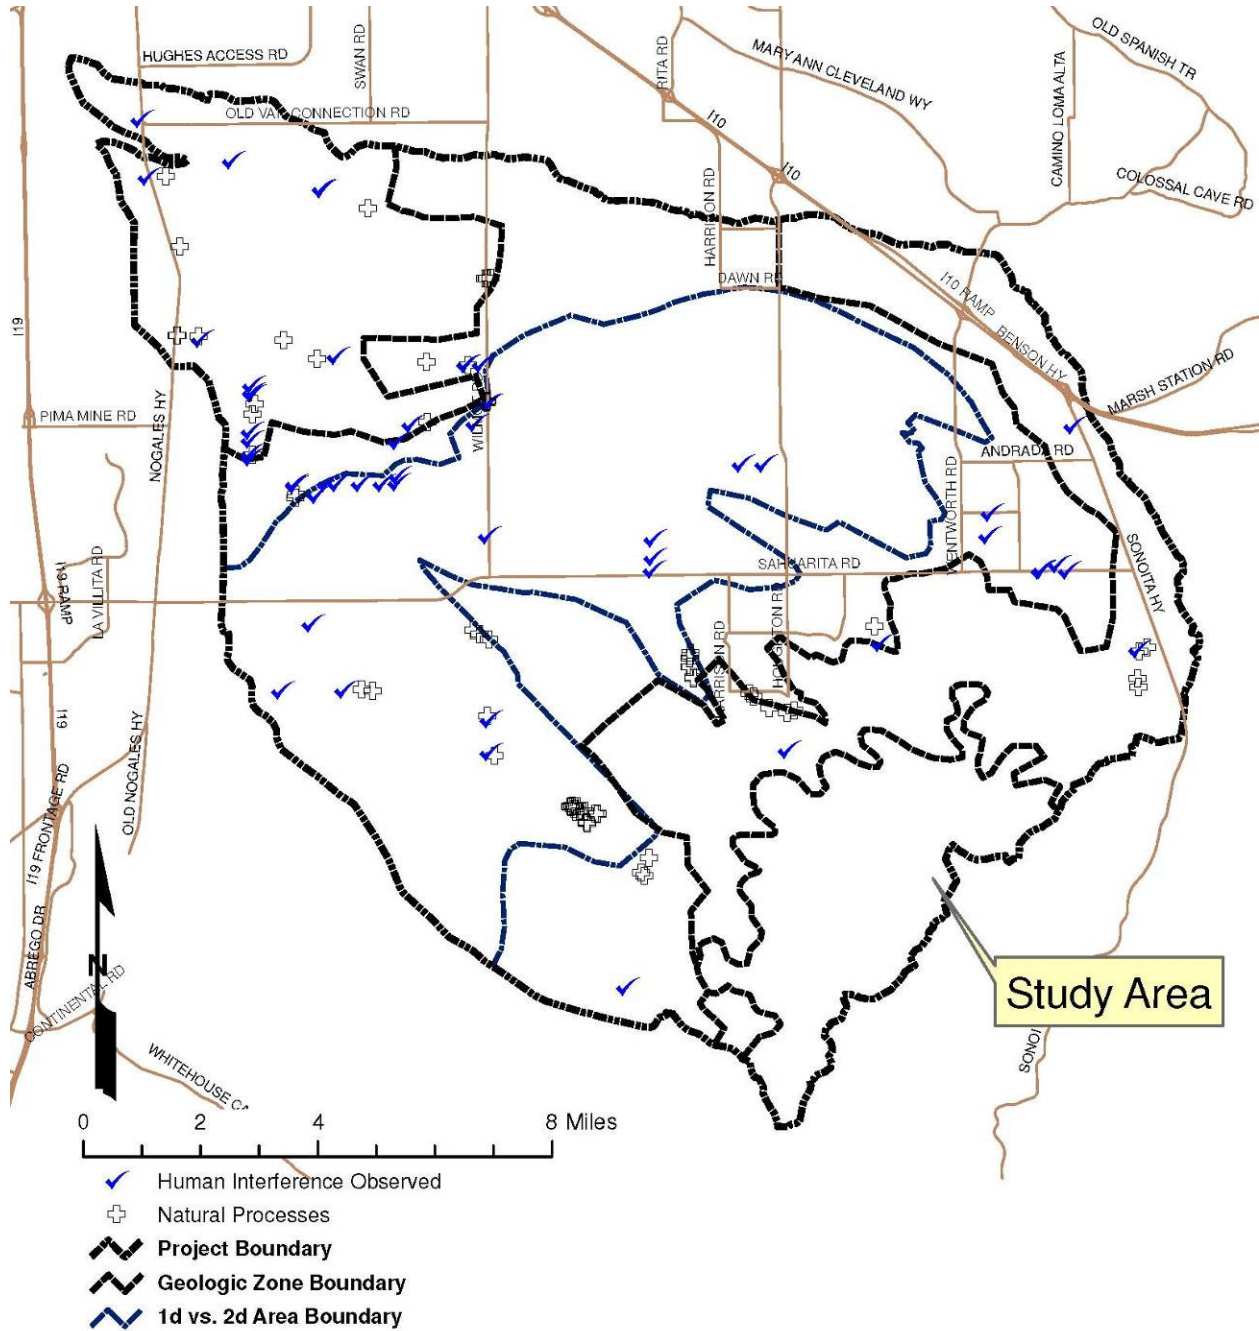
Figure 10 - Observed locations of naturally occurring and human activity influenced geomorphic processes

Figure 10 shows the locations of naturally occurring and human influenced geomorphic issues. Geomorphic processes which are solely natural are shown as natural. An example of a natural process would be vertical banks on an undisturbed channel in a bend. Examples of human influenced processes include scour caused by diversion of flow or from culvert outflow. The human influenced processes may often include or be accelerated by natural influences. An example would be placing a culvert in a headcutting channel, is the scour at the outlet caused by flow concentration, headcutting, or both? Therefore some amount of conjecture is required when assigning whether a process is natural or human caused. Additionally, the amount of human interference (relative to naturally occurring issues) may be disproportionately shown as observations were made where access is available, primarily along and near roads and development.

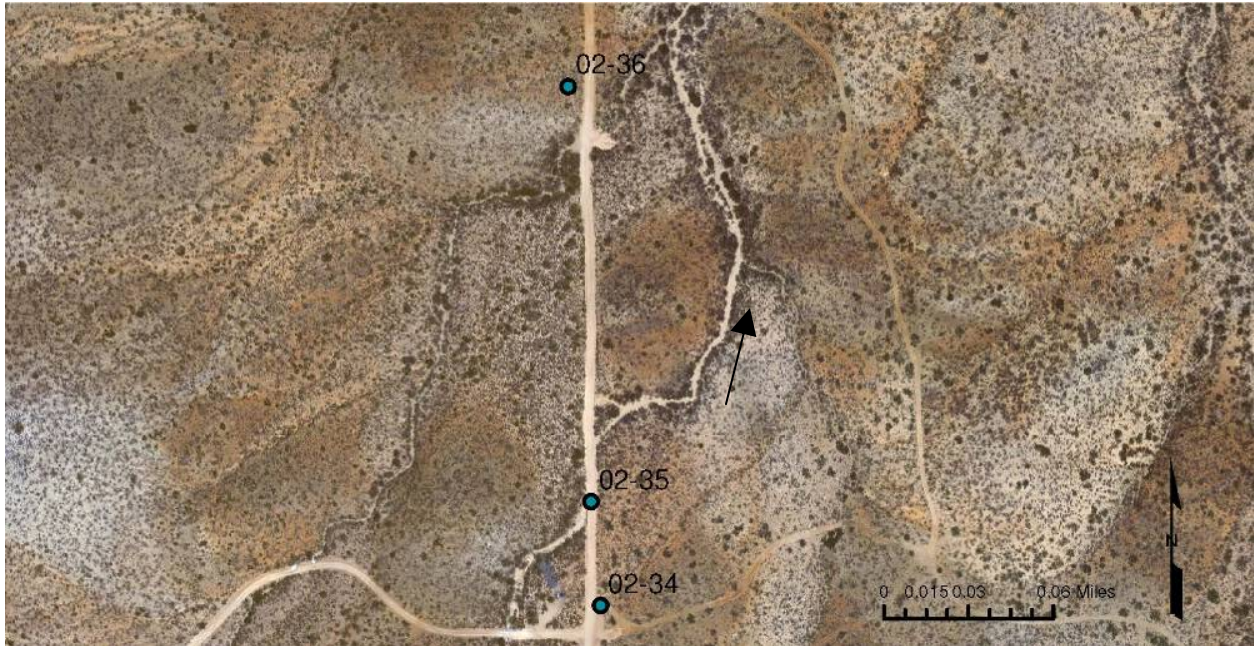
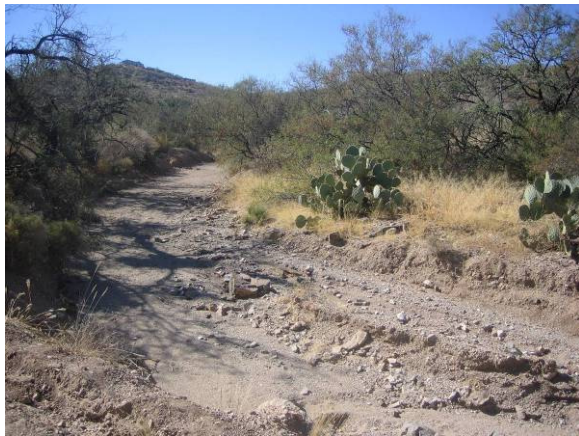
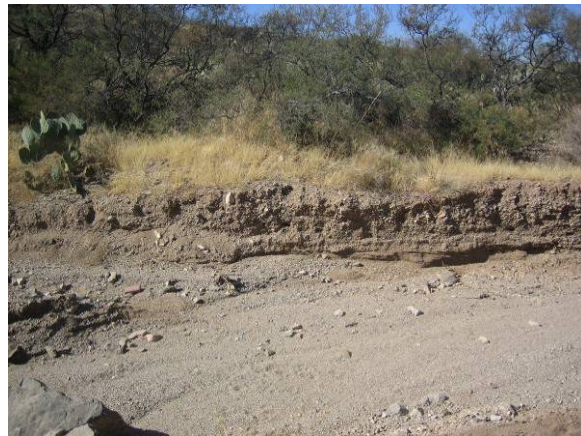
Figure 42 - Wash crossing road in upper Tributary Piedmont Zone

The small tributary channels in the Tributary Piedmont Zone uplands (southeastern end of the zone) are bounded by bedrock outcroppings and hillslopes. Access to existing development is typically on dirt roads paralleling and adjacent to the channels, increasing both the risk to the residents and the risk of erosion in and along the channels. Figure 42 shows an aerial view of a wash crossing a road in the uplands, the view upstream from the road crossing, and the west bank of the wash at the crossing. A relatively short vertical bank has developed as a result of the road crossing and minor vertical erosion extends a short distance upstream within the wash bottom.

View upstream of wash from along road (LM02-35-02)

Lateral erosion (along west bank) adjacent to road on Qy surface (LM02-35-01)

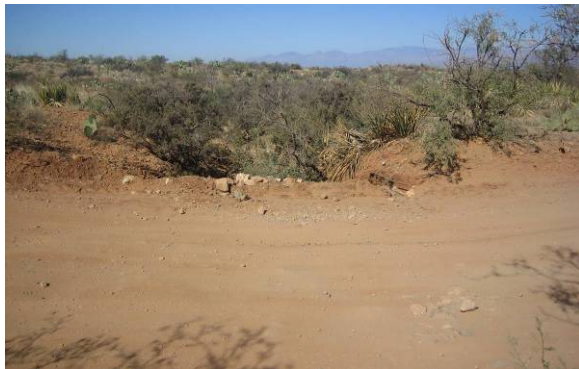
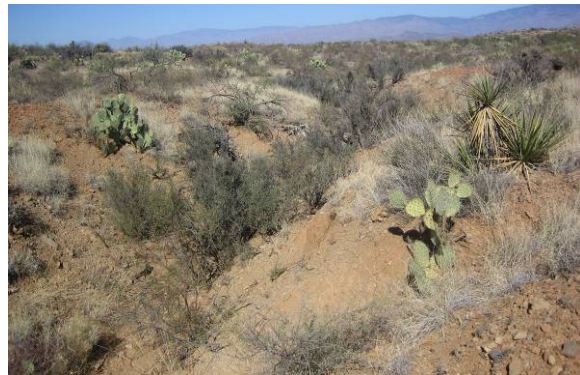
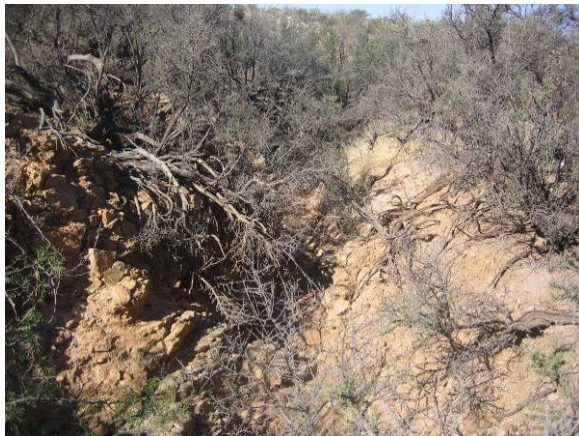
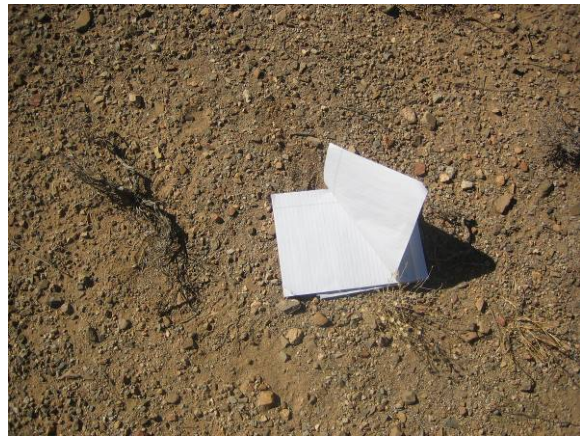
Figure 43 - Small washes on Qc surface of Tributary Piedmont Zone

Figure 43 shows images of two small washes on a Qc surface within the Tributary Piedmont Zone, near Highway 83. The dirt road is not labeled but is accessible from Highway 83 and is within Township 17, Range 16, Sections 23 and 24 at this location. LM02-37-01 is a downstream view of one of the washes crossing the road. The road is elevated above the wash at this location and no culvert was visible although one might exist. LM02-37-03 shows the view of the channel just upstream of the road. The wash is scoured at this location and rock outcrops are visible upstream of the road. LM02-39-01 shows the wash approximately 150 feet downstream of the road. The wash is in a relatively undisturbed condition at this location. The wash bottom is approximately 8 feet below the adjacent terrace. LM02-38-01 shows a ground shot of the adjacent terrace. The soil in the wash and on the adjacent terrace is poorly developed.

Vertical erosion (LM02-37-03)

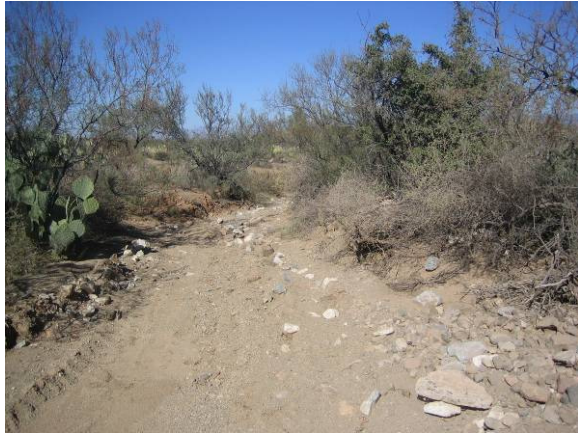
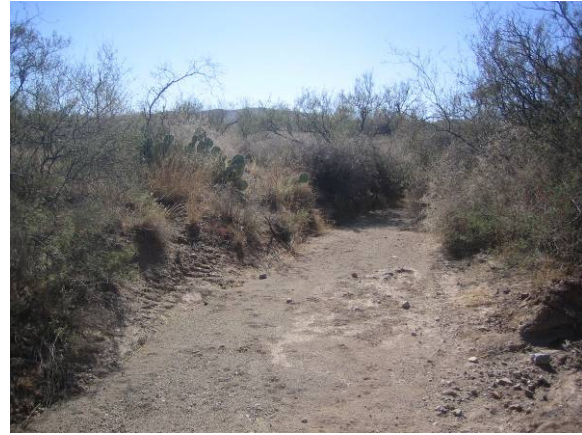
Figure 44 - Another wash on Qc surface of Tributary Piedmont Zone

Figure 44 shows another wash crossing on this surface. This wash is less impacted by the road but is also incised with scoured banks.

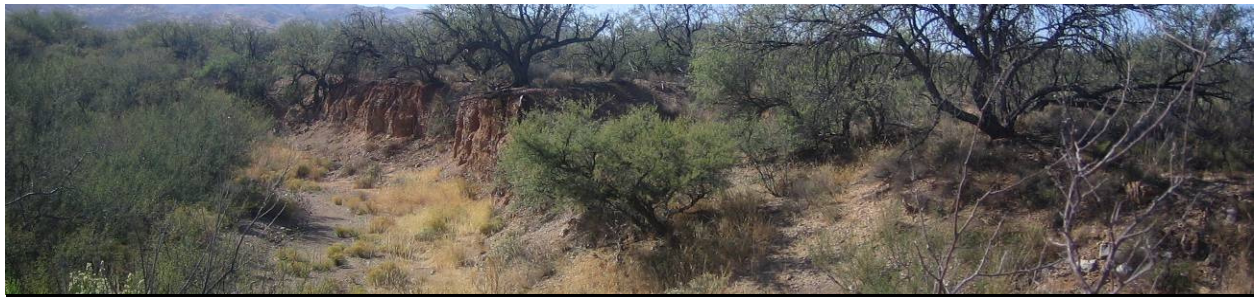
Figure 45 is a view of a wash crossing Highway 83. The banks upstream of the crossing are vertical and the bottom is approximately 10 feet below the adjacent Pleistocene terrace.

Figure 45 - Vertical banks on Qy surface upstream of Highway 83 (LM02-42-01)

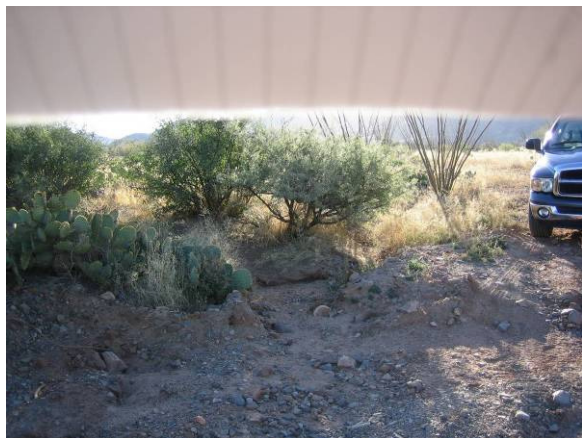
Figure 46 shows the location of a headcut observed along south Houghton Road. The flow direction is to the northwest at this location and flow crosses the road to drain to the wash located west of the road. The wash west of the road is not highly incised and is not impacted by headcutting. However, the wash is at an elevation below the road, and concentrated flow which crosses the road at this location and drains to the wash has caused a headcut to develop from the wash to the road. Only minor scour was noted upstream of the road (LM02-02-01) in association with almost no channel development. LM02-02-02 shows the downstream view where an incised wash has developed with vertical banks. The road has terminated the headcut.

View upstream of drainage across south Houghton Road (LM02-02-01)

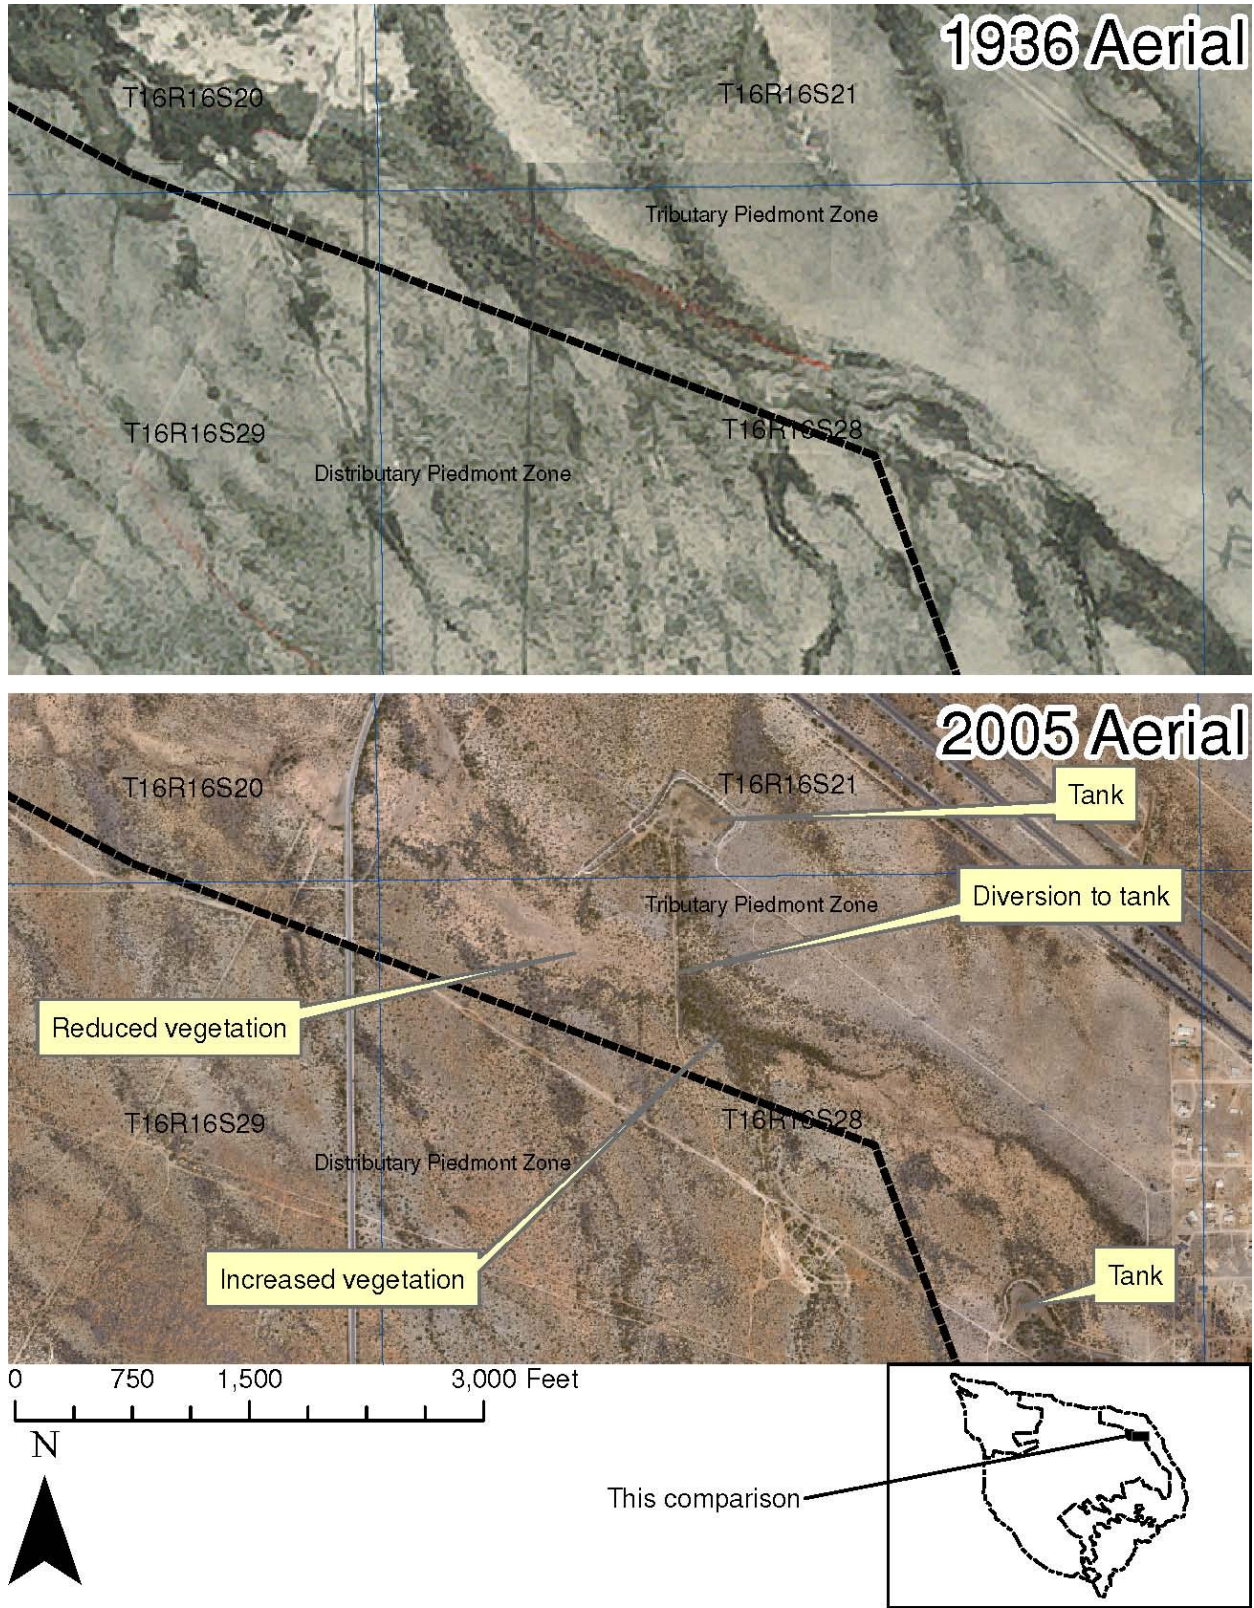
Figure 47 - Comparison of 1936 and current aerial images; station TPZ01

Very few changes were observed when comparing the aerial images within the Tributary Piedmont Zone. Some evidence of local geomorphic and hydrologic changes due to stock tanks and similar features is found when comparing the two sets of aerial images. Figure 47 shows a diversion near Wentworth Road which has caused aggradation upstream of the diversion and scour downstream of as evidenced by the vegetation patterns. The scour and aggradation are limited to the general area shown in this figure. Figure 48 shows another location with an impoundment, but the impacts to the fluvial system are unclear. Greater vegetative growth appears to have developed downstream of the impoundment and the primary flow path is less visible downstream of the impoundment.

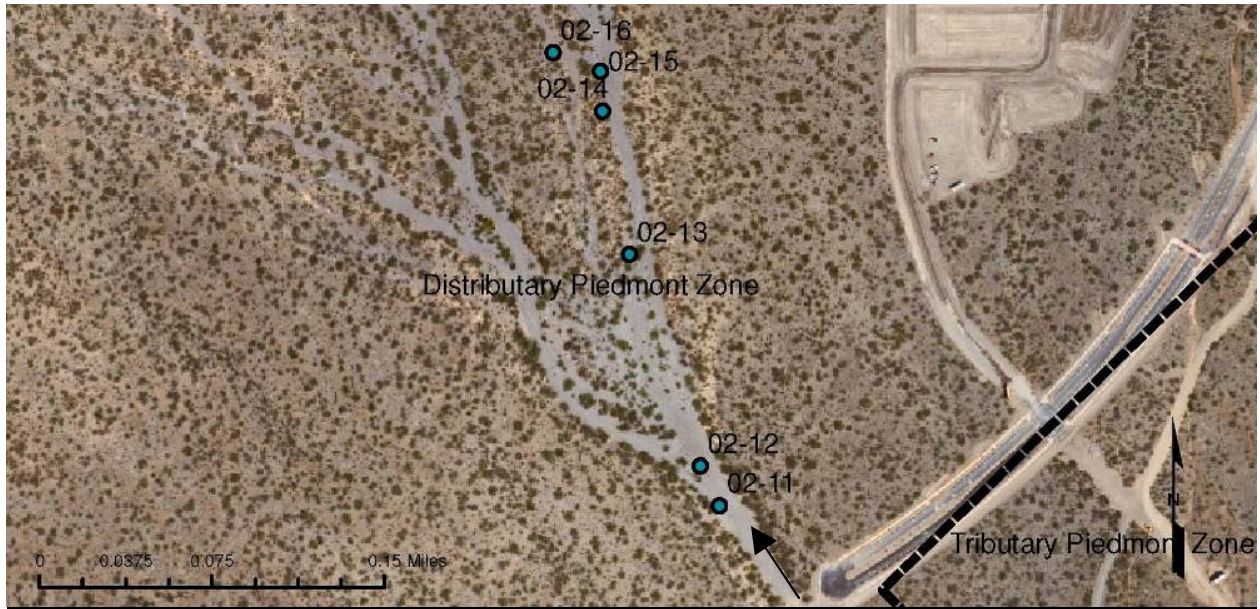
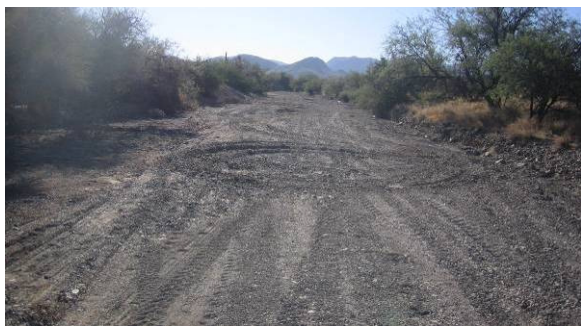
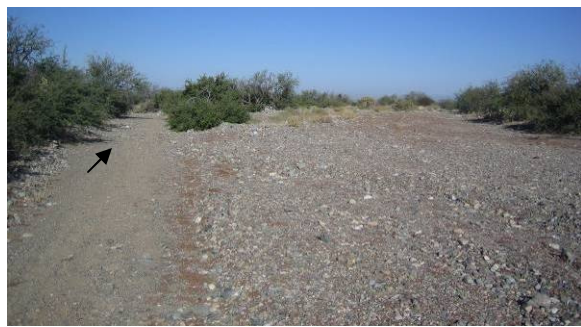
Figure 52 - Flow splits along Sycamore Canyon Wash

Figure 52 (following) is an illustration of how streamflow becomes unconfined as the piedmont gradient decreases. In this example, a contained wash (Sycamore Canyon Wash) with significant lateral relief breaks down into distributary flow. This wash is located along the west side of an area which is currently being developed and will continue to develop within the foreseeable future. Through a series of diffluences, this channel bifurcates into a half-dozen channels which recombine to three distinct channels, occurring over a distance of about 1.6-miles. The upstream tributary channel occupies a Qy surface and the distributary channels occupy both a Qy and an older Ql surface.

Flow splits along wash west of Sycamore Canyon Estates

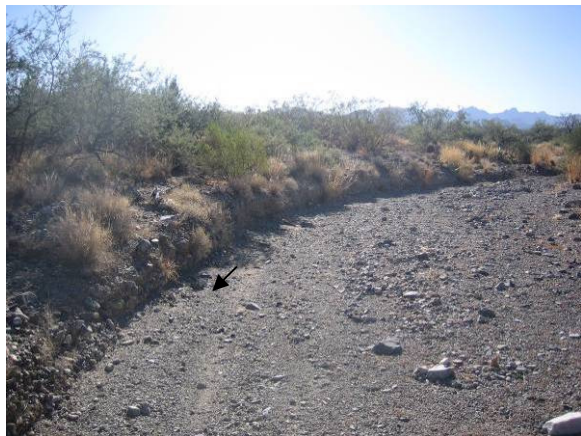
The breakout washes to the west show signs of lateral and vertical erosion at the flow split while the eastern wash shows signs of aggradation and reduced conveyance. LM02-16-01 shows the eastern bank of one of the western breakout washes. The bank shows signs of lateral erosion heading towards the east and future migration could capture more of the eastern wash. LM02-15-02 shows the aggraded section of channel downstream of the flow split area.

Lateral erosion along outside bend of breakout wash (LM02-16-01)

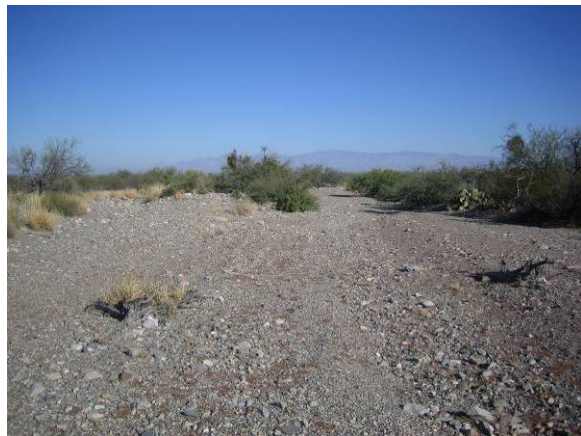
Aggraded channel downstream of flow splits (LM02-15-02)

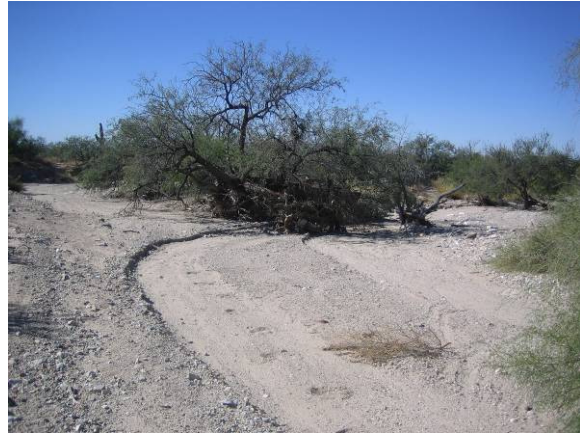
Lateral erosion and avulsion occur within this zone. Figure 53 shows a channel that has cut a path towards the inside of the channel bend. Several instances of vertical banks, specifically along outside bends, were noted. Vertical banks are typically about 4 feet high with exposed roots. Vertical cutbanks exceeding 250 feet in length were found.

Ground view of avulsion (LM01-34-02)

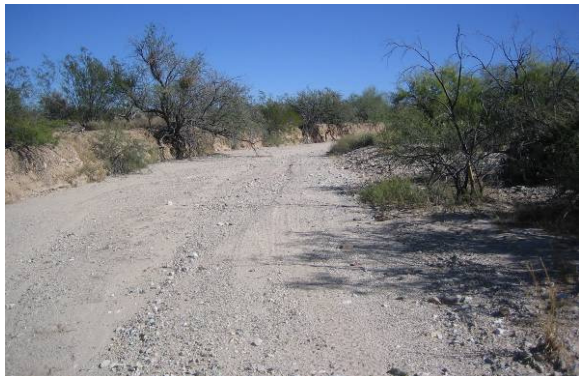
Vertical cut bank (LM01-34-01)

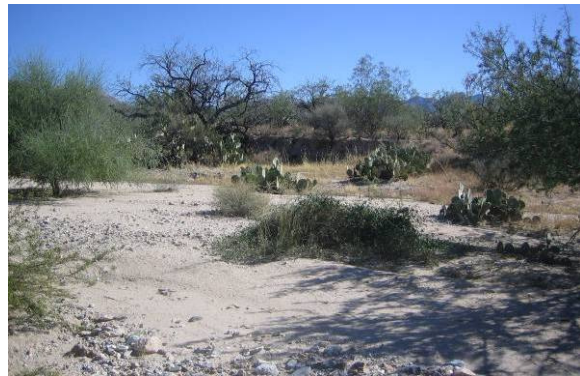
Abandoned channel bank (LM01-34-04)

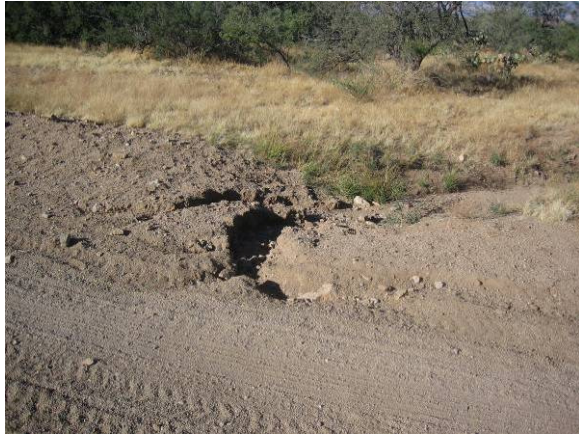
Figure 54 shows an instance of vertical erosion developing downstream of a dirt road crossing. There is no swale upstream of the road; flow is overland at this location.

Vertical erosion at downstream edge of dirt road (LM01-09-01)

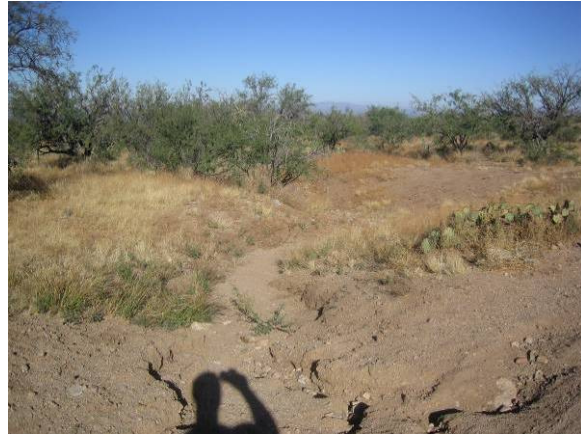
Scour formed downstream of dirt road (LM01-09-02)

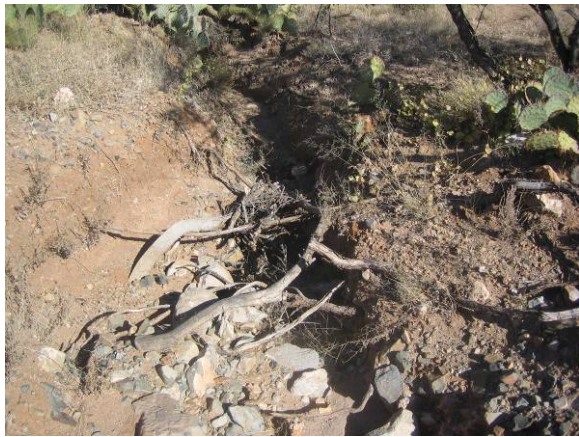
Figure 55 shows erosion downstream of a road at the transitional area from the Tributary Pediment Zone to the Distributary Pediment Zone. The underlying bedrock is exposed revealing how thin the veneer is at this location.

Vertical erosion on Qmo surface exposing underlying bedrock (LM02-29-02)

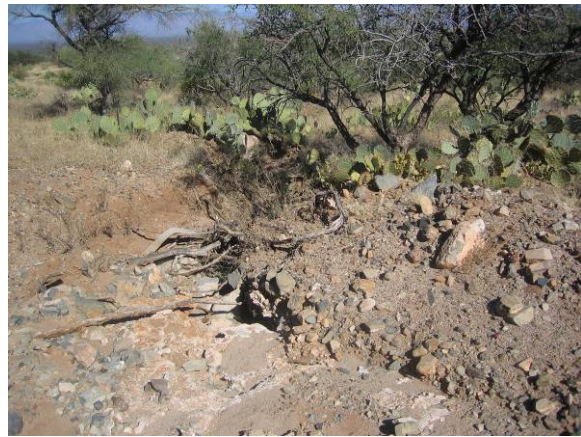
Vertical erosion downstream of road (LM02-29-01)

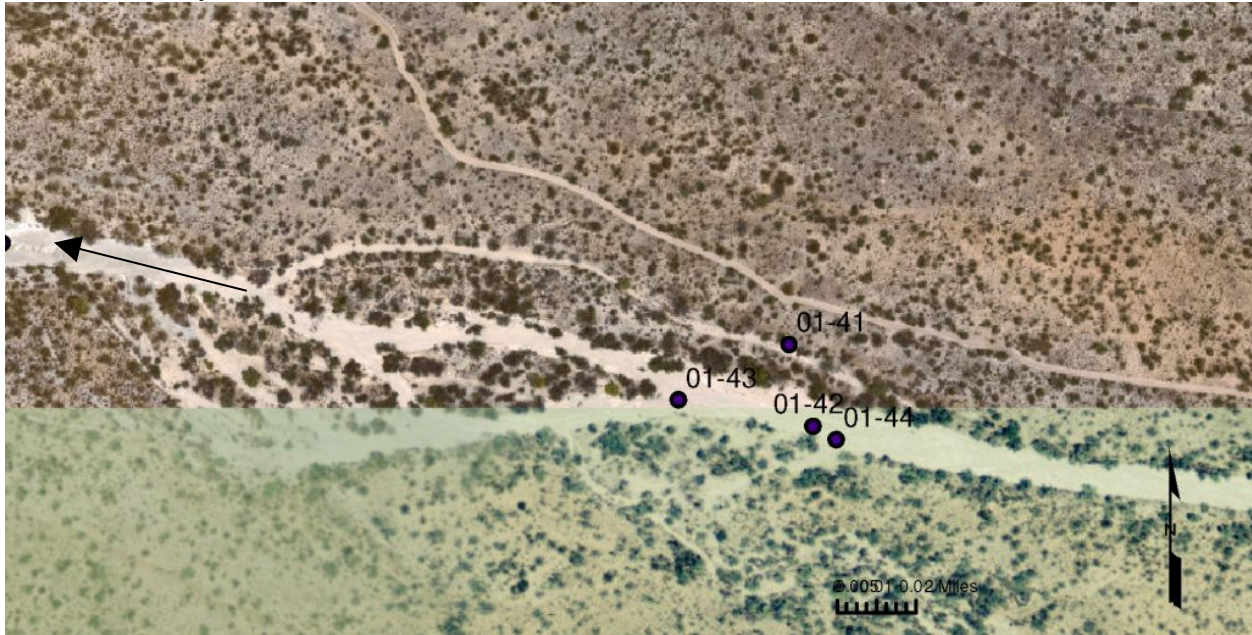
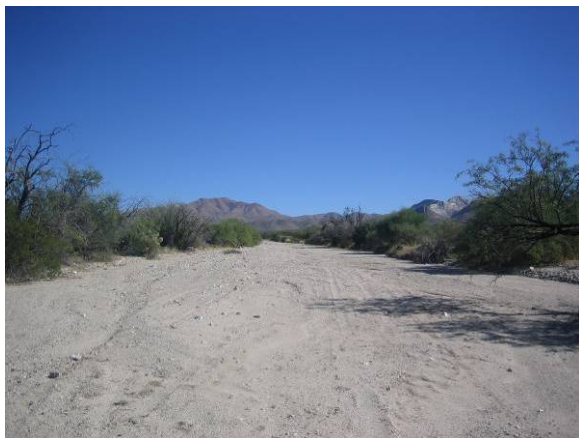
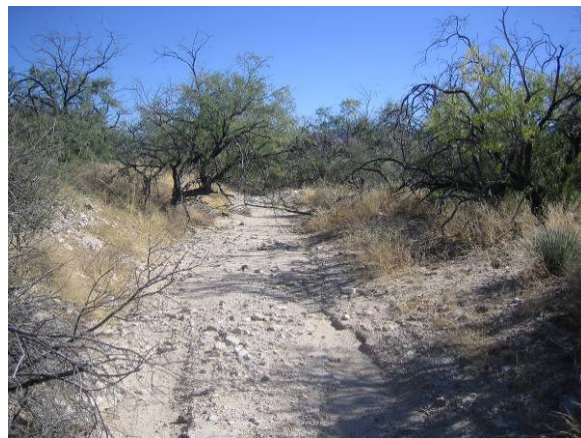
Figure 56 - Braided channel within Distributary Piedmont Zone

Figure 56 shows a braided channel within the Distributary Piedmont Zone. The main channel is sandy and flat with shallow banks. At this location the breakout channel located to the north of the main channel is actually about 2 feet below the main channel. The breakout channel has a rounded, cobbly bed with well established banks.

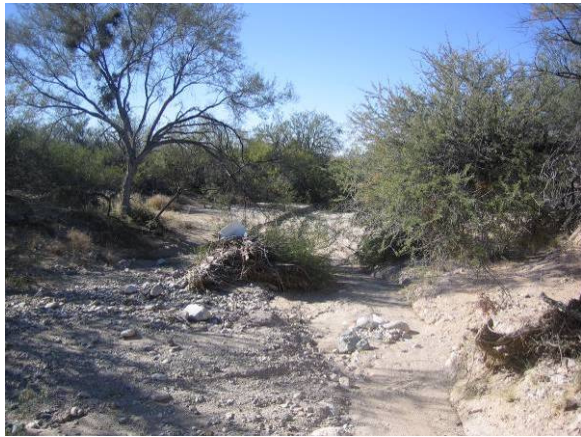
Figure 57 shows locations of sedimentation and deposition within wash corridors along with one example of scour on the upstream side of a channel island.

Aggradation upstream of debris in (LM01-50-03)

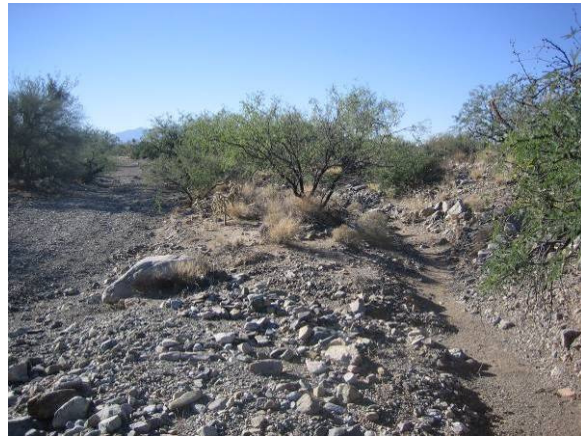
Old deposits along channel bar (LM02-17-01)

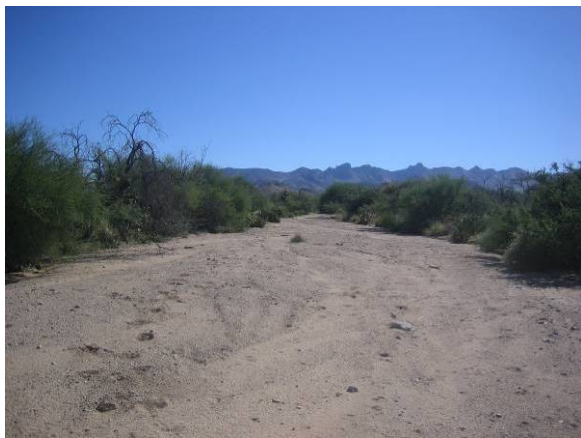
Aggraded channel (LM01-24-01)

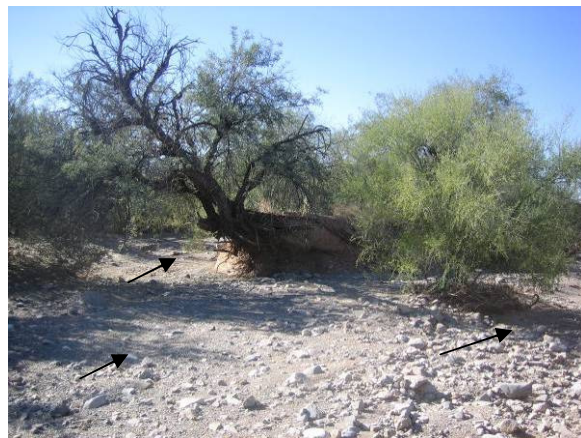
Scour on upstream end of channel island (LM01-51-02)

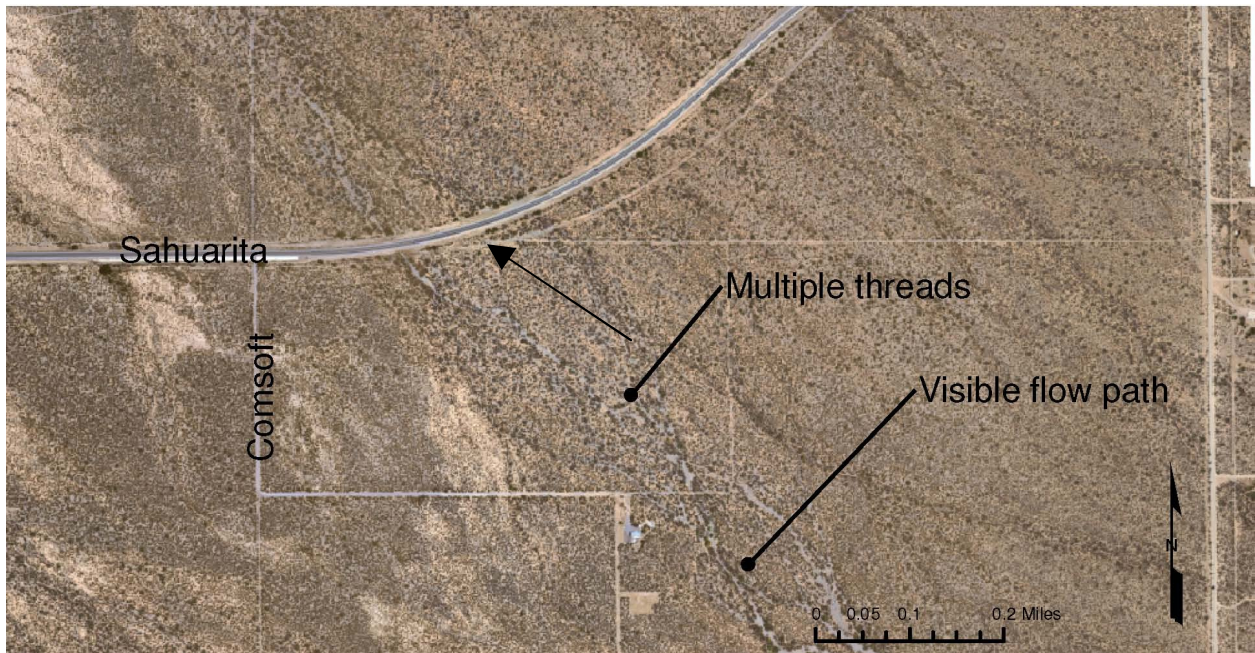
All of the identified disappearing washes are found within the Distributary Piedmont Zone. The cause of this phenomenon is most likely the deposition of sediment. As the gradient decreases, the energy necessary to convey the sediment within the channel diminishes and sediment is deposited. A transition to sheet flow ultimately occurs as flow is forced out of a main channel into multiple threads. Following are a few example locations of disappearing washes.

Disappearing wash, southeast of Sahuarita Road and Comsoft Drive intersection

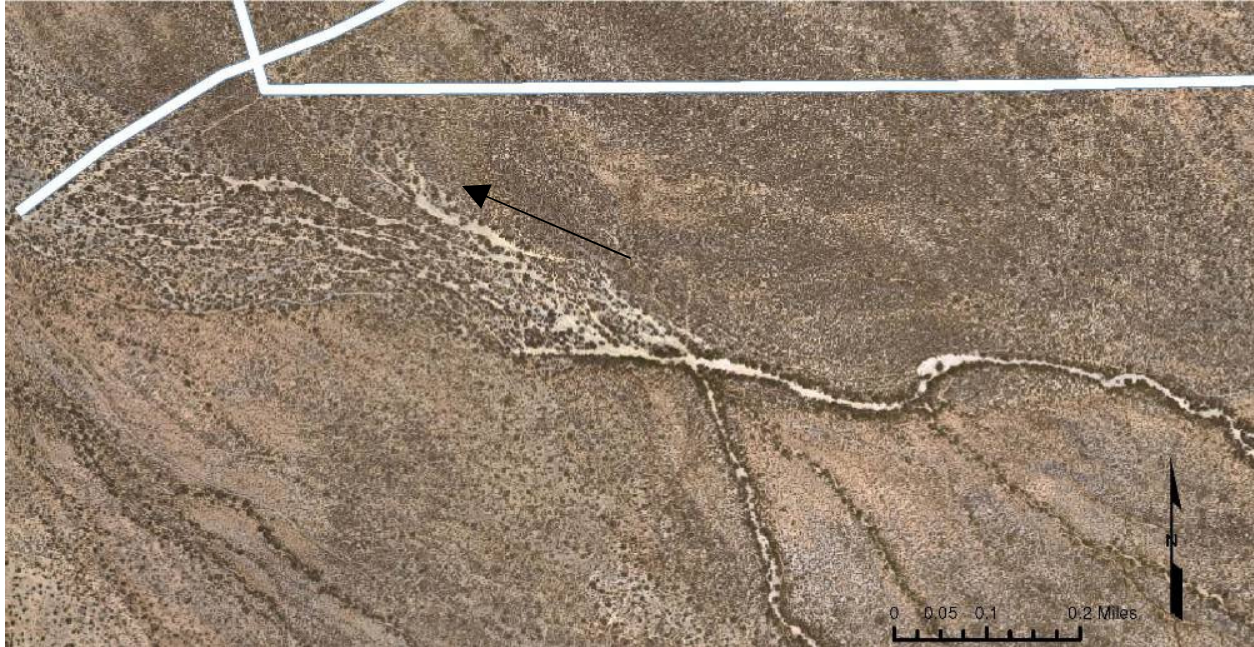
Disappearing wash in Section 26 of Township 17S, Range 14E

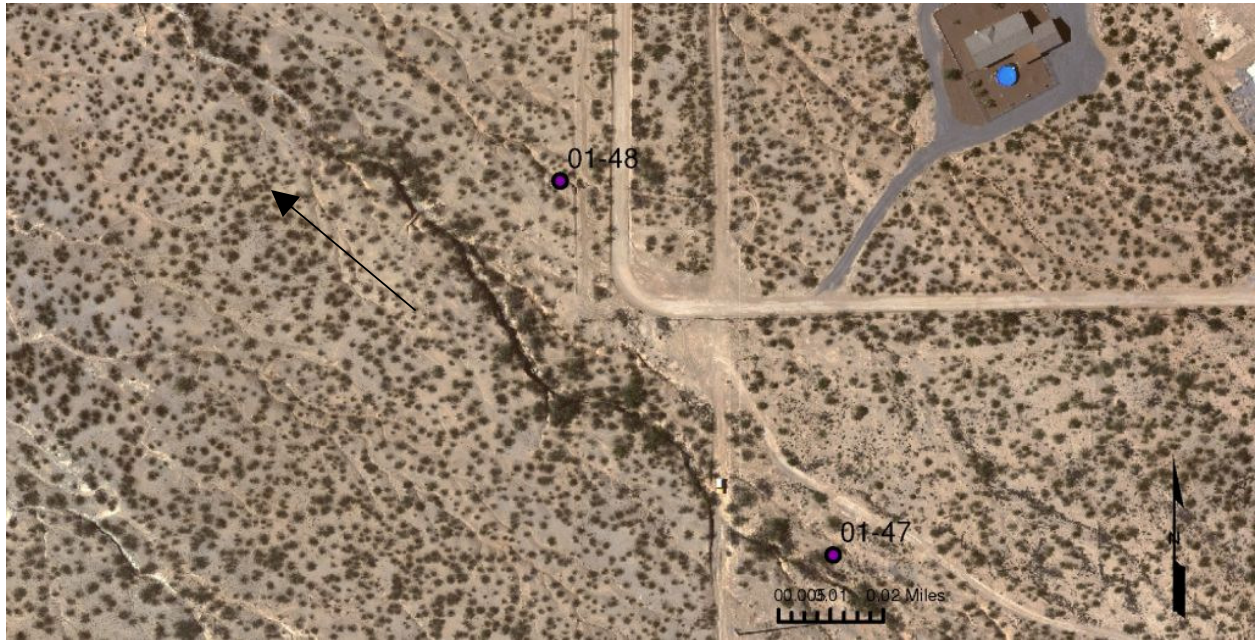
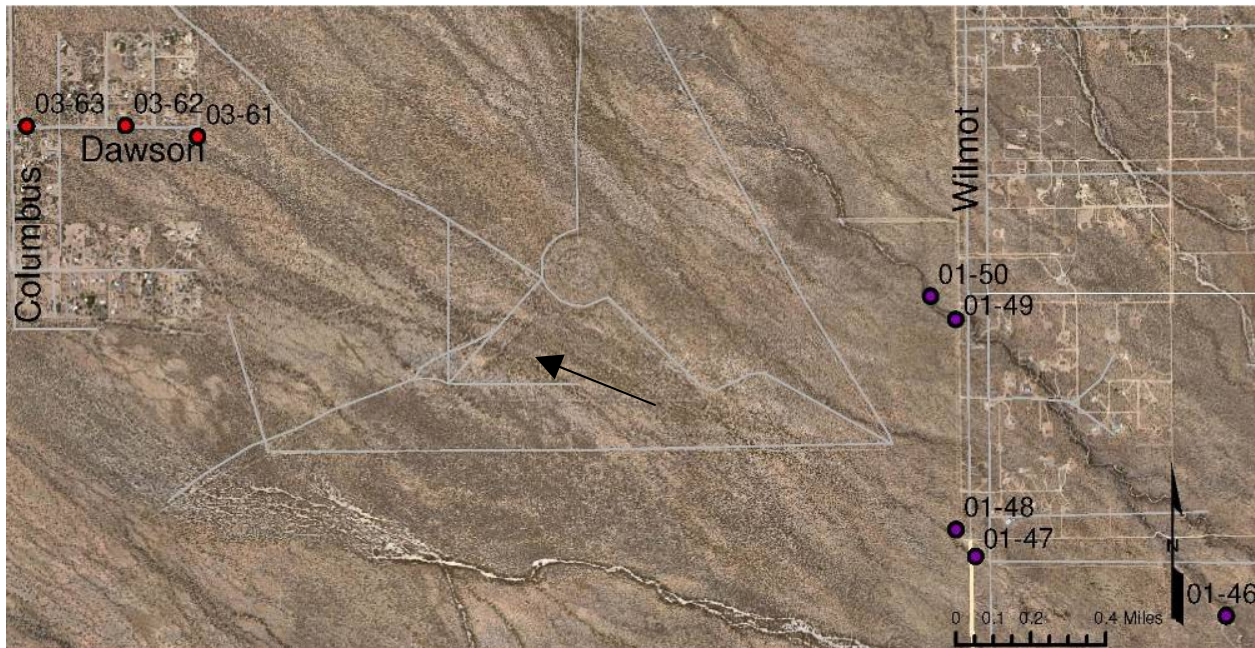
Figure 59 - Aerial view of gully formation

Headcuts originating within the Incised Zone have migrated a significant distance into the Distributary Piedmont Zone. The top aerial image within Figure 59 shows an example of a headcutting area within the western portion of the Corona de Tucson geologic map in an area mapped as M2/M1. The bottom half of the figure shows the same area and the extension of the flow path 2 miles downstream.

Gully formation in Distributary Piedmont Zone

Drainage from Wilmot Road to Columbus Blvd., two miles downstream of first image
