Geomorphic Analysis Report for the Lee Moore Wash Basin Management Study in Pima County Arizona

Prepared for and in cooperation with the
Pima County Regional Flood Control District

August 2008

By Ian P. Sharp, P.E., CFM
JE Fuller Hydrology & Geomorphology Inc.

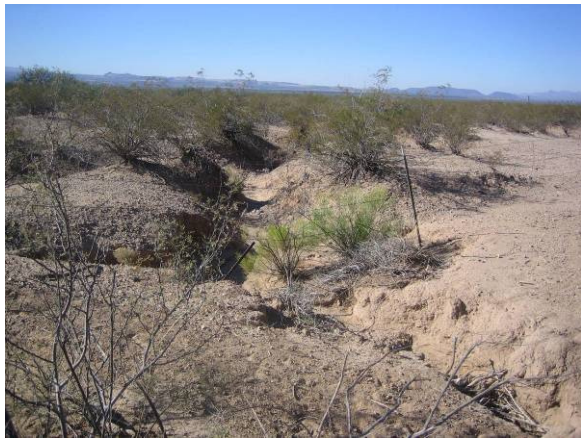
Gullies are forming in several of the flow paths shown in the above aerial images. An example is shown in Figure 60. The gullies are relatively young, narrow, and v-shaped with no gravel or sandy bed material. The primary cause of the gully development is headcutting. The bottom right image (LM03-61-02) within Figure 60 is a view of the same channel network over 2 miles downstream. The channel at this location is incised. In addition to the headcutting which is migrating upstream to this point, local scour has been introduced by the road crossing and is also progressing upstream near photo point 01-47.

View upstream of headcutting (LM01-48-05)

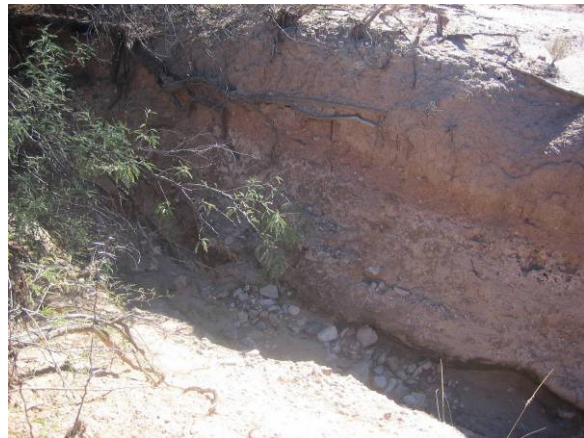
Visible soil horizons below M1/M2 surface (LM01-47-01)

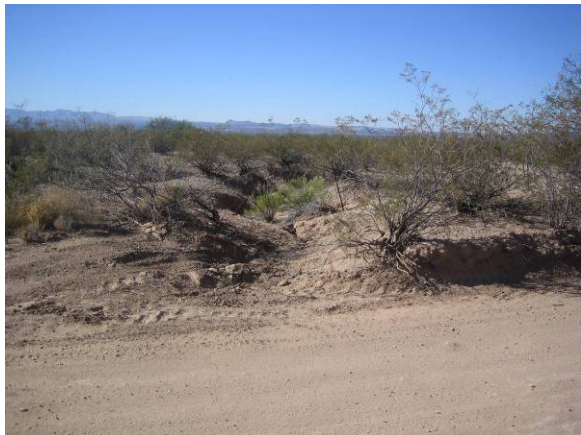
View downstream from Wilmot Road in headcutting channel on M1/M2 surface (LM01-48-04)

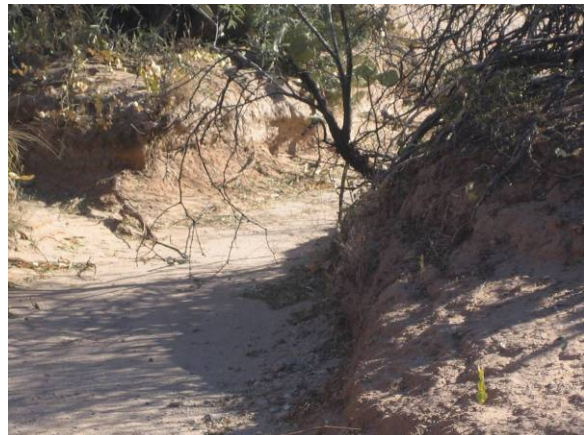
Incised channel along Dawson Road (LM03-61-02)

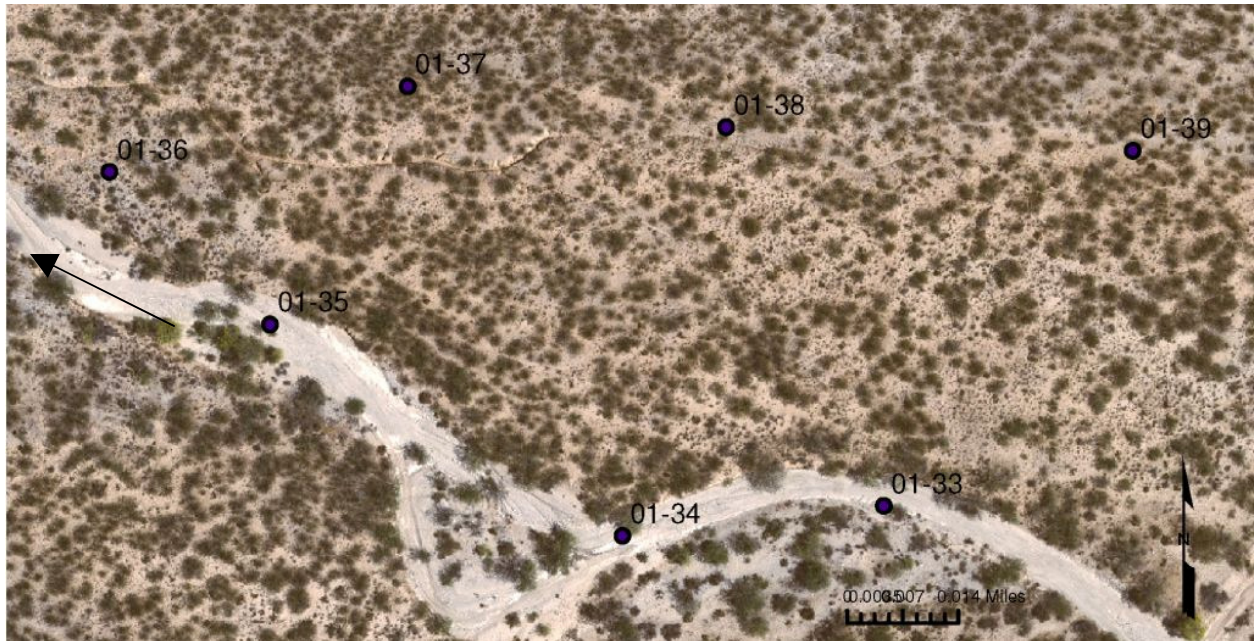
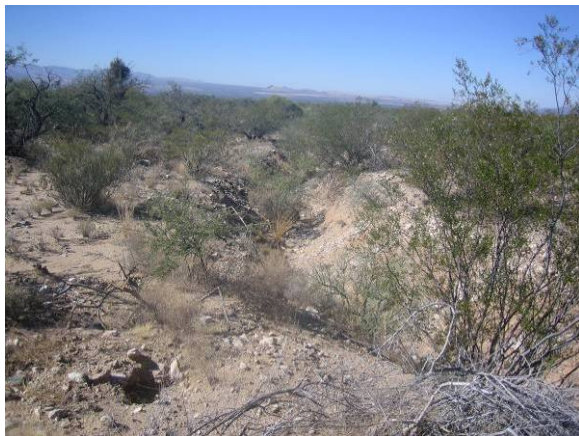
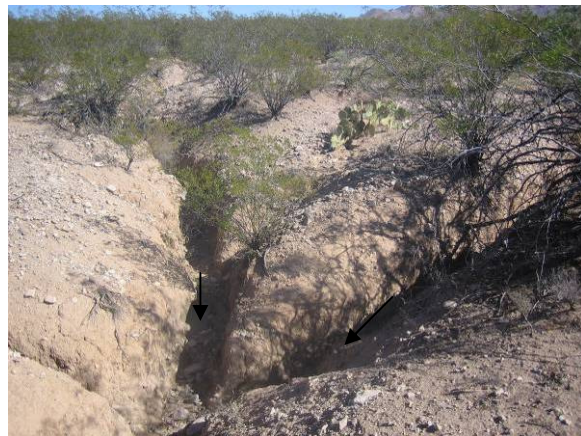
Figure 61 - Gully formation at LM01-36 within Distributary Piedmont Zone

Another instance of headcutting and gully formation on a Pleistocene terrace is shown on Figure 61. The main wash (to the south) is mapped as Qy (ch) and the area to the north near photo ID points 1-36, 1-37, 1-38, and 1-39 is mapped as Ql (M2). Breakout from the main channel is apparent. This breakout flow drains to the headcutting area, increasing the flow in the young channel and encouraging future headcutting.

Aerial view of headcut on Ql surface

Ground view of headcut (LM01-36-01)

Confluence of 2 developing washes (LM01-37-01)

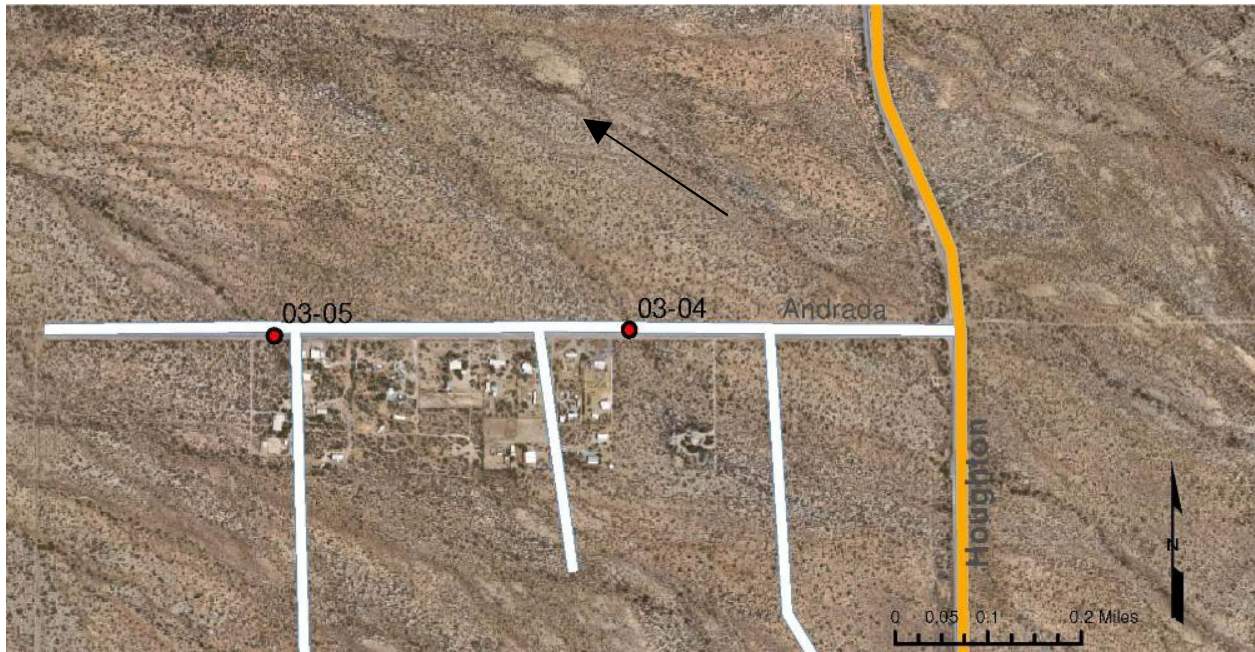
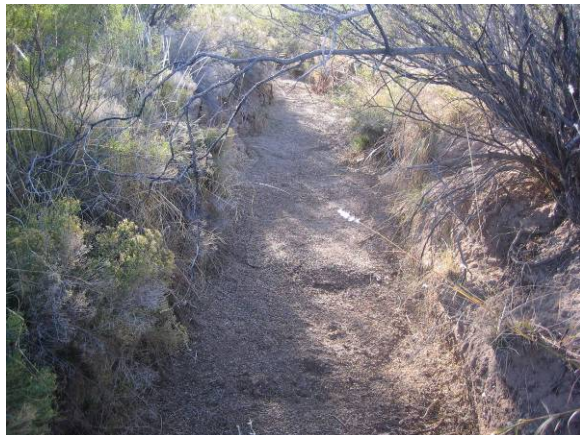
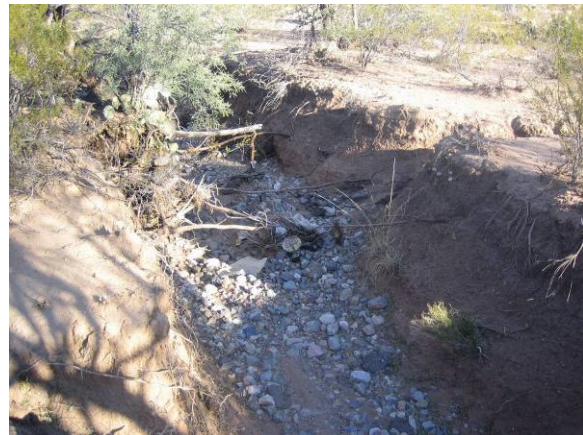
Figure 62 - Incising washes along Andrada Road, West of Houghton Road

In addition to the above examples, larger, older channels within this zone were found to be impacted by headcutting. Figure 62 shows a couple of washes which cross Andrada Road where headcutting was observed. The wash shown on the ground shots is 4 feet deep with vertical banks and a 4 foot wide bottom. The headcut extends up the channel, upstream of Andrada Road, until it terminates at Houghton Road. The area around field point 03-04 is Pleistocene alluvium mapped as M1/M2.

Upstream view of incising wash across Andrada Road (LM03-04-01)

Downstream view of incising wash across Andrada Road (LM03-04-03)

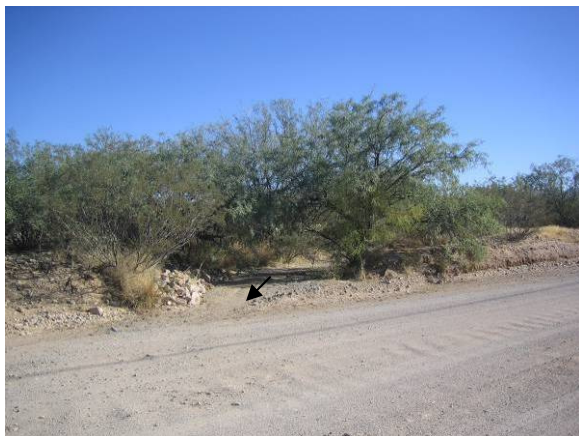
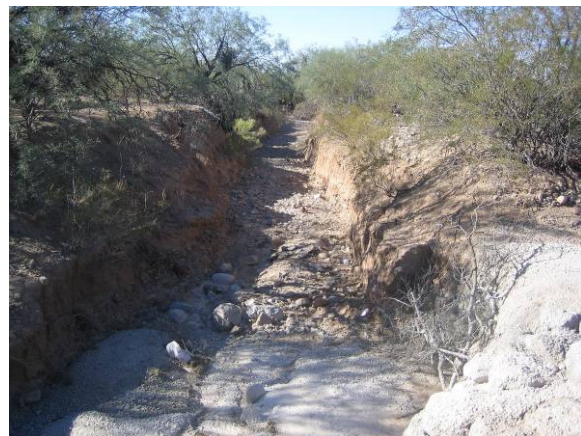
Figure 63 - Incision and sedimentation on Qly surface along Salero View Road

Another location of headcutting was found along Salero View Road, north of Sahuarita Road, see Figure 63. The crossing is a simple crossing; the profile of the road does not dip down into a channel. Both ground images were obtained from the same location. The channel is not much lower than the adjacent landscape and it appears that some sediment deposition has occurred upstream of the road with the channel aggrading to the elevation of the road. Vertical scour downstream of the road has cut a significant trench with the channel banks extending up approximately 6-feet. This is a location identified as an abrupt scour difference, and the observed scour downstream of the road is primarily a result of headcutting. A small, local contribution to the scour may be due to concentration of flow at the crossing and scour introduced by weir flow over the road. Headward erosion is mitigated by the placement of a concrete spillway.

Wash upstream of Salero View Road, draining across road (LM02-52-02)

Wash downstream of Salero View Road (LM02-52-01)

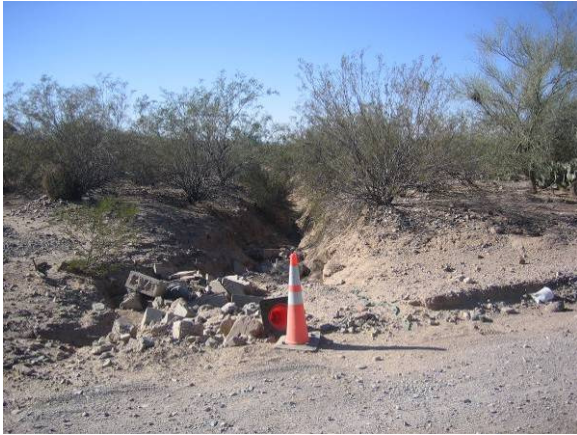
Figure 64 shows two instances of low flow crossings with head cutting scour mitigated by dumped concrete and rock.

Vertical scour downstream of Salero View Road, near Three Kings Road, Qly surface (LM02-53-01)

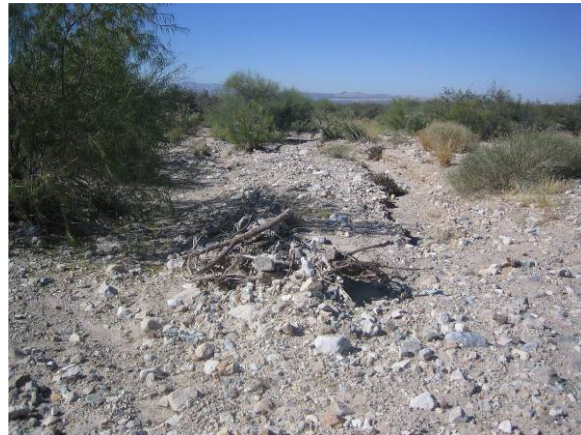
Figure 65 shows two locations where possible nick points were found along minor headcuts. The scour shown in the first photo is also associated with the debris lodged within the channel. The nick point shown in the second photo is along a seemingly abandoned flow path.

Nick point on abandoned wash, facing downstream (LM01-32-03)

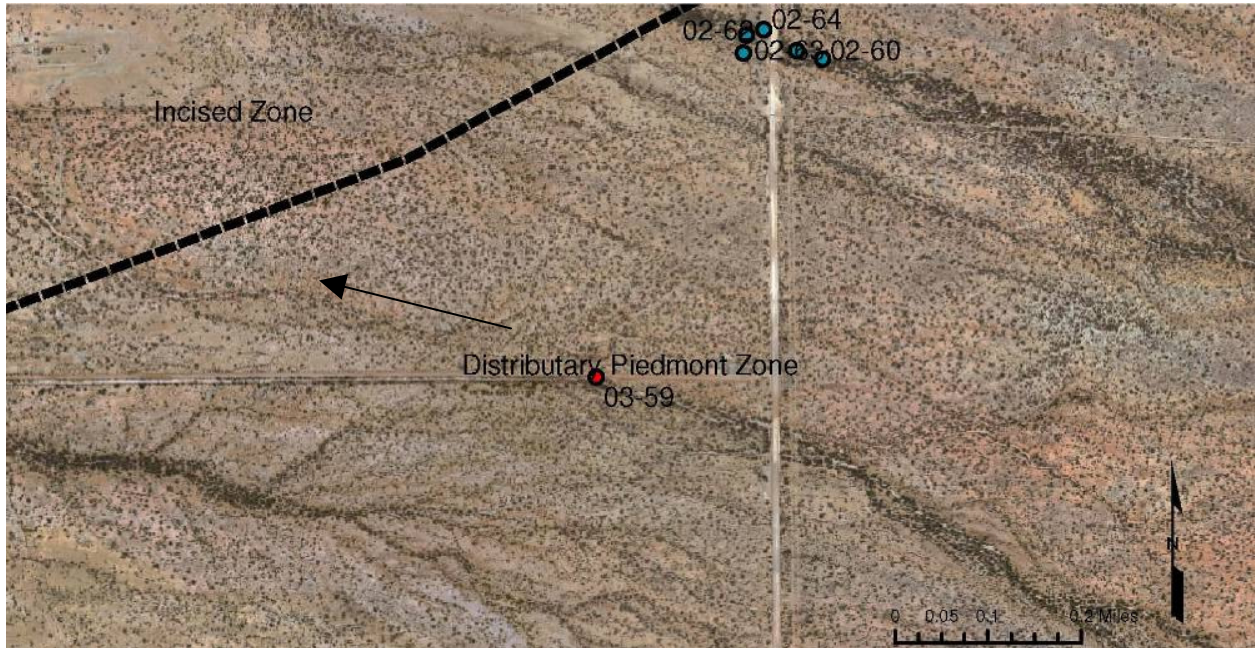
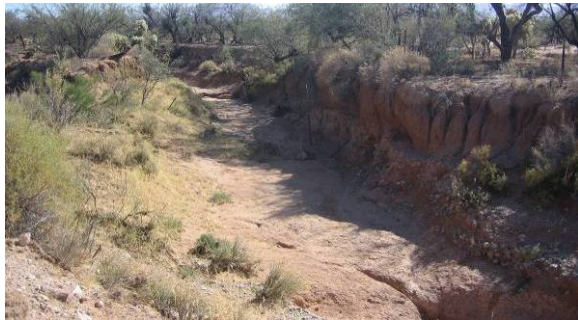
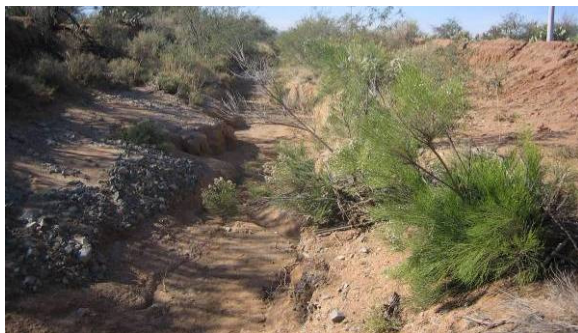
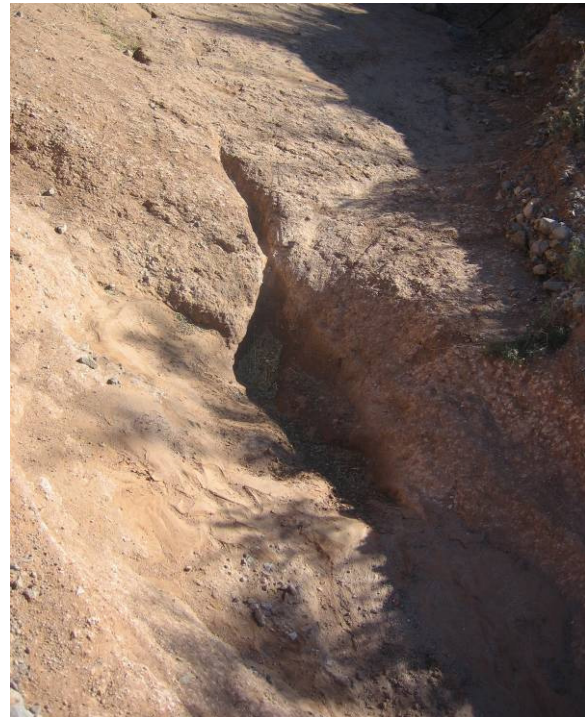
Figure 66 - Headcut terminating at a nick point within Distributary Piedmont Zone

Figure 66 shows a headcutting channel with a headcut which has terminated at a nick point. Headcutting actually extends upstream of the nick point but at a reduced scale.

Nick point location in Distributary Piedmont Zone

Channel upstream of nick point, facing upstream (LM03-59-01)

Headcut downstream of nick point, facing downstream (LM03-59-03)

Nick point in incised wash, facing upstream (LM03-59-02)

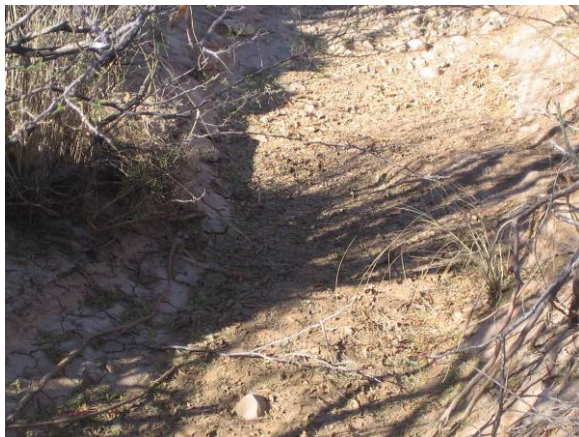
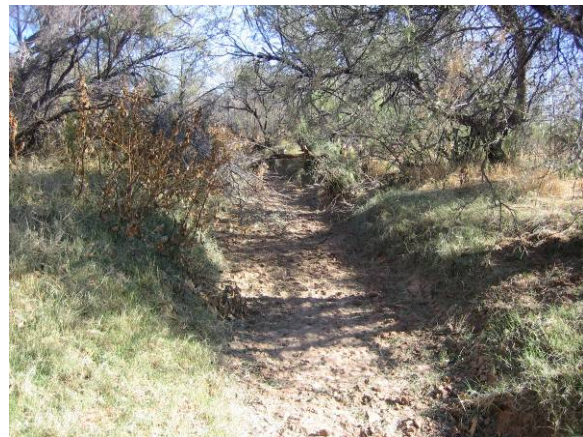
Figure 67 - Aerial and ground view of flow paths parallel to dirt roads

Figure 67 shows aerial views of flow paths within the Distributary Piedmont Zone that run parallel to roads. Multiple geomorphic processes seem to have caused the observed erosion. Note that in the top photo of Figure 67 the wash at the bottom of the frame is cutting into the floodplain terrace. This wash (LM03-17-01) is not impacted locally by the road, indicating that the roads are not entirely responsible for the scour and that headcutting and system wide scour is occurring. Furthermore, this area is tributary to the Cuprite Wash. A downstream reach of this tributary was observed to be incising as shown on LM03-26-01 (within the upper limit of the Incised Zone). Furthermore, it was observed elsewhere that the Fagan Wash, which Cuprite Wash is tributary to, is incised downstream of this location.

Incised wash at field point 03-17 (LM03-17-01)

Incision on Cuprite Wash Tributary (LM03-26-01)

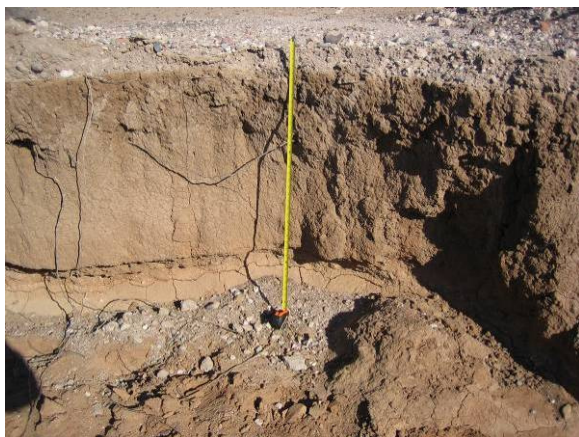
Figure 69 shows a couple of ground shots along flow paths parallel to a road. The vertical banks along the channels within this area range from one to several feet high (LM03-15-04). The scoured washes are generally not vegetated and have neither sand nor gravel present as a bed material. Exposed roots from older trees are common on the vertical banks. The flow paths occupy incised Holocene deposits and Holocene to late Pleistocene alluvial deposits. Flows draining into the washes tend to scour the top of the bank as shown in LM03-15-02.

Vertical bank on Qyd surface beside road (LM03-15-04)

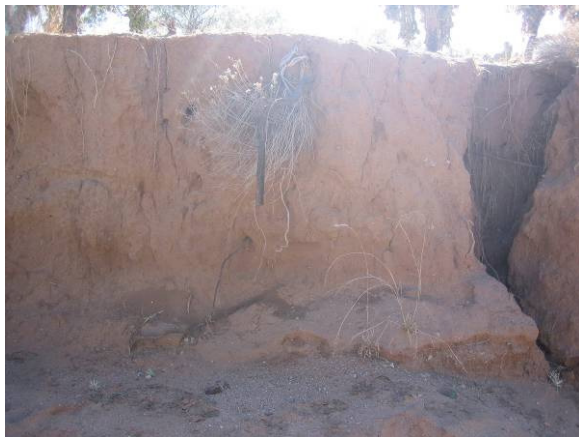
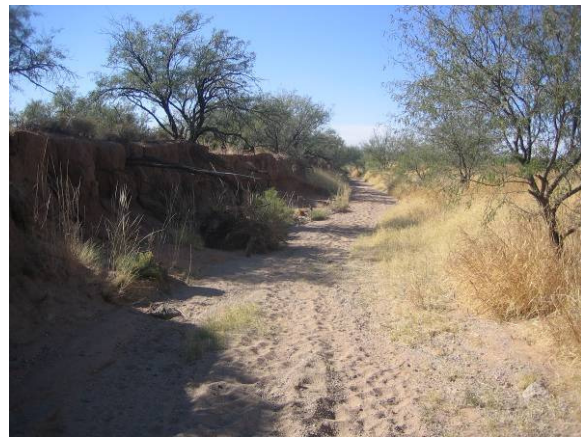
Figure 70 - Flow path parallel to Dawson Road

Other areas where roads are parallel to flow paths and with similar, yet less severe scour problems were found in areas such as along the south side of Dawson Road within the southwest portion of the Distributary Piedmont Zone (Figure 70) and south of Sahuarita Road, west of Houghton Road. The natural flow paths do not parallel the roads, but the flow paths have been redirected by the roads and therefore parallel the road for some distance.

Vertical bank along wash south of Dawson Road (LM03-64-04)

View downstream of roadside drainage south of Dawson Road (LM03-64-05)

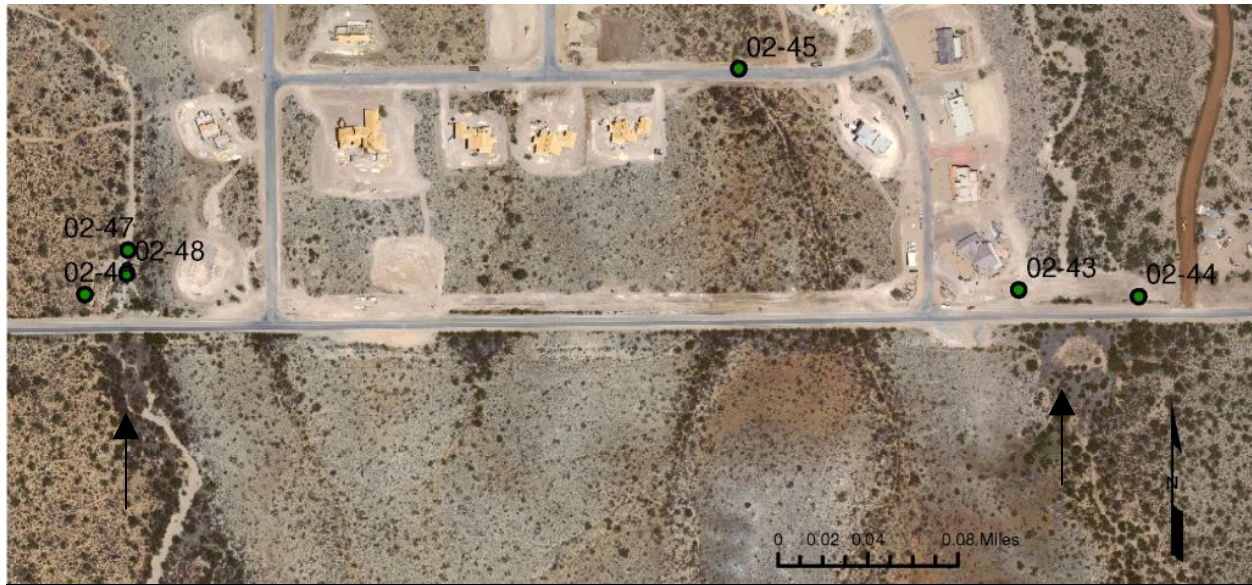
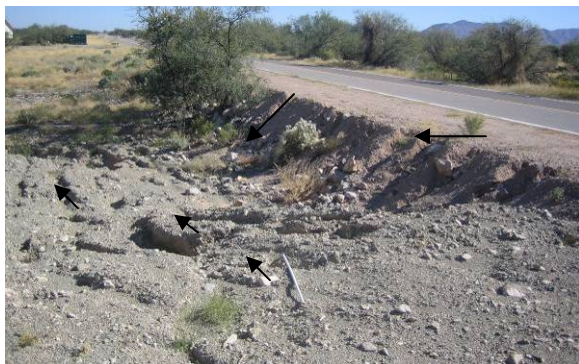
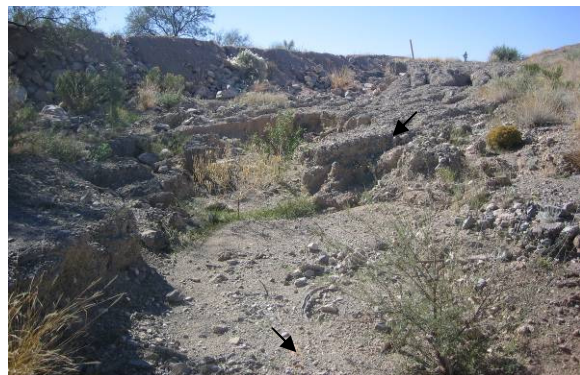
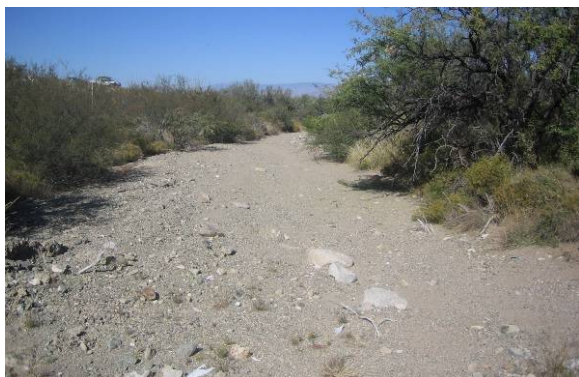
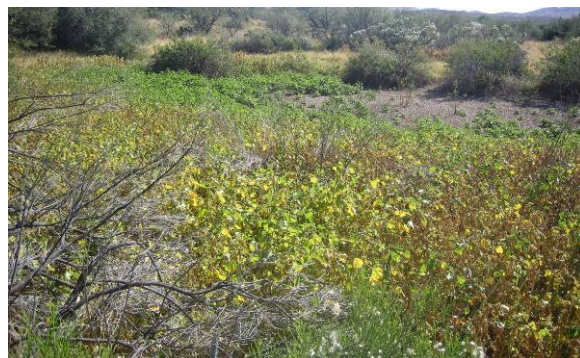
Figure 71 - Underfit drainage crossings along Sahuarita Road

Aerial view of two underfit drainage crossings

Vertical erosion developing downstream of Road on QTs surface (LM02-43-02), facing east

Vertical erosion downstream of Road, facing road, on QTs surface (LM02-43-05), facing southwest

Wash downstream of vertical erosion (LM02-43-06)

Sediment deposition upstream of Rd (LM02-43-08)

Figure 71 also includes ground shots showing the effects of the east undersized drainage crossing along Sahuarita Road, between Suntan Drive and Atrisco Drive (field point LM02-43). Flow is to the north at this location, crossing Sahuarita Road from the south. Extensive vertical erosion which extends from the Qy wash surface to the adjacent and older QTs surface was observed.

- Sediment is deposited upstream of the road yielding clear water scour downstream of the road.
- Runoff from the road flows down the steep embankment, causing scour due to relatively high velocity, clear water flow.
- Flow likely overtops the road on occasion. This overtopping flow will have a hydraulic drop across the steep, downstream embankment, again causing scour due to high velocity flow.
- Headward erosion was observed downstream of this and may also be a contributing factor to the erosion.

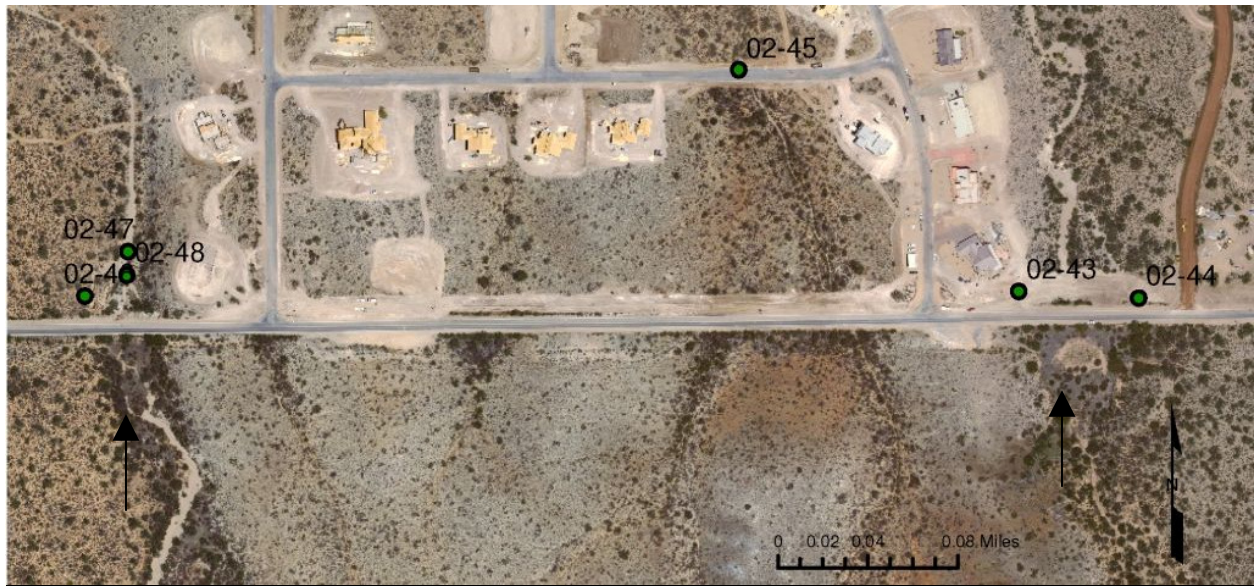
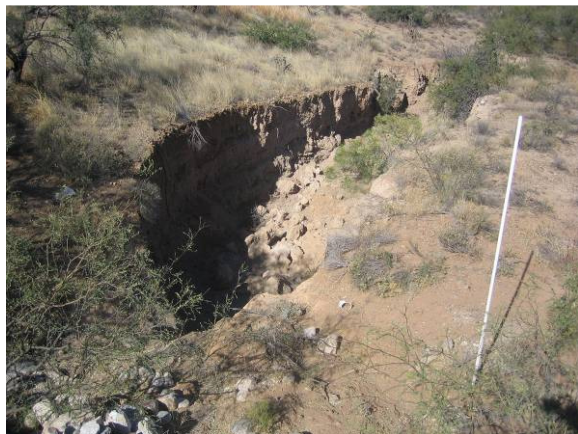
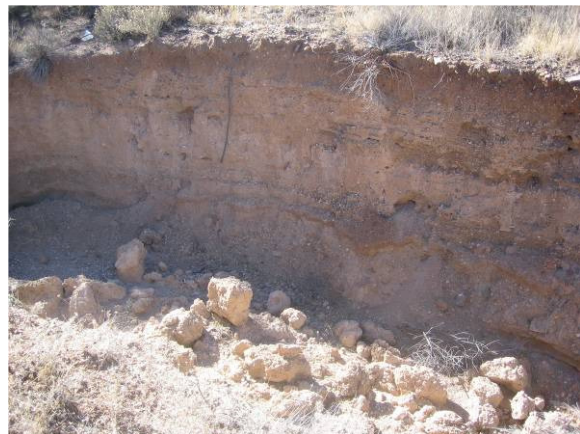
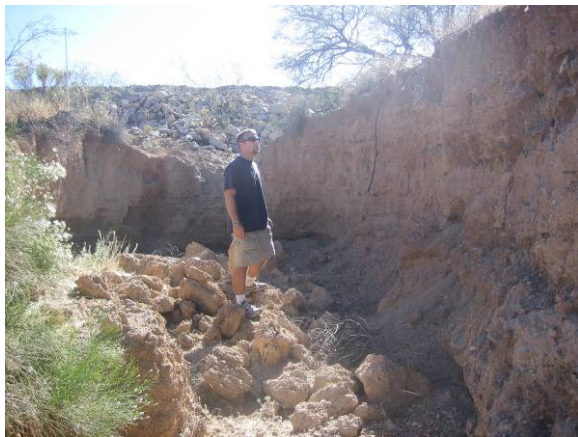
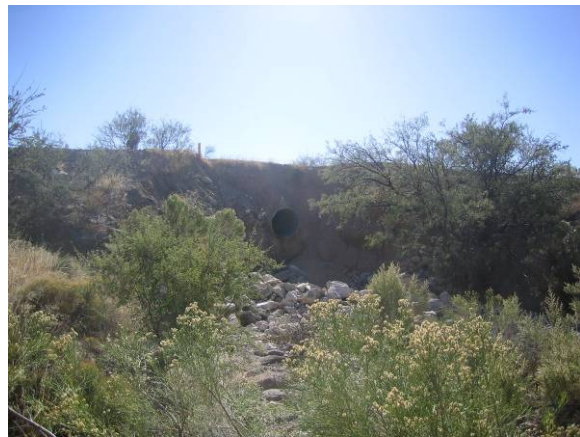
Figure 72 - Another underfit drainage crossings along Sahuarita Road

The second underfit drainage crossing on Sahuarita road is shown on Figure 72. This crossing is situated between Hilton Drive and Sharon Road. Figure 72 shows vertical erosion downstream of the road at this location which is much more developed than the erosion shown in Figure 71. At this location vertical cut banks exceed 7 feet deep. The erosive activity is primarily occurring outside of the main wash corridor, away from the location of the single CMP. The main wash corridor and the CMP are approximately 40 feet east of (to the right of) the erosion shown in Figure 72. This suggests that the erosion shown in Figure 72 is a result of headcutting with the underfit culvert crossing worsening the condition.

Aerial view of two underfit drainage crossings

Vertical erosion downstream of Rd. (LM02-46-01)

Erosion shown in channel (LM02-46-05)

Erosion in channel, facing Rd. (LM02-46-06)

Undersized CMP east of erosion (LM02-48-01)

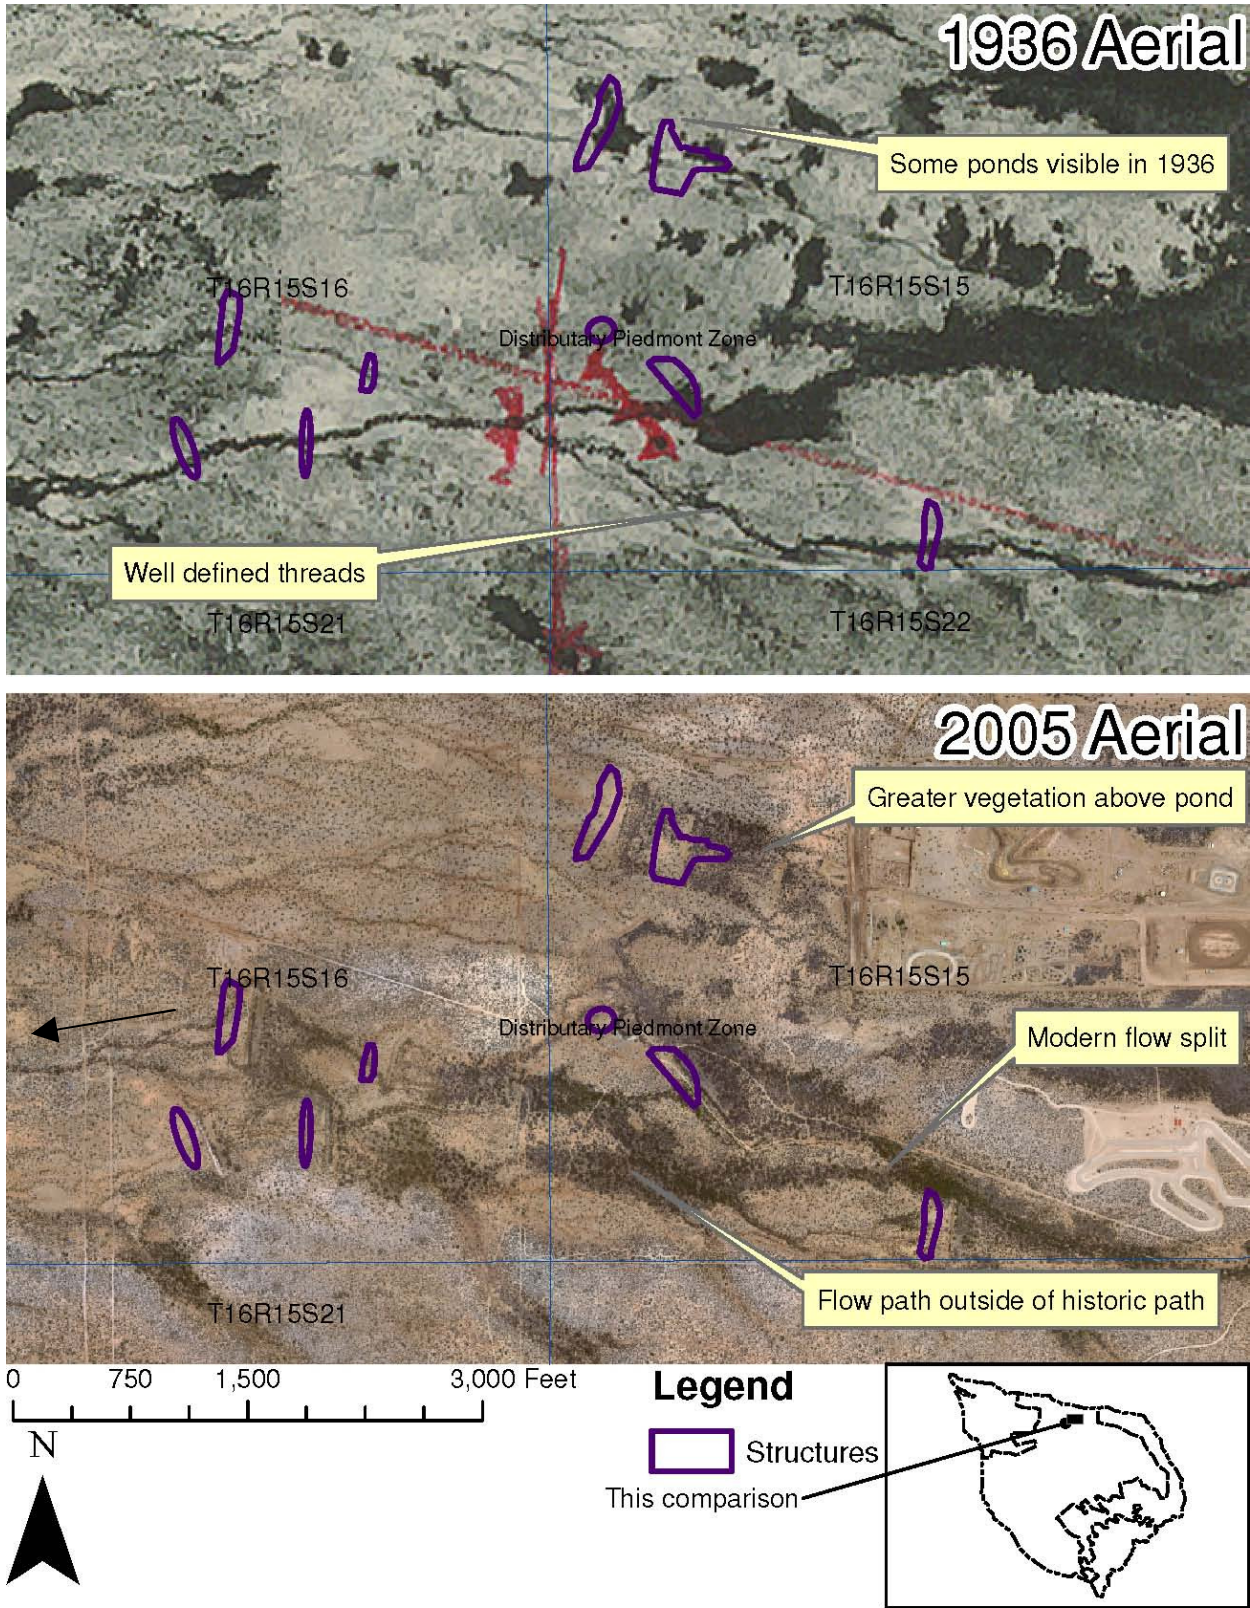
Figure 74 - Comparison of 1936 and current aerial images; station DPZ02

Figure 74 shows an area with multiple impoundments, some of which are visible on the 1936 aerial image. The historic flow paths represented by both the 1936 aerial image and the Surficial Geologic Map (bottom half of Figure 75) are mildly distributary with well defined primary flow paths. The modern flow paths are highly distributary and braided. Dense vegetation is observed upstream of the impoundments while the areas downstream are much less vegetated, suggestive of aggradation upstream of the impoundment and scour downstream. A diversion and stock pond are shown on Figure 85 with no significant changes to the fluvial systems observed at this location.

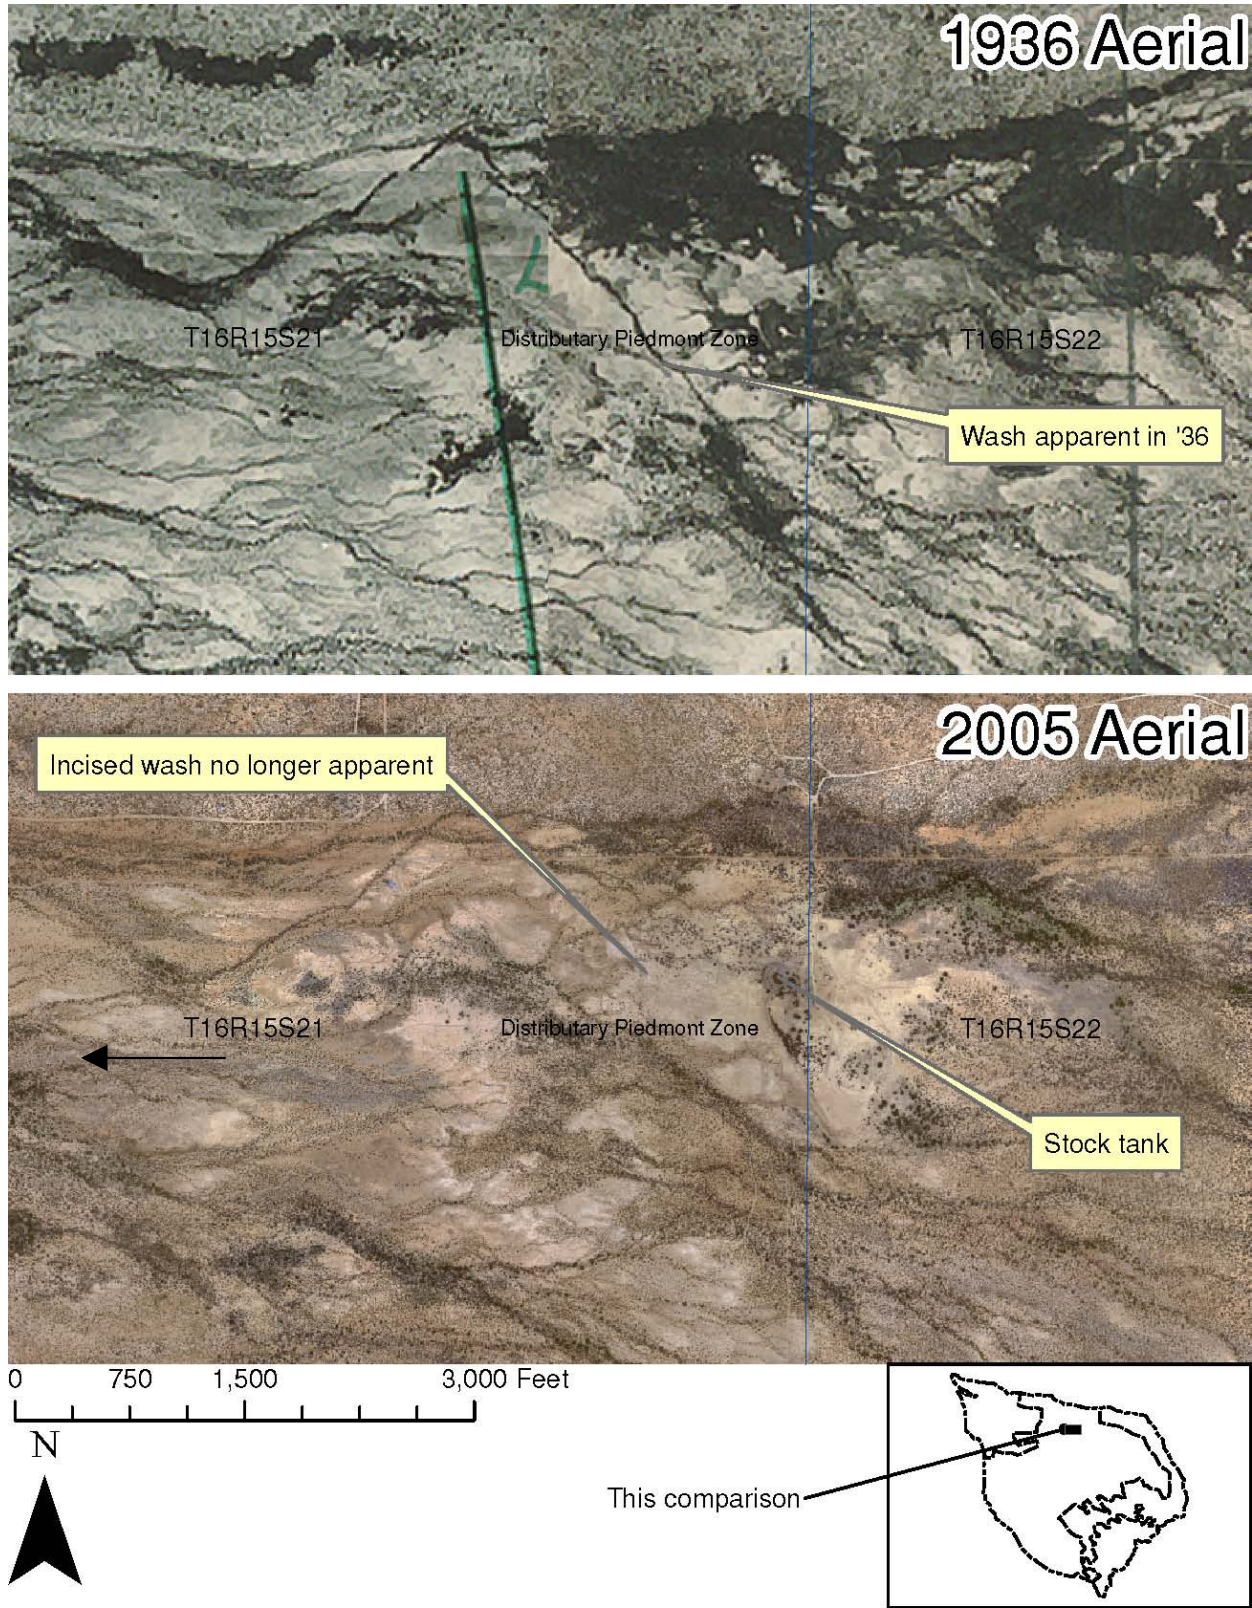
Figure 76 - Comparison of 1936 and current aerial images; station DPZ03

Figure 76 shows a wash which was found in the 1936 image but is no longer visible. In addition, a stock tank is visible on Figure 76. The wash cutting through the middle of the 1936 portion of Figure 76 cuts through a Qyd (incised Holocene deposits) area, breaking from one Qyc (modern channel deposits) to another Qyc thread. This indicates the potential for wash threads to develop and be abandoned within the dissected Holocene and Pleistocene alluvium deposits. It is unclear what impact the stock tank had on this process, if any.

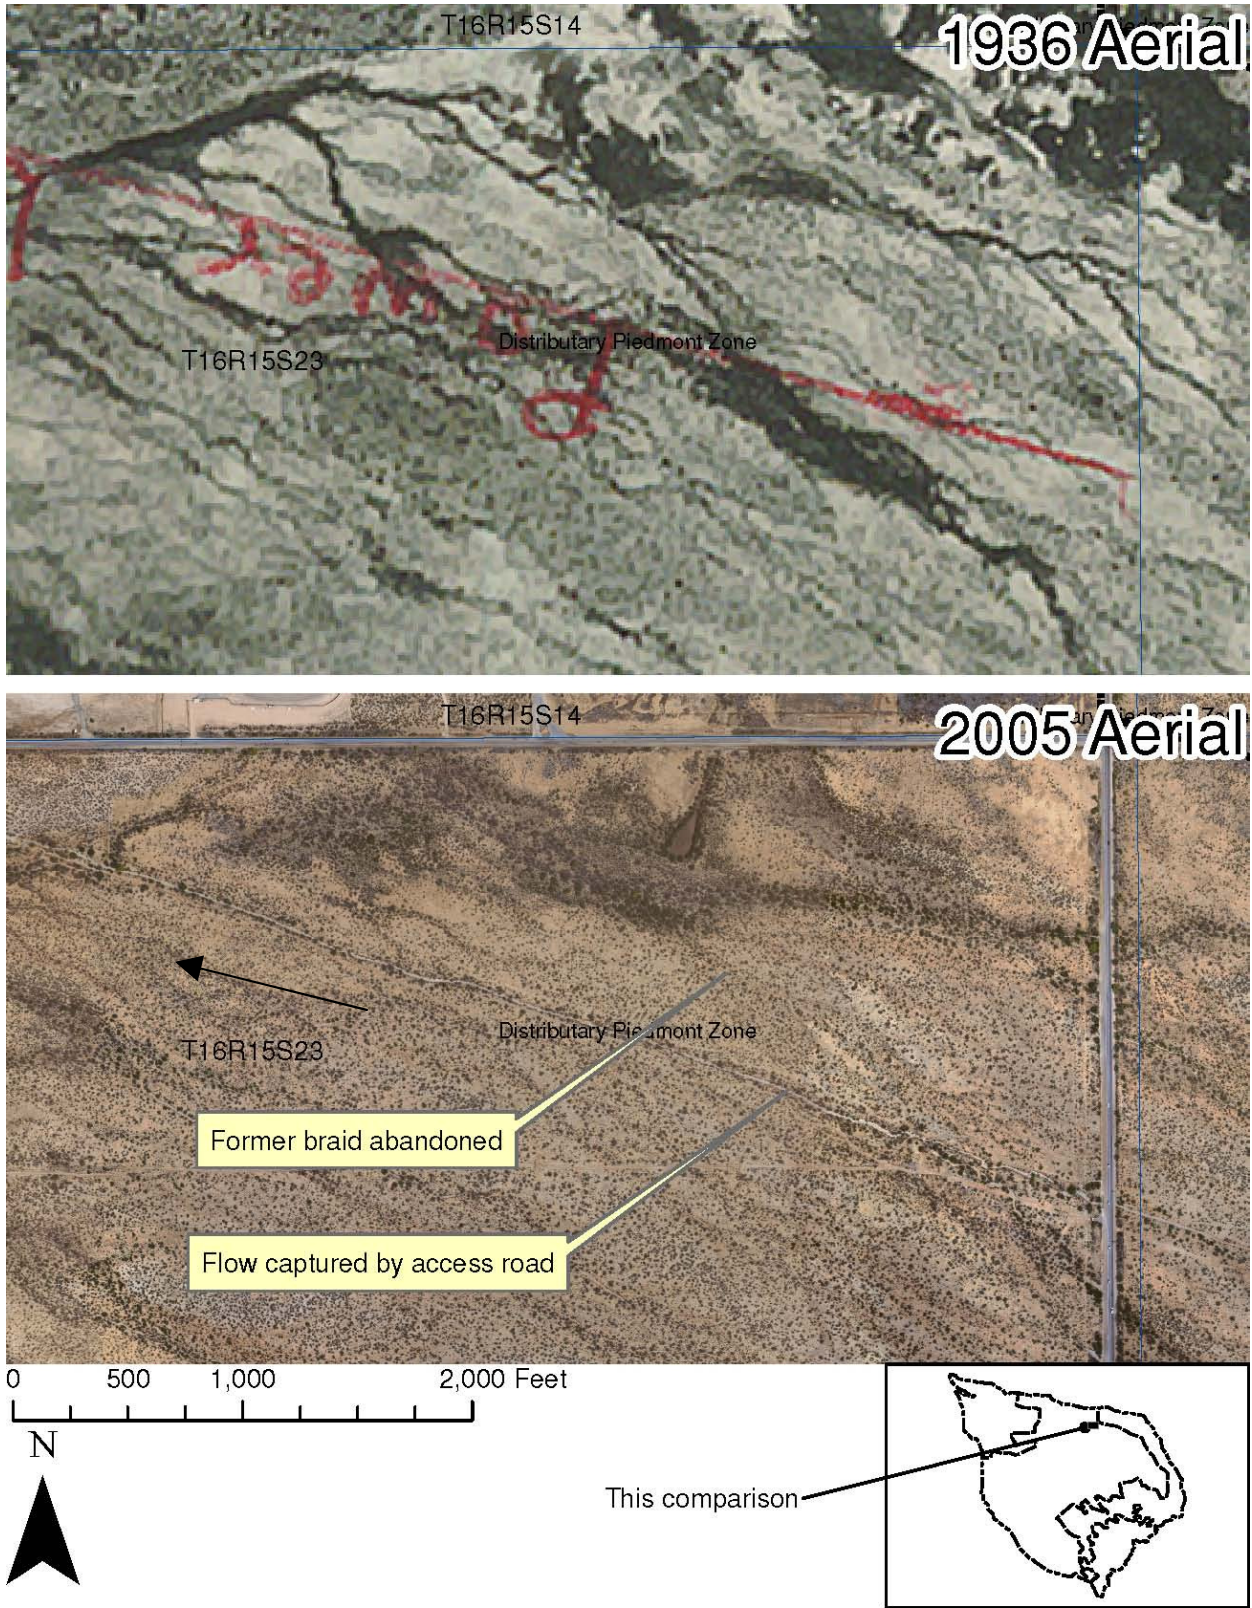
Figure 77 - Comparison of 1936 and current aerial images; station DPZ04

Evidence of channel realignment due to natural causes and human activity was found in the aerial comparison exercise. Figure 77 shows a small wash thread which has been captured by a dirt access road. The wash thread, mapped as a Qyc area, is much more evident on the 1936 aerial as the wash appears to have since taken the course of the road west to rejoin the primary channel. An instance of channel development is shown on Figure 78 where a flow path has developed since 1936. The cause of this may be in part due to the headcutting within this area and in part due to the section line road at this location. Evidence of flow conveyed along the road is found in the figure, specifically along the north section line of Section 34. Over time, it is likely that a small gully developed which eventually scoured in response to headcutting.

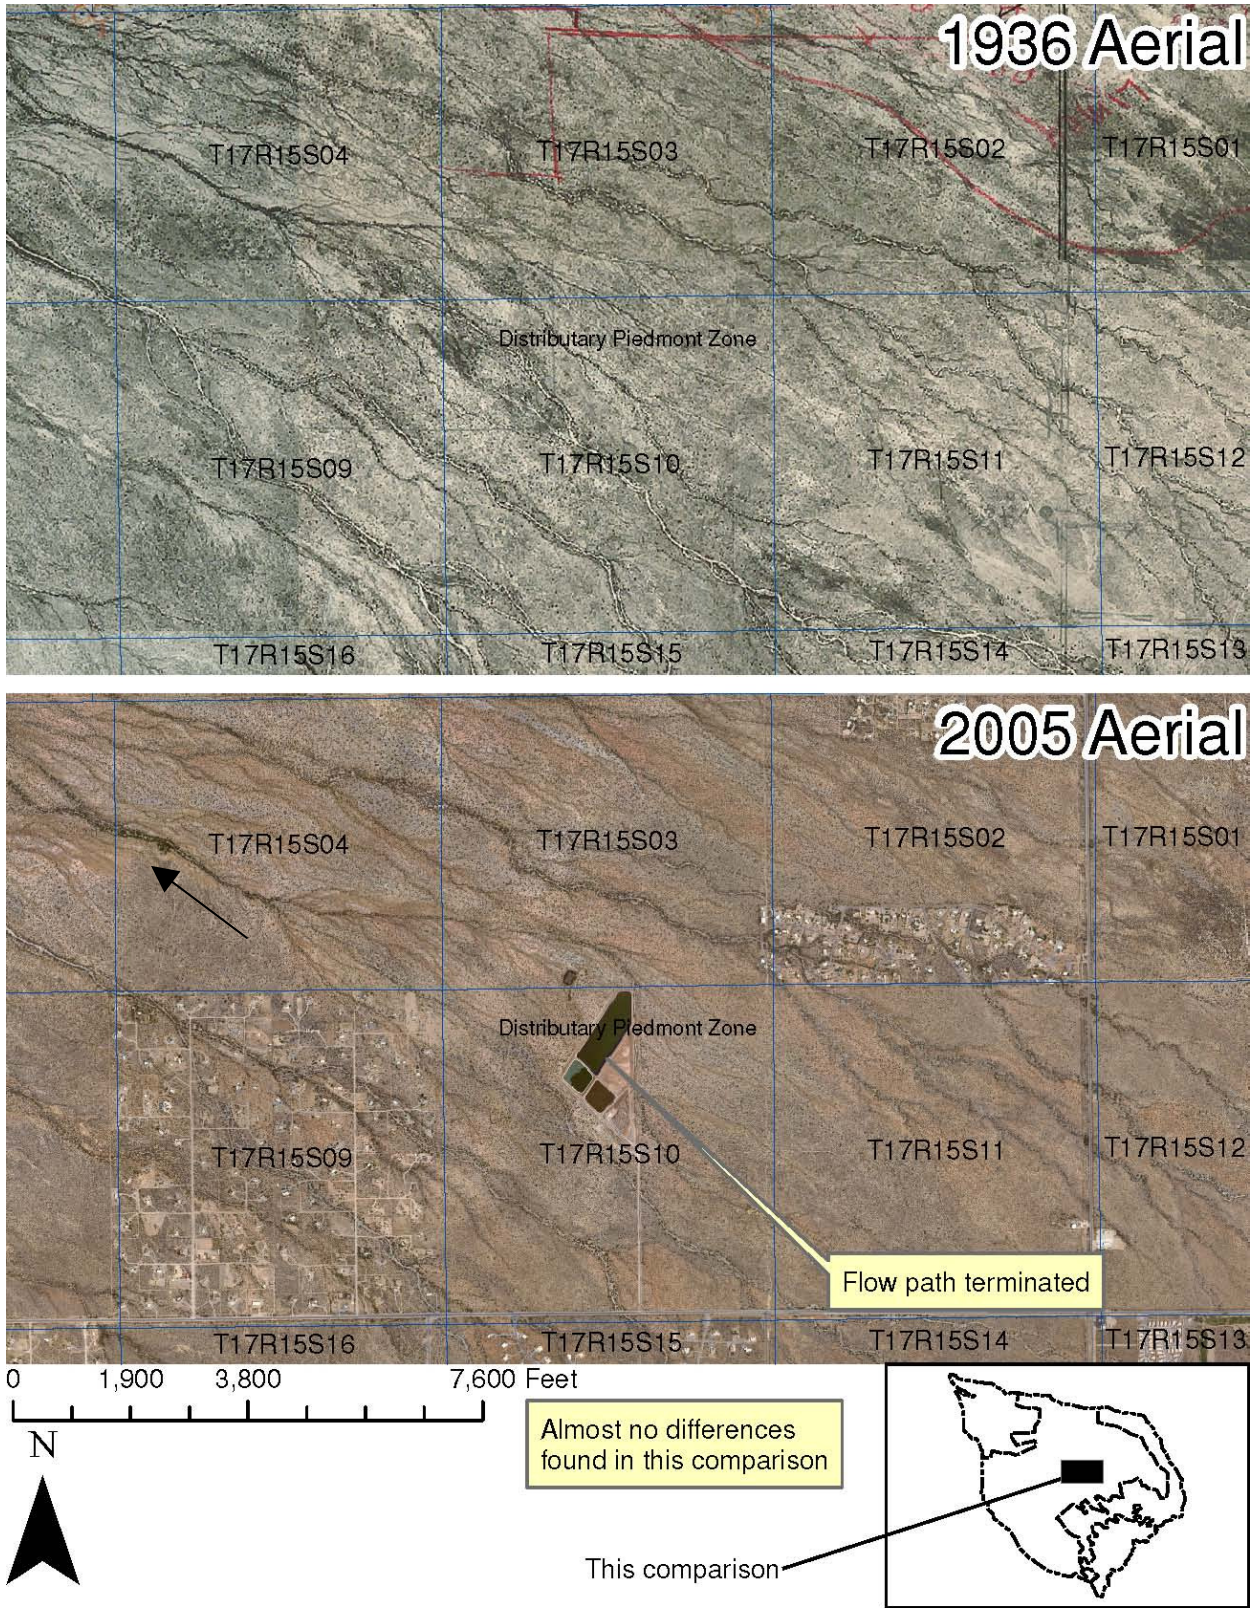
Figure 79 - Comparison of 1936 and current aerial images; station DPZ06

An interesting finding is that much of the upland areas of the Distributary Piedmont Zone show little to no signs of changes to the fluvial systems in the aerial photograph comparison as shown in Figure 79, Figure 84, and Figure 86. Human influence to the systems is minimal in Figure 79 and Figure 84 as development within this area is limited and is low intensity. Greater development density is found near Figure 86, but development has generally preserved the flow corridors. Figure 83 shows the significant difffluence of the Sycamore Canyon Wash, another upland area within this zone. Review of the 1936 aerial indicates that the bifurcations currently
