Geomorphic Analysis Report for the Lee Moore Wash Basin Management Study in Pima County Arizona

Prepared for and in cooperation with the
Pima County Regional Flood Control District

August 2008

By Ian P. Sharp, P.E., CFM
JE Fuller Hydrology & Geomorphology Inc.

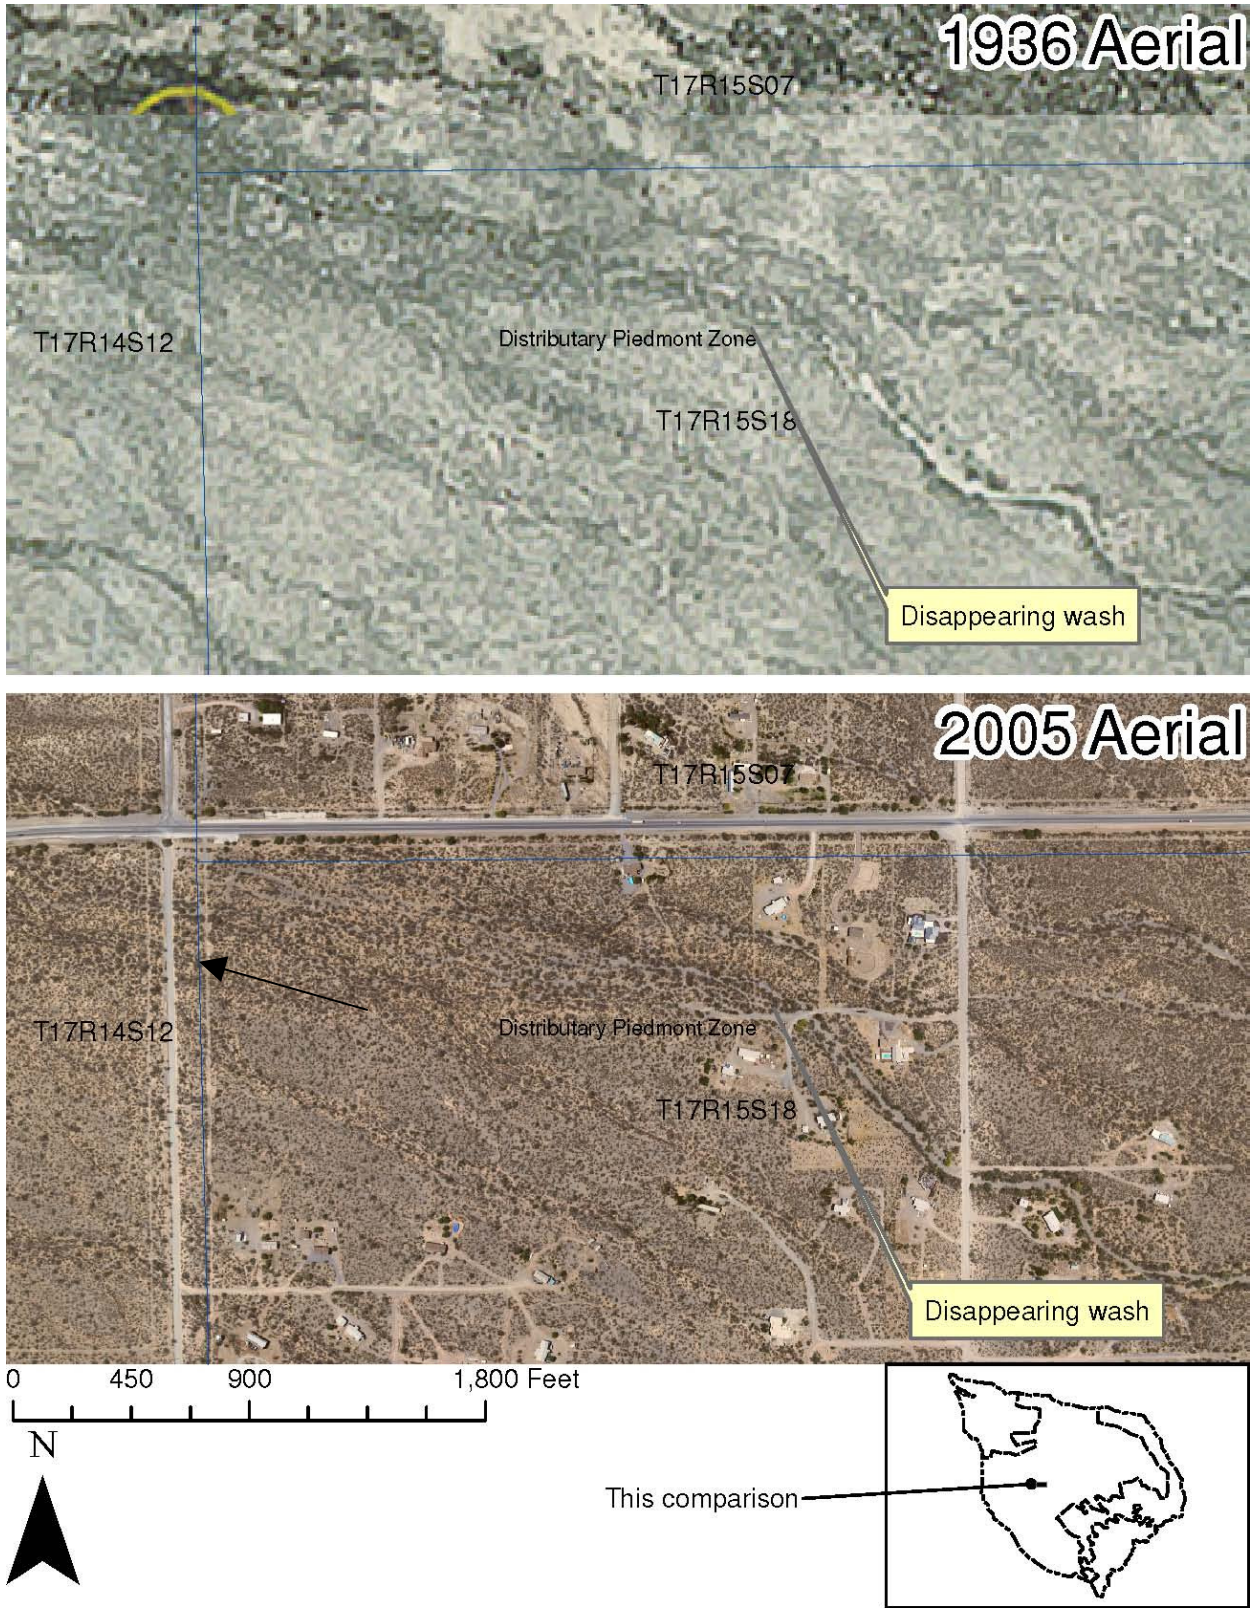
Figure 80 - Comparison of 1936 and current aerial images; station DPZ07

Sedimentation is shown on Figure 80 and Figure 81 which show instances of disappearing washes. The resolution of the 1936 images is grainy and it is not clear if the deposition has increased since 1936. The surficial geology map (top half of Figure 82) shows the disappearing wash of Figure 80, with the defined channel mapped as Unit ch and the depositional area mapped as Y2. The surficial geology map (bottom half of Figure 82) shows the washes of Figure 81 as a Unit Qy and the depositional area as Unit Qly. Note that ch and Qy are similar units as are Y2 and Qly. Logic suggests that this combination of younger channel alluvium followed downstream by slightly older depositional alluvium can be used to identify discontinuous streams and depositional areas.

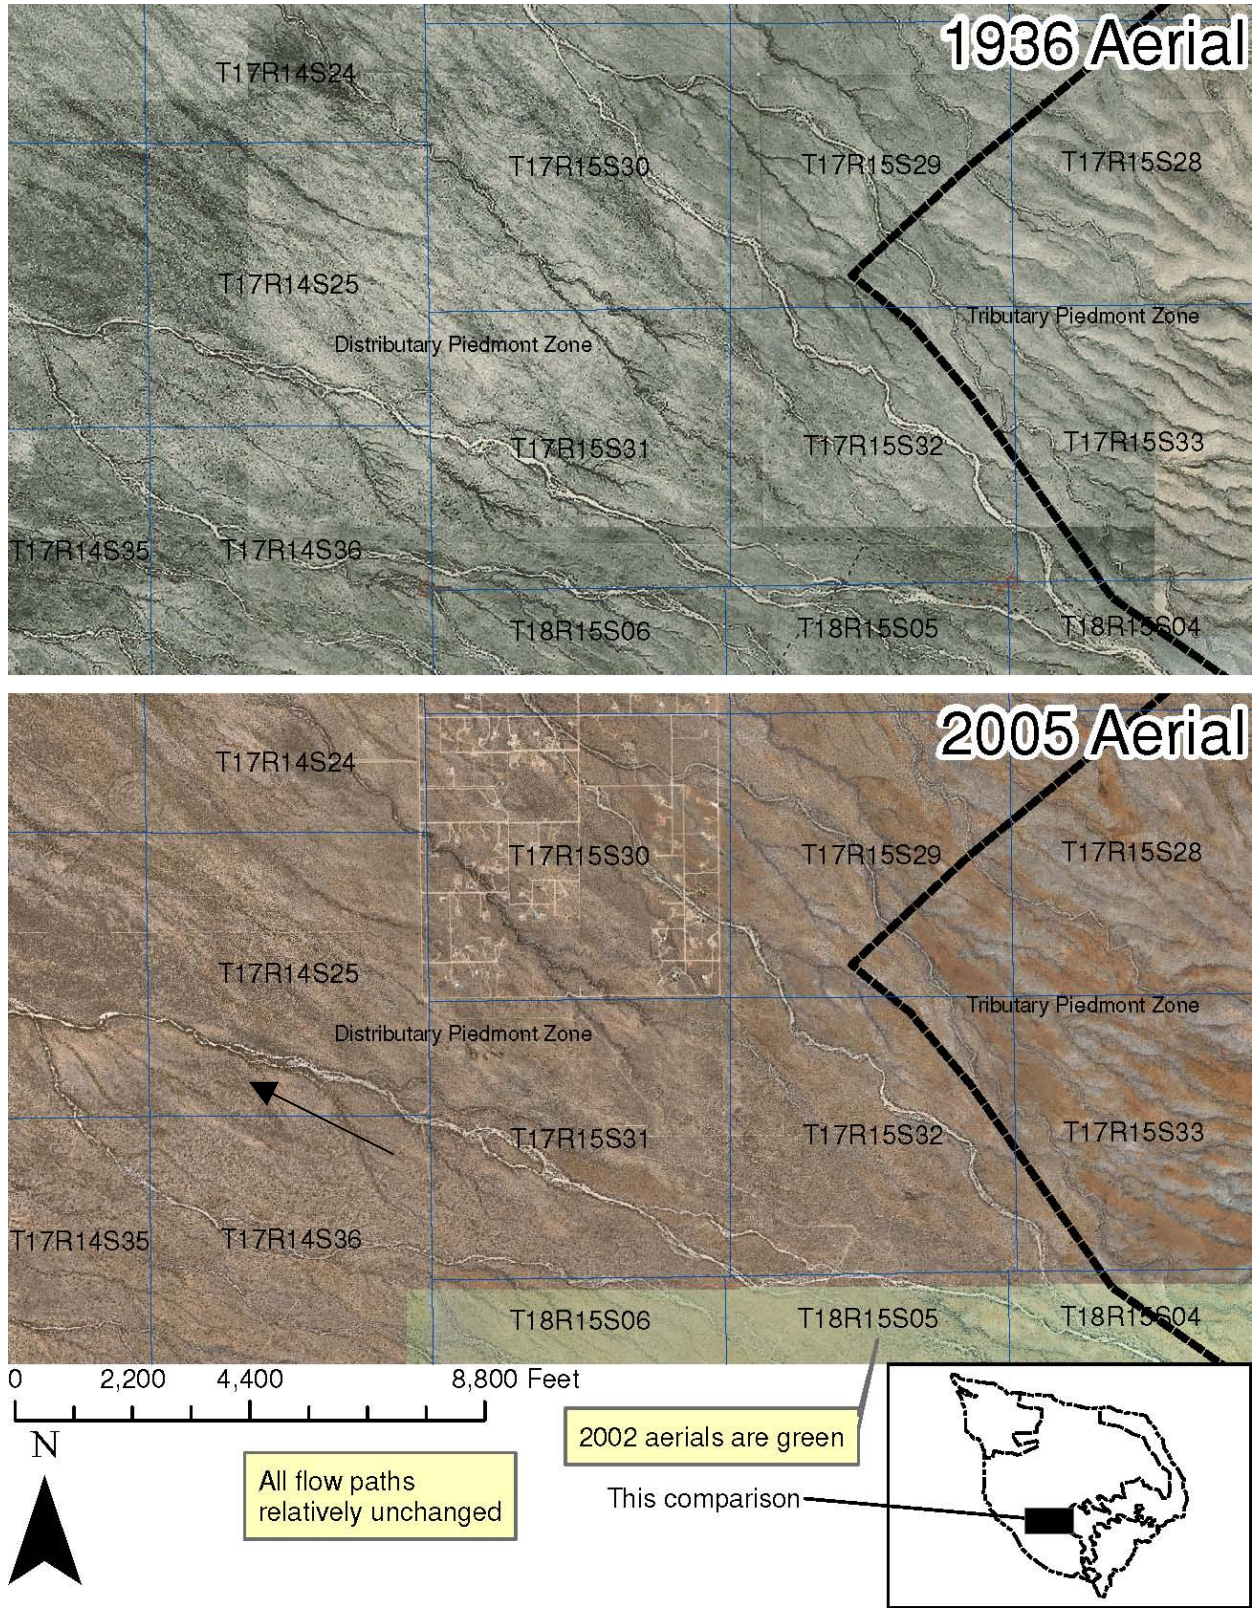
Figure 84 - Comparison of 1936 and current aerial images; station DPZ10

An interesting finding is that much of the upland areas of the Distributary Piedmont Zone show little to no signs of changes to the fluvial systems in the aerial photograph comparison as shown in Figure 79, Figure 84, and Figure 86. Human influence to the systems is minimal in Figure 79 and Figure 84 as development within this area is limited and is low intensity. Greater development density is found near Figure 86, but development has generally preserved the flow corridors. Figure 83 shows the significant difffluence of the Sycamore Canyon Wash, another upland area within this zone. Review of the 1936 aerial indicates that the bifurcations currently

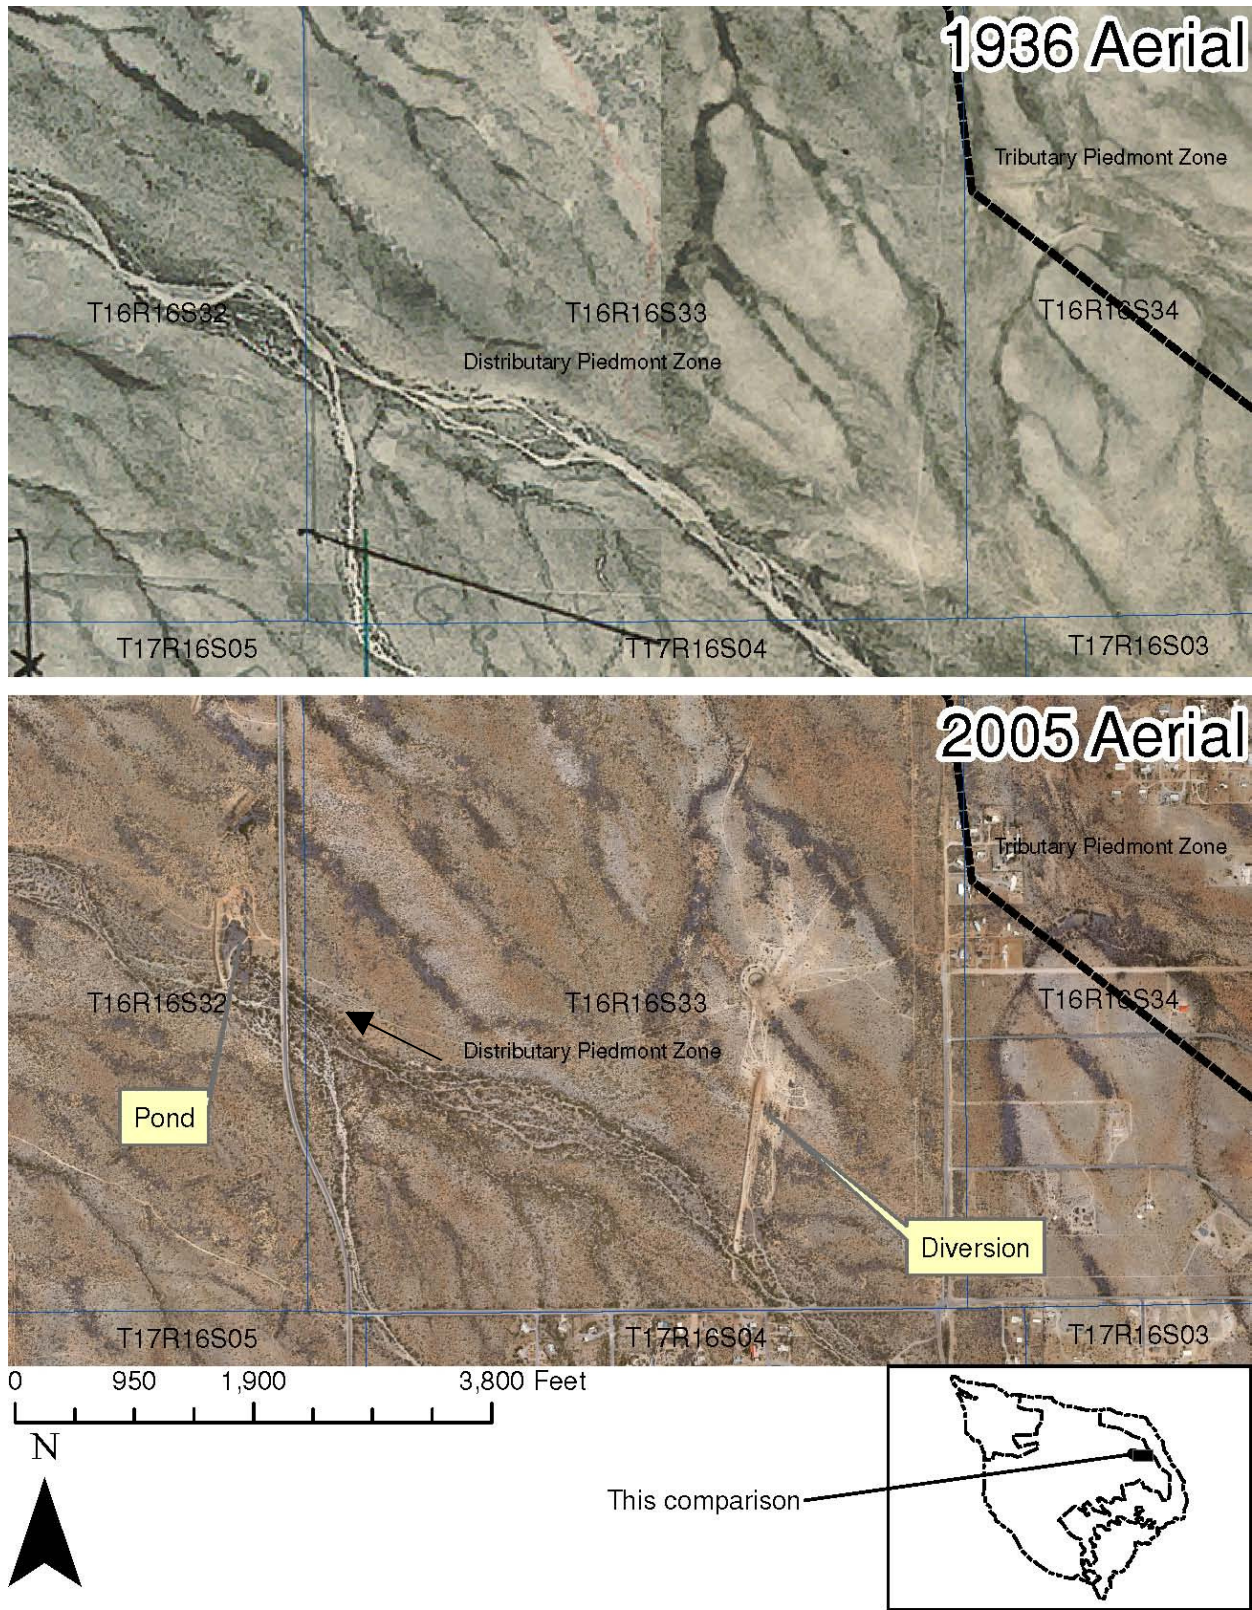
Figure 85 - Comparison of 1936 and current aerial images; station DPZ11

Figure 74 shows an area with multiple impoundments, some of which are visible on the 1936 aerial image. The historic flow paths represented by both the 1936 aerial image and the Surficial Geologic Map (bottom half of Figure 75) are mildly distributary with well defined primary flow paths. The modern flow paths are highly distributary and braided. Dense vegetation is observed upstream of the impoundments while the areas downstream are much less vegetated, suggestive of aggradation upstream of the impoundment and scour downstream. A diversion and stock pond are shown on Figure 85 with no significant changes to the fluvial systems observed at this location.

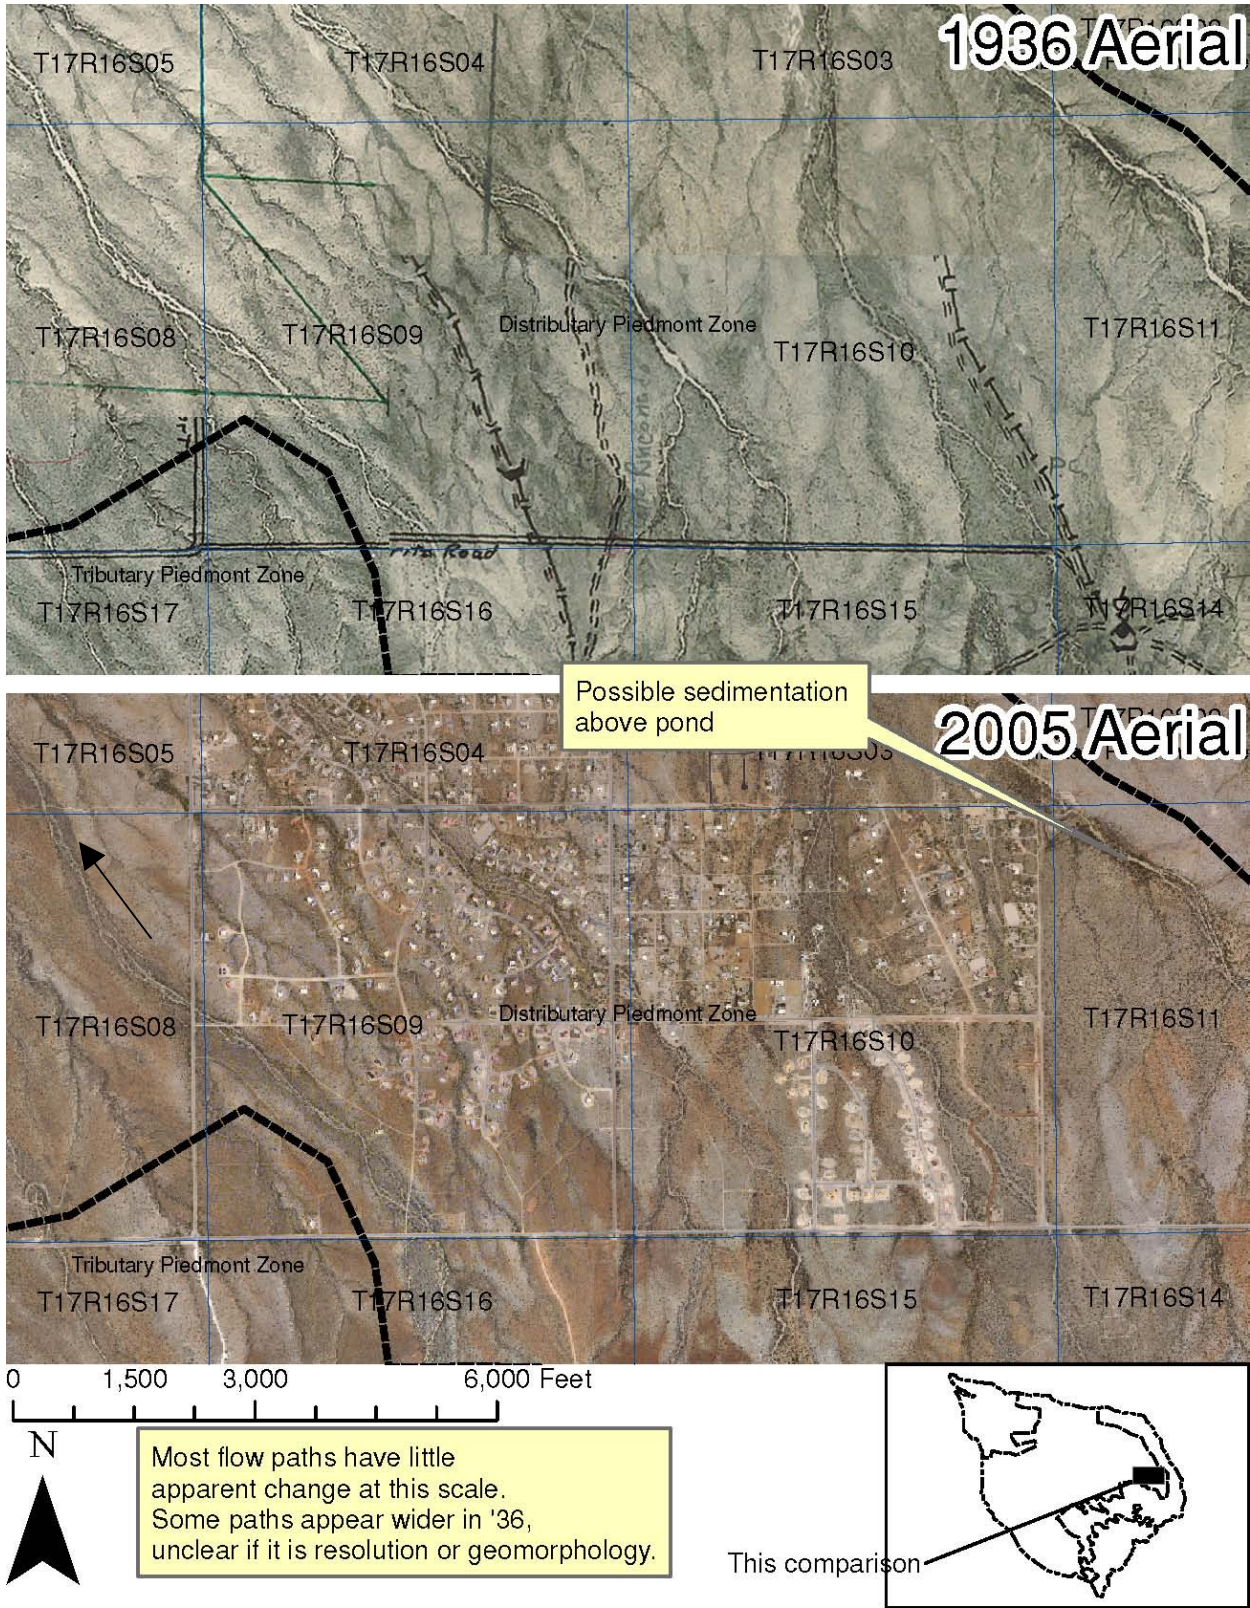
Figure 86 - Comparison of 1936 and current aerial images; station DPZ12

observed have changed relatively little since 1936. It should be noted that headcutting and significant local scour were observed in the field within the area shown on Figure 86 while the aerial comparison did not indicate this was happening. This highlights some of the limitation of the aerial comparison as the level of detail and the scale of the comparison preclude finding evidence of no changes to the fluvial systems.

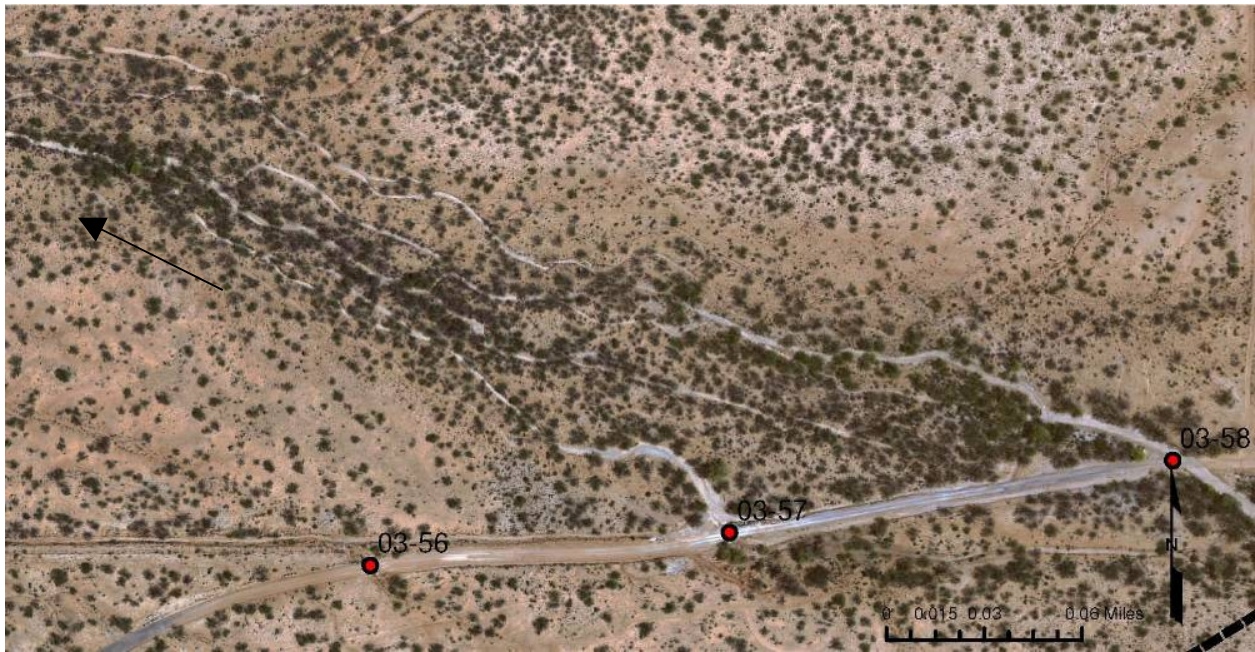
During field visits both lateral and vertical erosion were found along the older terraces where roads capture and/or redirect stream flows. Figure 88 shows three locations where flow was found crossing an unimproved road near the transition from the Distributary Piedmont Zone to the Incised Zone (note that some distributary flow patterns are found at this location as it is near the transition into this zone). Field point 03-56 is located on a T5 surface while 03-57 and 58 are on Qy surfaces. LM03-56-01 shows the downstream view of the flow path on the T5 surface; vertical and horizontal erosion are found at this location. LM03-57-01 shows the downstream view of the flow path on the Qy surface; this wash is relatively stable.

Aerial view of flow patterns on Holocene and Pleistocene surfaces

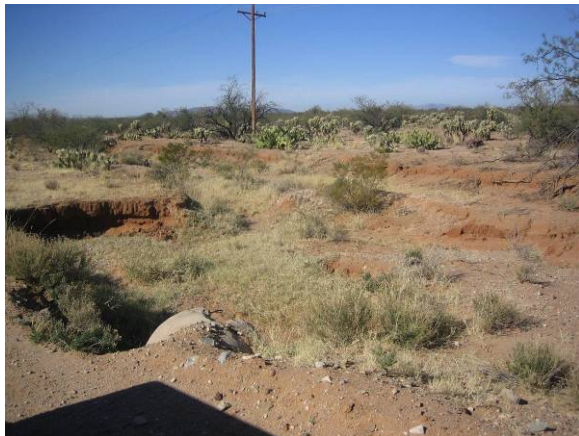
Eroded flow path on T5 surface (LM03-56-01)

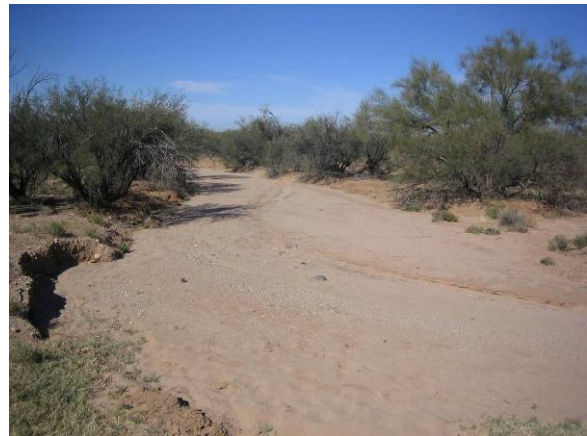
Stable flow path on Qy surface (LM03-57-01)

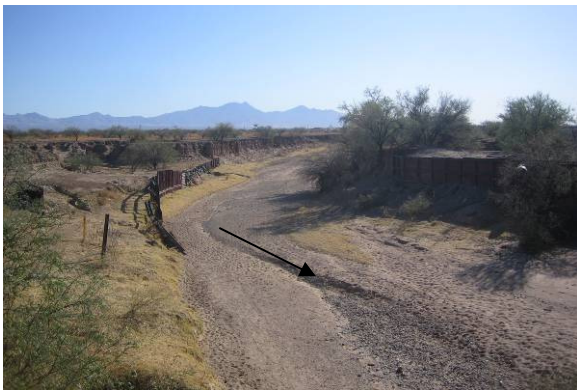
Relatively high vertical banks were found on the larger washes west of Nogales Highway. The adjacent floodplain terraces in these areas are typically mapped as T2 surfaces. These vertical banks are a result of substantial headcutting. Examples of vertical banks and areas of highly incised channels on abandoned terrace surfaces are shown on Figure 89. The panorama of LM03-65 shows erosion on a T2 surface just south of where the Lee Moore Wash crosses the Nogales Highway. LM03-67-01 shows the Lee Moore Wash which has the bed mapped as a Qy (ch) surface and the adjacent floodplain terrace mapped as a T2 surface.

View from UPRR Bridge up the Lee Moore Wash, at the Petty Ranch Wash confluence, channel on Qy surface and overbanks on T2 surface (LM03-67-01)

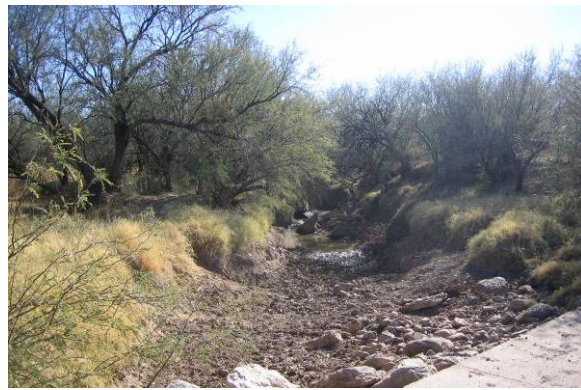
View of the Fagan Wash facing upstream from Country Club Road alignment, T2 surface (LM03-33-01)

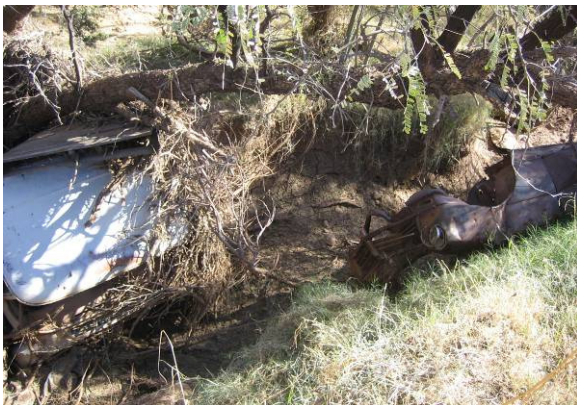
Incised braid of Fagan Wash with debris and old cars, T2 surface (LM03-34-01)

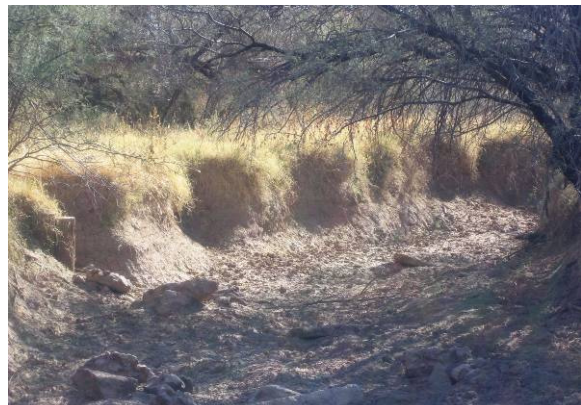
View of the Lee Moore Wash facing upstream from Country Club Road alignment, Qy surface and scalloped outer bank (LM03-41-01)

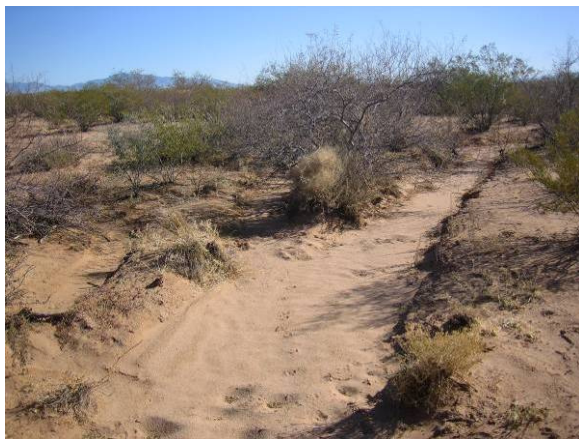
Instances of aggraded washes or washes with extensive sediment supply were generally found in the upper limits of the Incised Zone. Figure 90 shows two locations where such washes were found. LM03-25-01 and LM03-26-02 show the ground views of these washes.

Small aggraded wash emanating from Cuprite Wash breakout flow, T5 terrace (LM03-25-01)

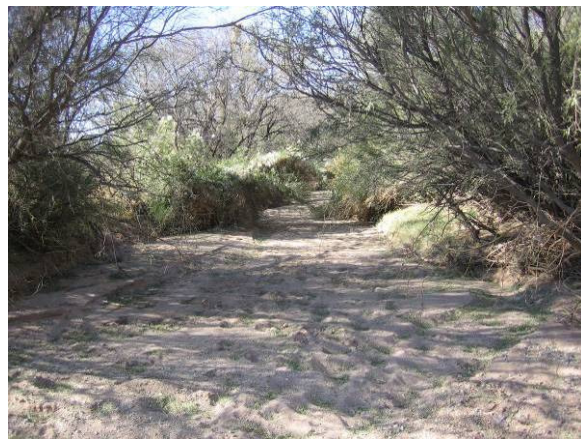
Aggraded wash at transition from Distributary Piedmont to Incised Zone on Qy surface (LM03-26-02)

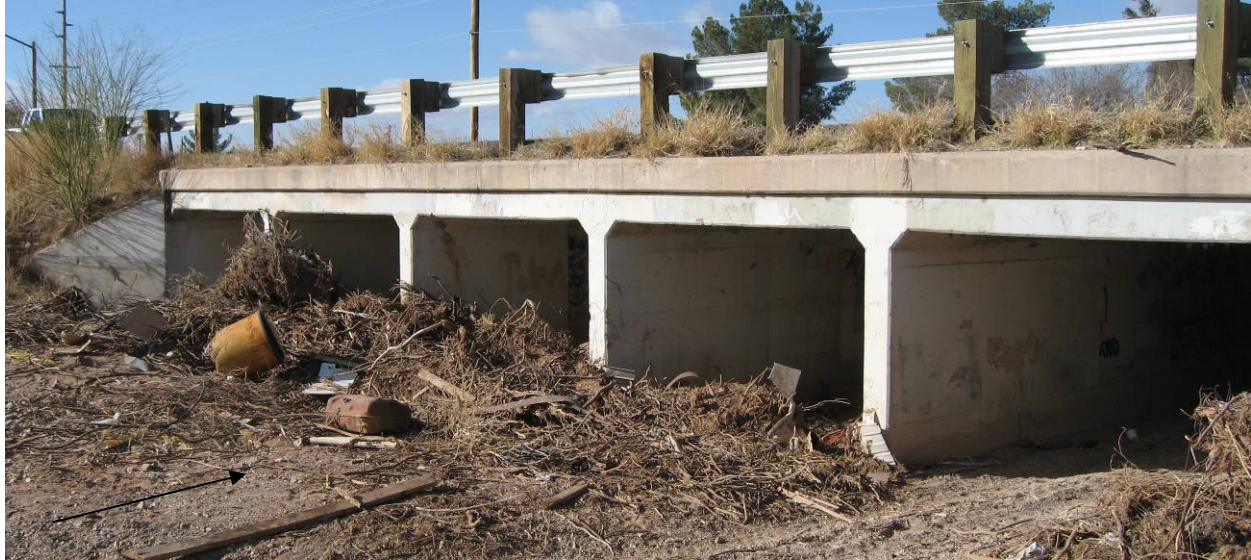
The washes in the Incised Zone, more so than in any other zone, have become a place to deposit trash. While smaller items of trash have little impact on geomorphic processes, the larger items such as tires and refrigerators can have alarming impacts when drainage structures become partially or totally blocked. Following are a few representative ground photos of trash accumulation.

Accumulation of debris and trash upstream of Franco Wash crossing of Old Nogales Highway (LM04-07-01)

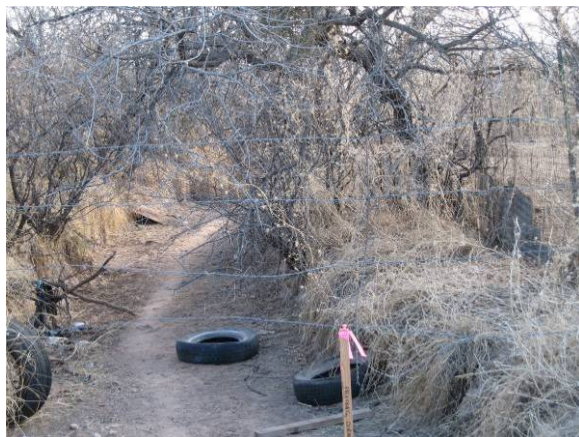
Trash in incised wash south of Summit Street on Qy surface (LM04-05-01)

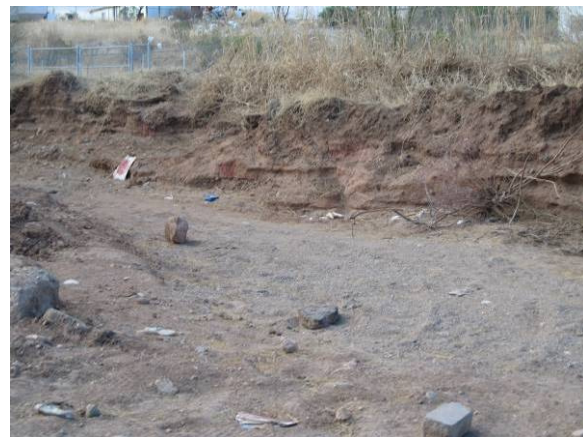
Trash and vertical scour on Franco Wash upstream of Summit Street, Qy surface (LM04-06-02)

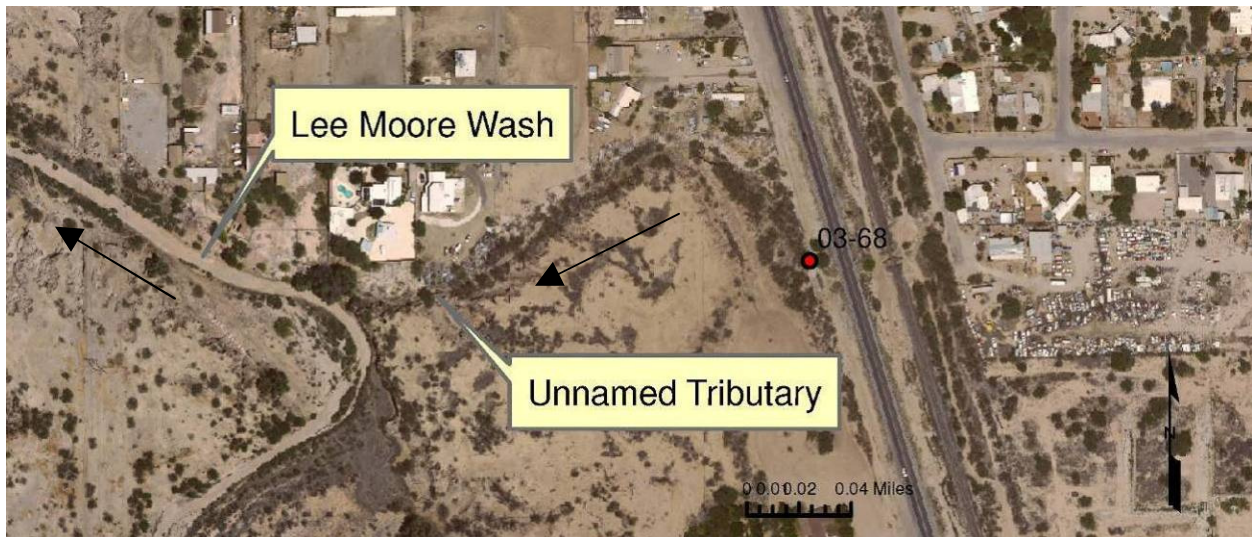
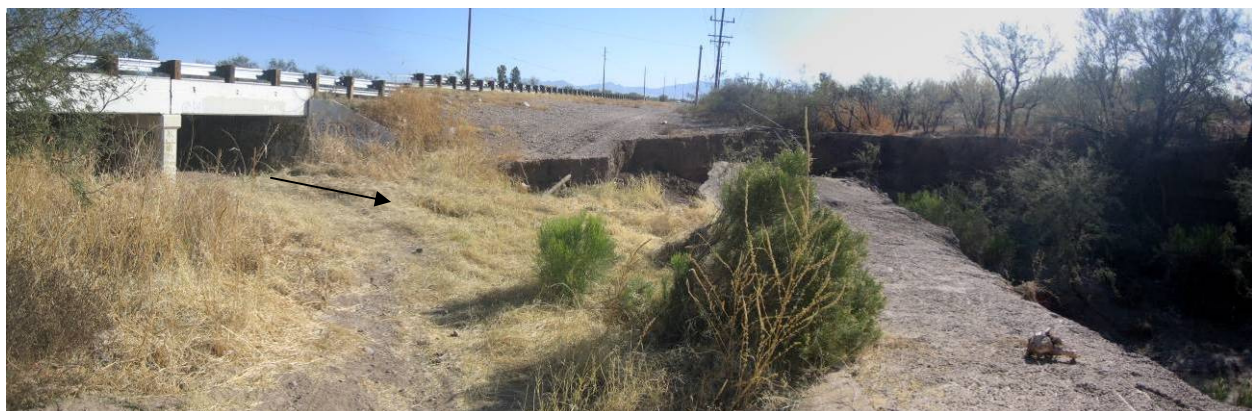
Figure 92 -Incised tributary to Lee Moore Wash

Figure 92 shows the location of an incised wash with extensive vertical scour downstream of a series of culvert structures within the Incised Zone. The wash drains to the Lee Moore Wash just upstream of its confluence with the Santa Cruz River. The panorama of LM03-68-01&02 shows the downstream face of the culvert under Nogales Highway which is on a T2 surface. The wash upstream of the culvert is a Qy surface and a Qy (ch) surface is mapped in the downstream wash. The panorama of LM03-68-04&05 shows the wash downstream of the concrete apron and grade control structure. The wash downstream of the apron is approximately 12 feet below the top of the concrete apron and is deeply incised. The incision within the tributary wash may be primarily caused by downcutting of the Santa Cruz River and the linked effect (refer Section 4.3) on the Lee Moore Wash and its tributaries. It is also likely that the highway and culvert crossing have forced an increase in flow concentration into this channel, further inducing headcutting.

Culvert under Nogales Highway and grade control structure on unnamed wash (Pan. of LM03-68-01, 02)

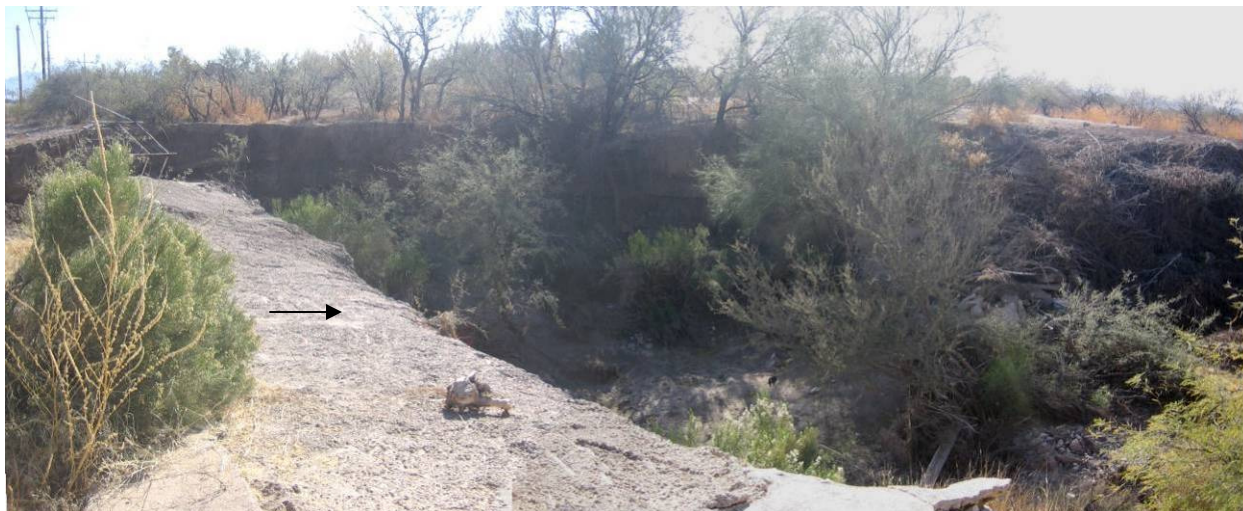
Vertical scour downstream of grade control structure on unnamed wash crossing Nogales Highway (Panorama of LM03-68-04 and 05)

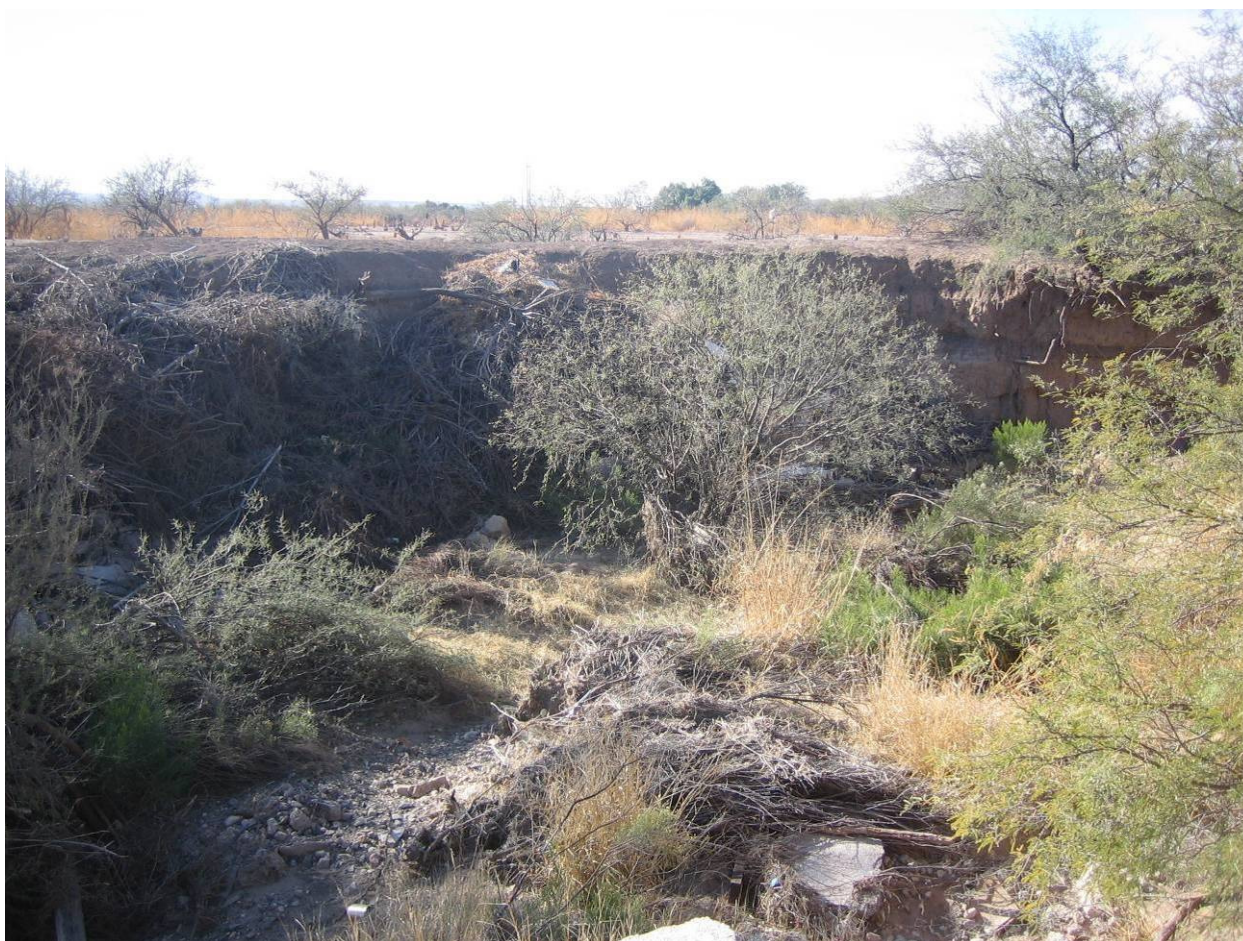
Vertical banks on T2 surface downstream of Nogales Highway (LM03-68-05)

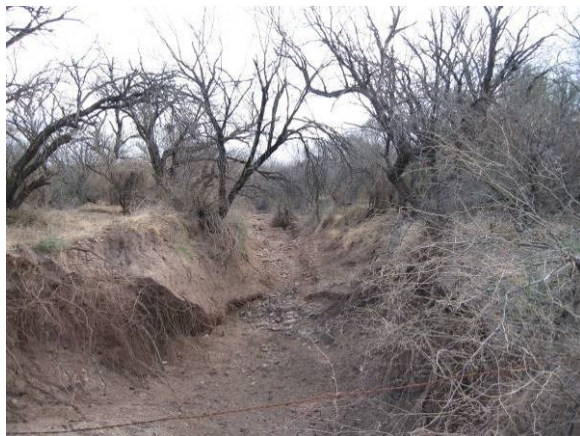
Headcutting and an abrupt scour difference were found along the Petty Ranch Wash ford crossing of the Old Nogales Highway, shown in Figure 93. The wash upstream of the road is highly incised with semi stable banks while the banks are less stable downstream of the road. The channel downstream of the road has scoured right up to the edge of the road which might wash away during a significant event. Reworking of the channel upstream of this location may have reduced sediment supply to this area, further encouraging scour.

Petty Ranch Wash, upstream of Old Nogales Highway, Qy surface (LM04-02-01)

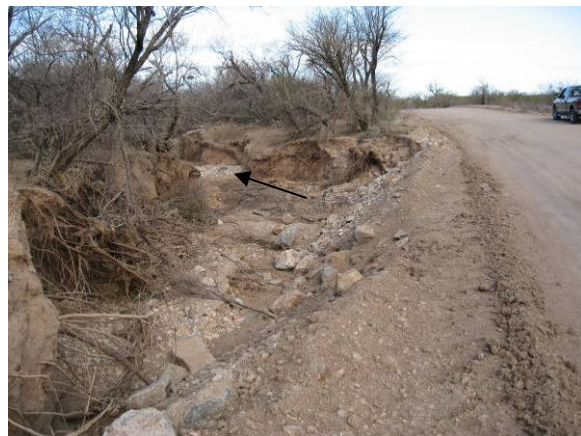
Scour downstream of Old Nogales Highway on Petty Ranch Wash, Qy Surface (LM04-02-02)

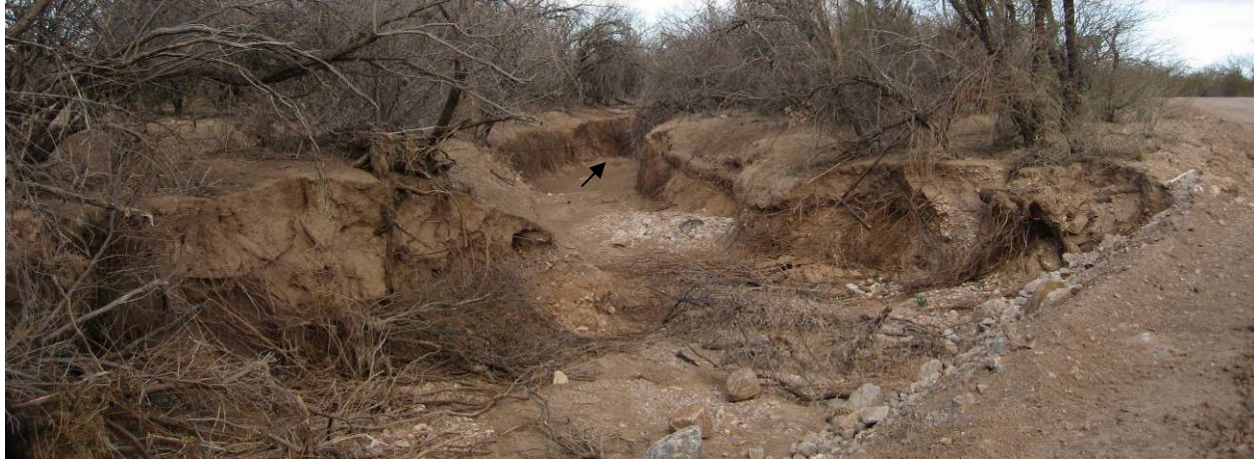
Vertical banks and scour downstream of Old Nogales Highway on Petty Ranch Wash, T2 surface (LM04-02-03)

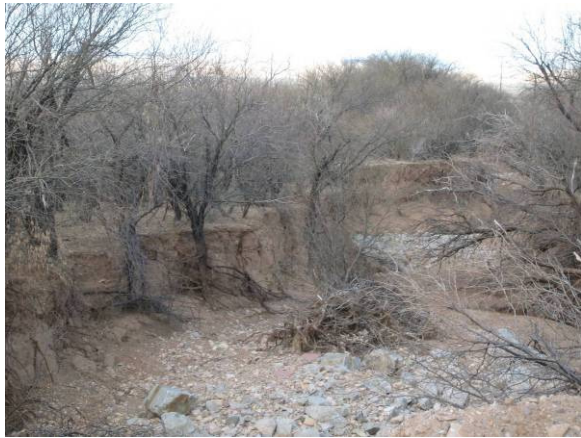
Vertical banks on Petty Ranch Wash (LM04-03-01)

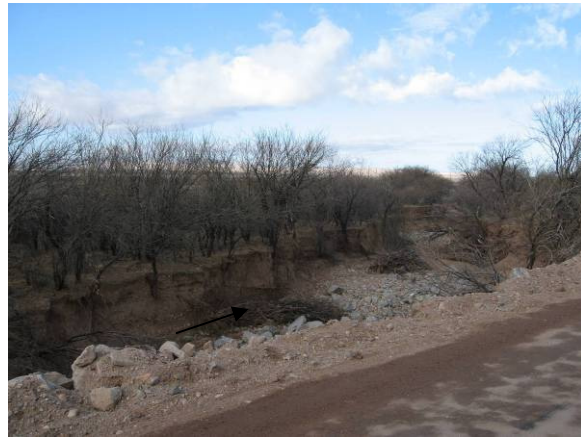
Vertical banks on Petty Ranch Wash (LM04-03-02)

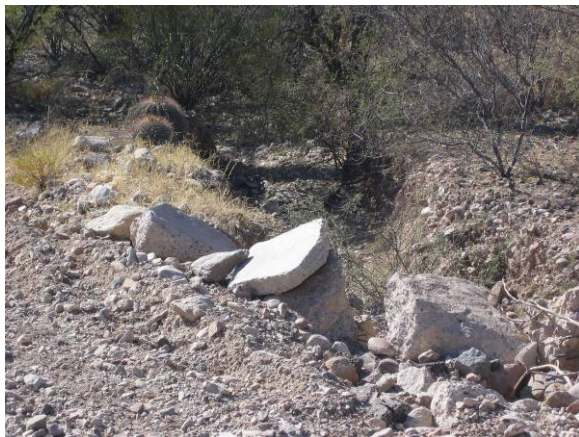
Headcutting along the Fagan Wash was observed along the Country Club Road alignment. The headward erosion extends up minor flow paths such as was observed at field point 03-31; see LM03-31-01. The main channel of the Fagan wash is scarred by headcutting as shown in LM03-33-02. Dumped rip rap has been placed downstream of the road, impounding the water observed in the photograph.

Headward erosion progressing towards Country Club Road along minor flow path (LM03-31-01)

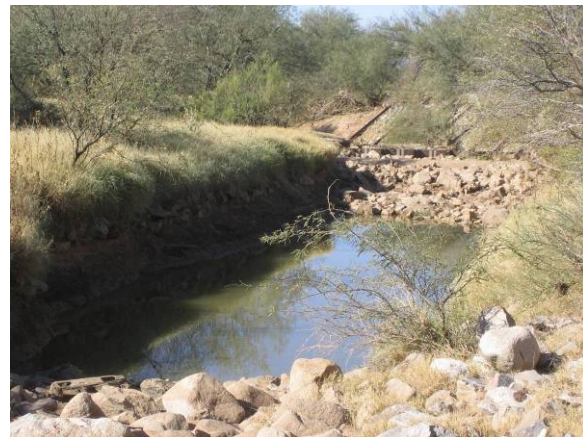
Riprap within Fagan Wash (LM03-33-02)

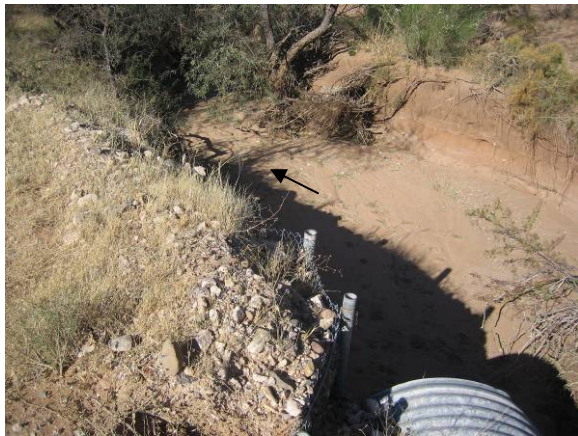
Figure 95 shows a tributary to the Petty Ranch Wash. This wash is incised and shows evidence of impacts due to headcutting with vertical scour shown in LM03-23-06 and LM03-23-02.

Headcut and scour hole downstream of culvert on T5 surface (LM03-23-06)

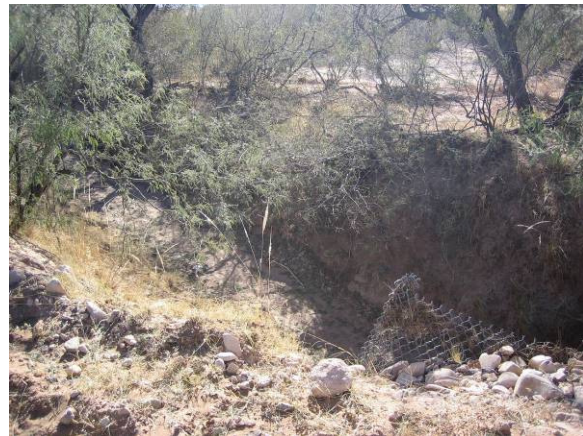
Incised wash upstream of culvert on T5 surface (LM03-23-02)

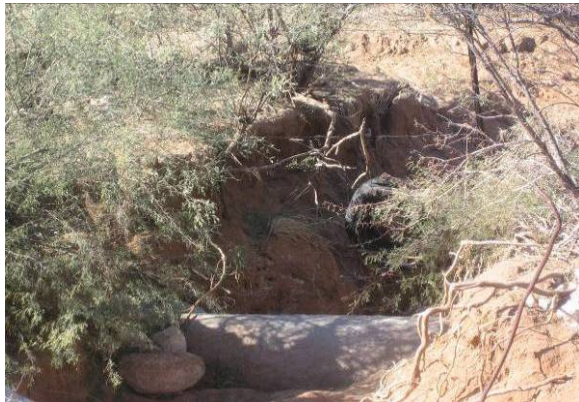
Vert. scour dstrm of rd., Qm surface (LM03-38-01)

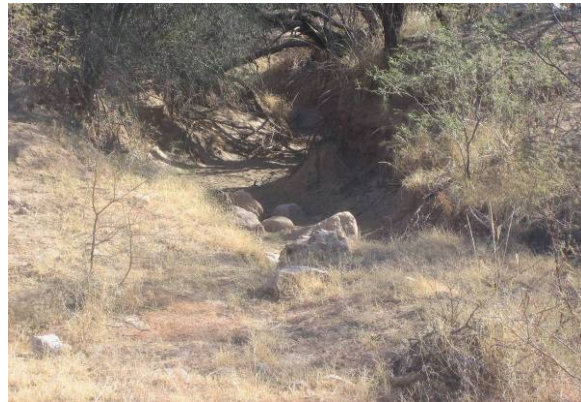
View upstrm of Lee Moore Wash trib.(LM03-39-02)

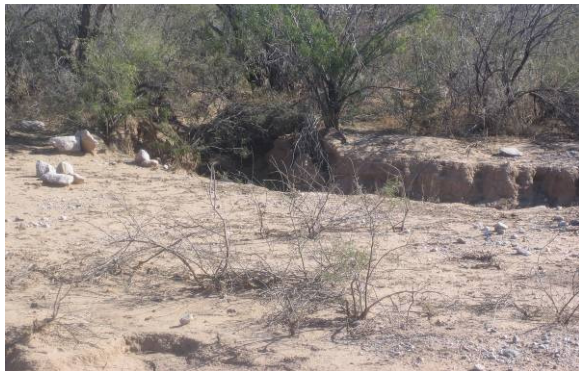
Vertical scour on Qy surface (LM03-40-01)

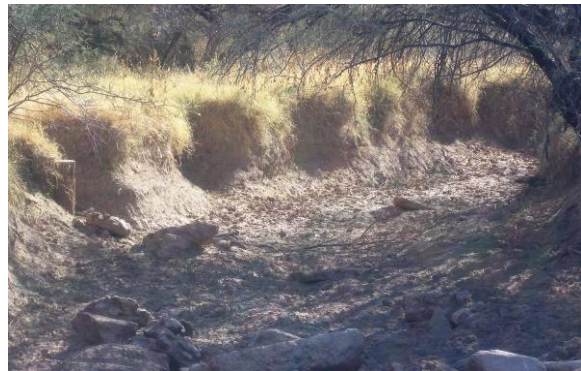
Lee Moore at Country Club Rd. alignment (LM03-41-01)

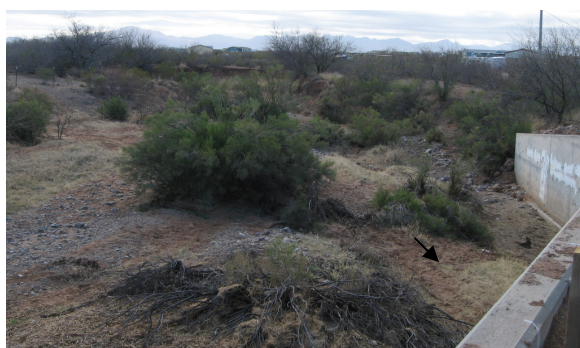
Figure 97 shows a wash tributary to the Franco Wash within the Incised Zone, just down-gradient of the Distributary Piedmont Zone. The picture shows the wash on a QTbf surface, beginning at Swan Road and extending approximately 4,700 feet downstream to Singing Cactus Lane. The wash upstream of Swan Road and downstream of Singing Cactus Lane occupies a Qy surface. The wash crosses Swan Road via a 5-cell, 12' x 8' RCB culvert and crosses Singing Cactus Lane (field point 04-12) via a concrete ford crossing. The RCBC plans for the Swan Road culvert indicate that the 100-year flow will overtop the road at a depth of less than one foot. The wash upstream of Swan Road has some lateral scour with vertical banks, but is generally not highly eroded and the culvert at Swan Road is not filled with sediment. Downstream of Swan Road the wash is stable with well vegetated banks.

View upstream from Swan Road (LM04-10-04)

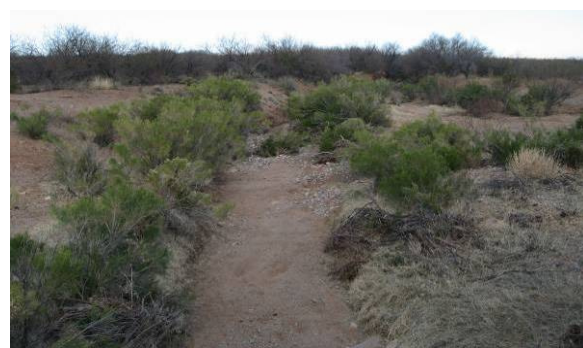
View downstream from Swan Road, QTbf surface (LM04-10-02)

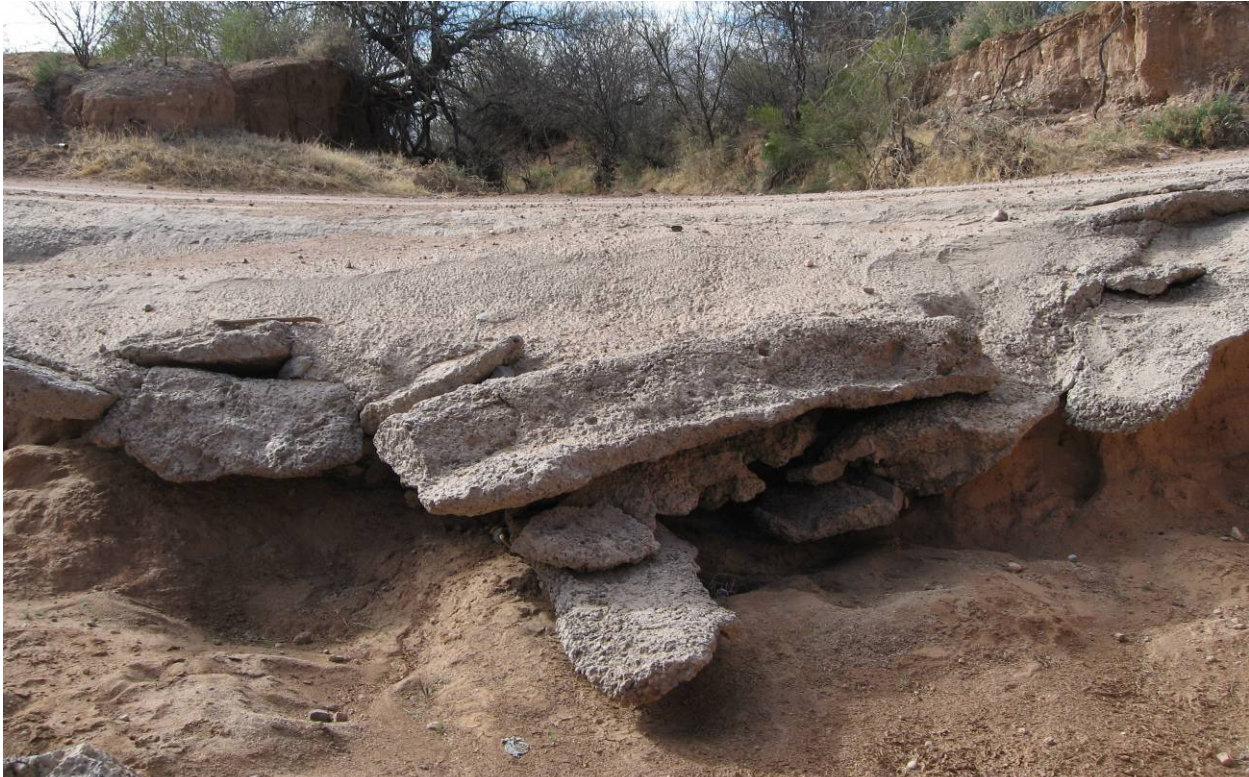
The unvented ford crossing shown in Figure 98 is the Singing Cactus Lane crossing referenced in the plan view of Figure 97. This crossing has steep approaches with no erosion protection for the banks. The wash upstream of Singing Cactus Ln. is moderately stable with vegetated banks and sedimentation upstream of the crossing. It is not clear whether the crossing was placed slightly above the natural channel grade at the time or if it was placed at grade. The wash downstream of Singing Cactus Ln. is highly scoured without any gravel or large sand armoring present. The wash has scoured vertically 3 to 4 feet below the elevation of the road.

Facing south towards concrete ford crossing, (LM04-12-07)
