Geomorphic Analysis Report for the Lee Moore Wash Basin Management Study in Pima County Arizona

Prepared for and in cooperation with the
Pima County Regional Flood Control District

August 2008

By Ian P. Sharp, P.E., CFM
JE Fuller Hydrology & Geomorphology Inc.

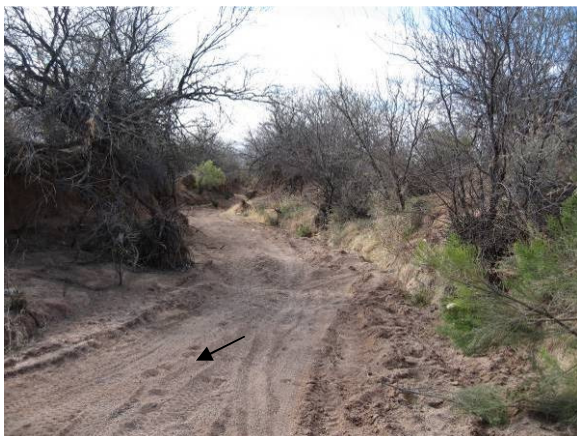
The unvented ford crossing shown in Figure 98 is the Singing Cactus Lane crossing referenced in the plan view of Figure 97. This crossing has steep approaches with no erosion protection for the banks. The wash upstream of Singing Cactus Ln. is moderately stable with vegetated banks and sedimentation upstream of the crossing. It is not clear whether the crossing was placed slightly above the natural channel grade at the time or if it was placed at grade. The wash downstream of Singing Cactus Ln. is highly scoured without any gravel or large sand armoring present. The wash has scoured vertically 3 to 4 feet below the elevation of the road.

Sedimentation upstream of Singing Cactus Lane, QTbf surface (LM04-12-01)

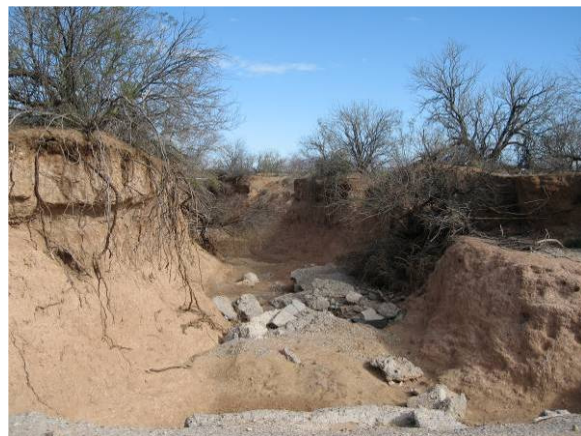
Extreme scour downstream of road, QTbf surface, facing north (LM04-12-03)

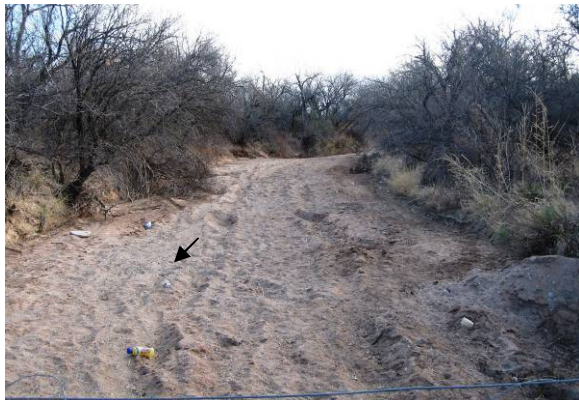
Old Nogales Highway crosses several washes by way of low flow crossings. The washes at these locations are highly incised and susceptible to lateral erosion and vertical bank development. Figure 99 shows the aerial view along with upstream and downstream ground views of the Flato Wash crossing within the Incised Zone. The crossing is paved and appears to be constructed above the natural grade of the channel. Deposition of fine grained gravel and sand is present upstream of the crossing while the channel downstream of the crossing is starved of this sediment. The vertical and lateral scour at this location are however limited.

Aggradation upstream of Highway, T2 surface (LM04-04-02)

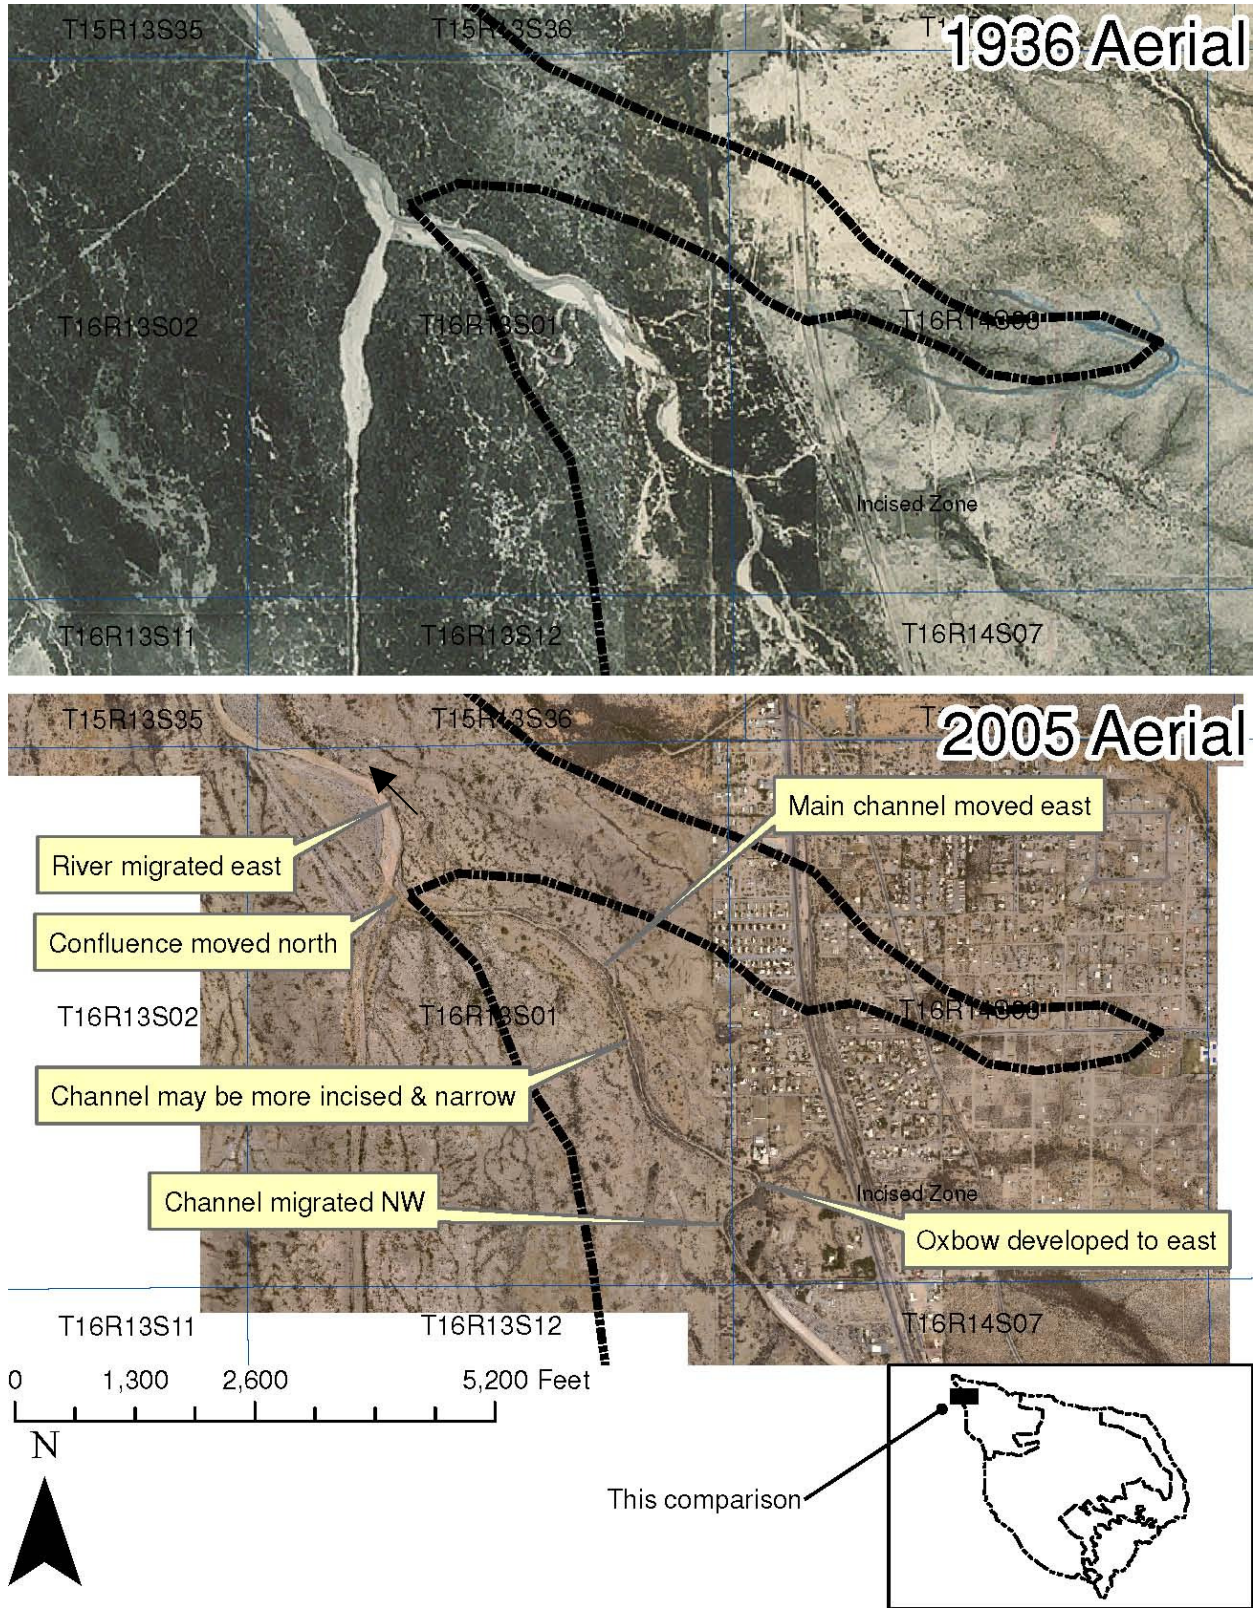
Figure 100 - Comparison of 1936 and current aerial images; station IZ01

Noticeable changes to the alignments of both the Santa Cruz River and the Lee Moore Wash near the Santa Cruz River are evident upon comparison of the aerial images, see Figure 100. In addition to lateral migration, it appears that the main channel of the Lee Moore Wash in this area is narrower, and probably more incised than it was in 1936. (Note that this assertion cannot be quantitatively proven as no topography was obtained related to the 1936 aerial flight.) Further upstream, the portion of the Lee Moore Wash shown in Figure 102 has changed significantly since 1936 as a result of adjacent floodplain development.

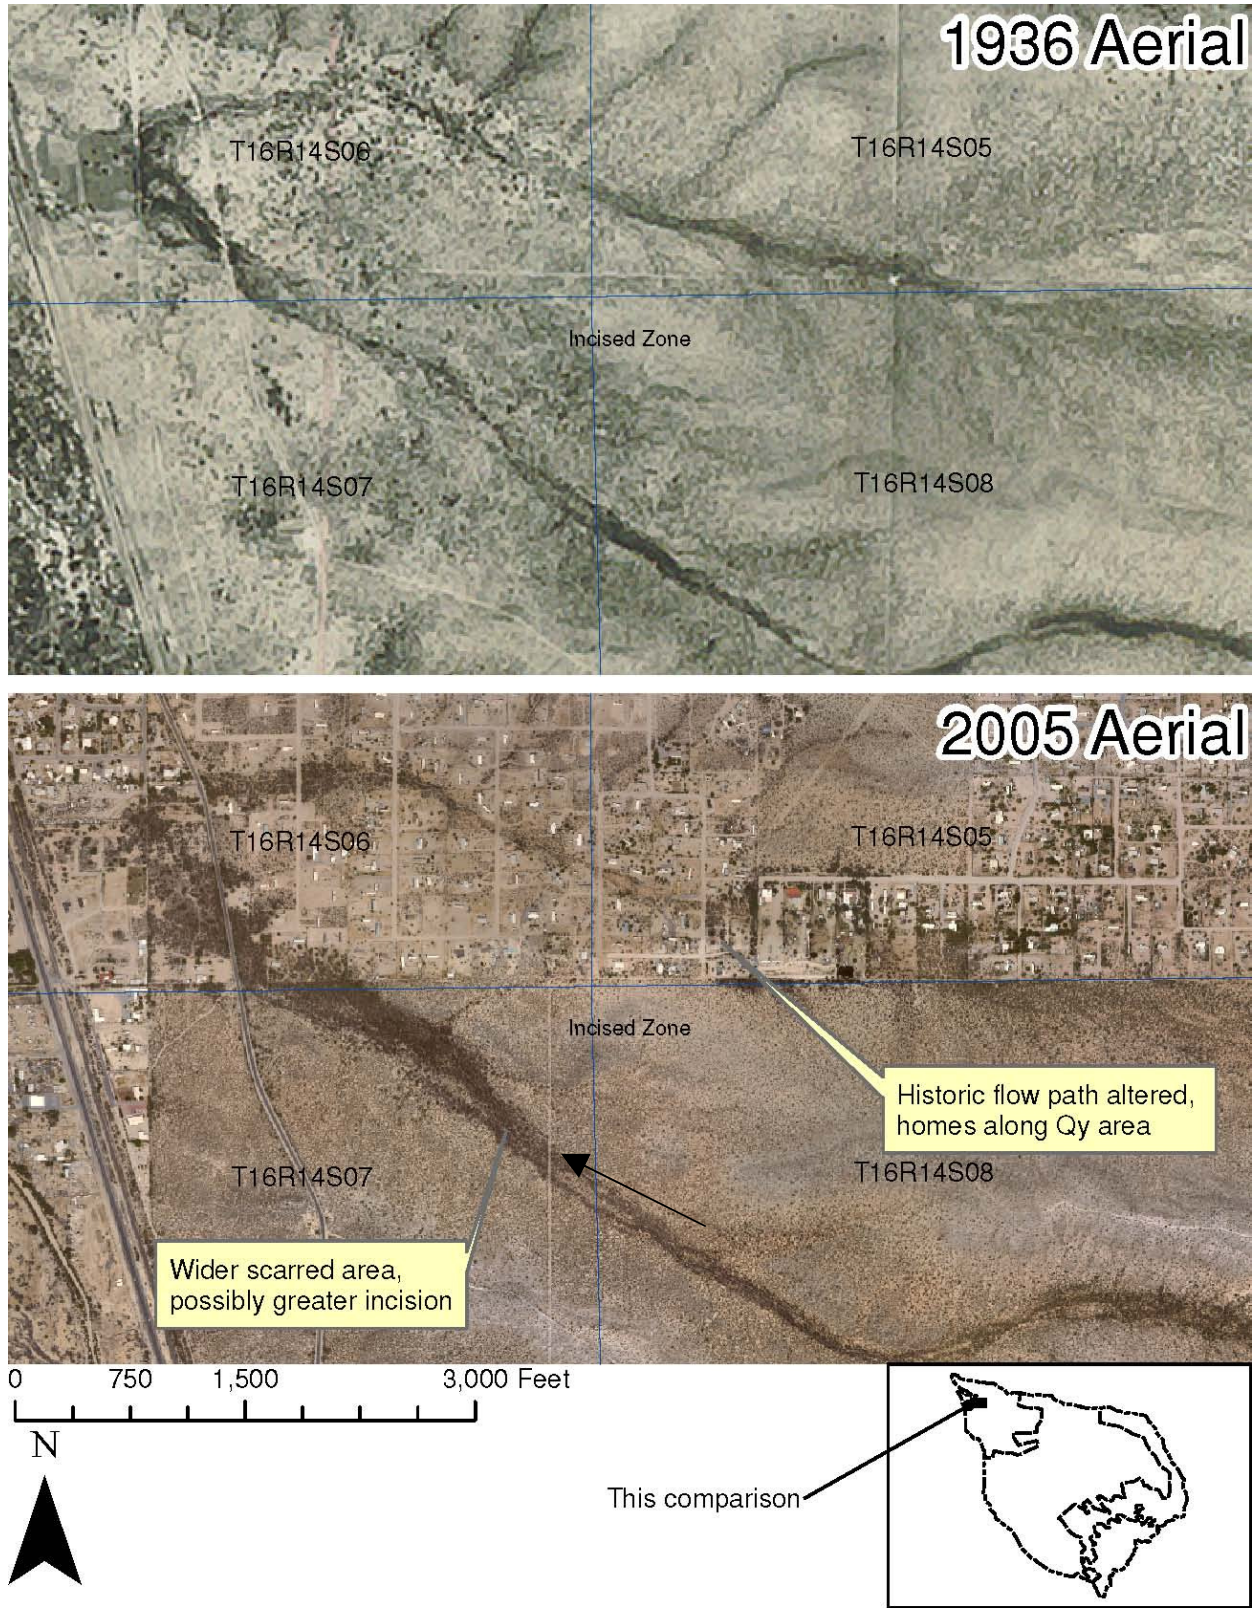
Figure 101 - Comparison of 1936 and current aerial images; station IZ02

Impacts to the fluvial systems within this zone have occurred as a result of the development of homes and construction of stock tanks and impoundments. Figure 101 shows a Qy corridor where homes have been developed, somewhat altering the historic flow path. Figure 105 compares the aerial sets in areas below an impoundment. Figure 105 does not give any clear indication of changes to the main channels as a result of the existence of the impoundment, but it is noteworthy that the majority of the scarred area shown on Figure 105 is mapped as a Qy zone indicating historic flooding and the potential for future flooding around the existing structures.

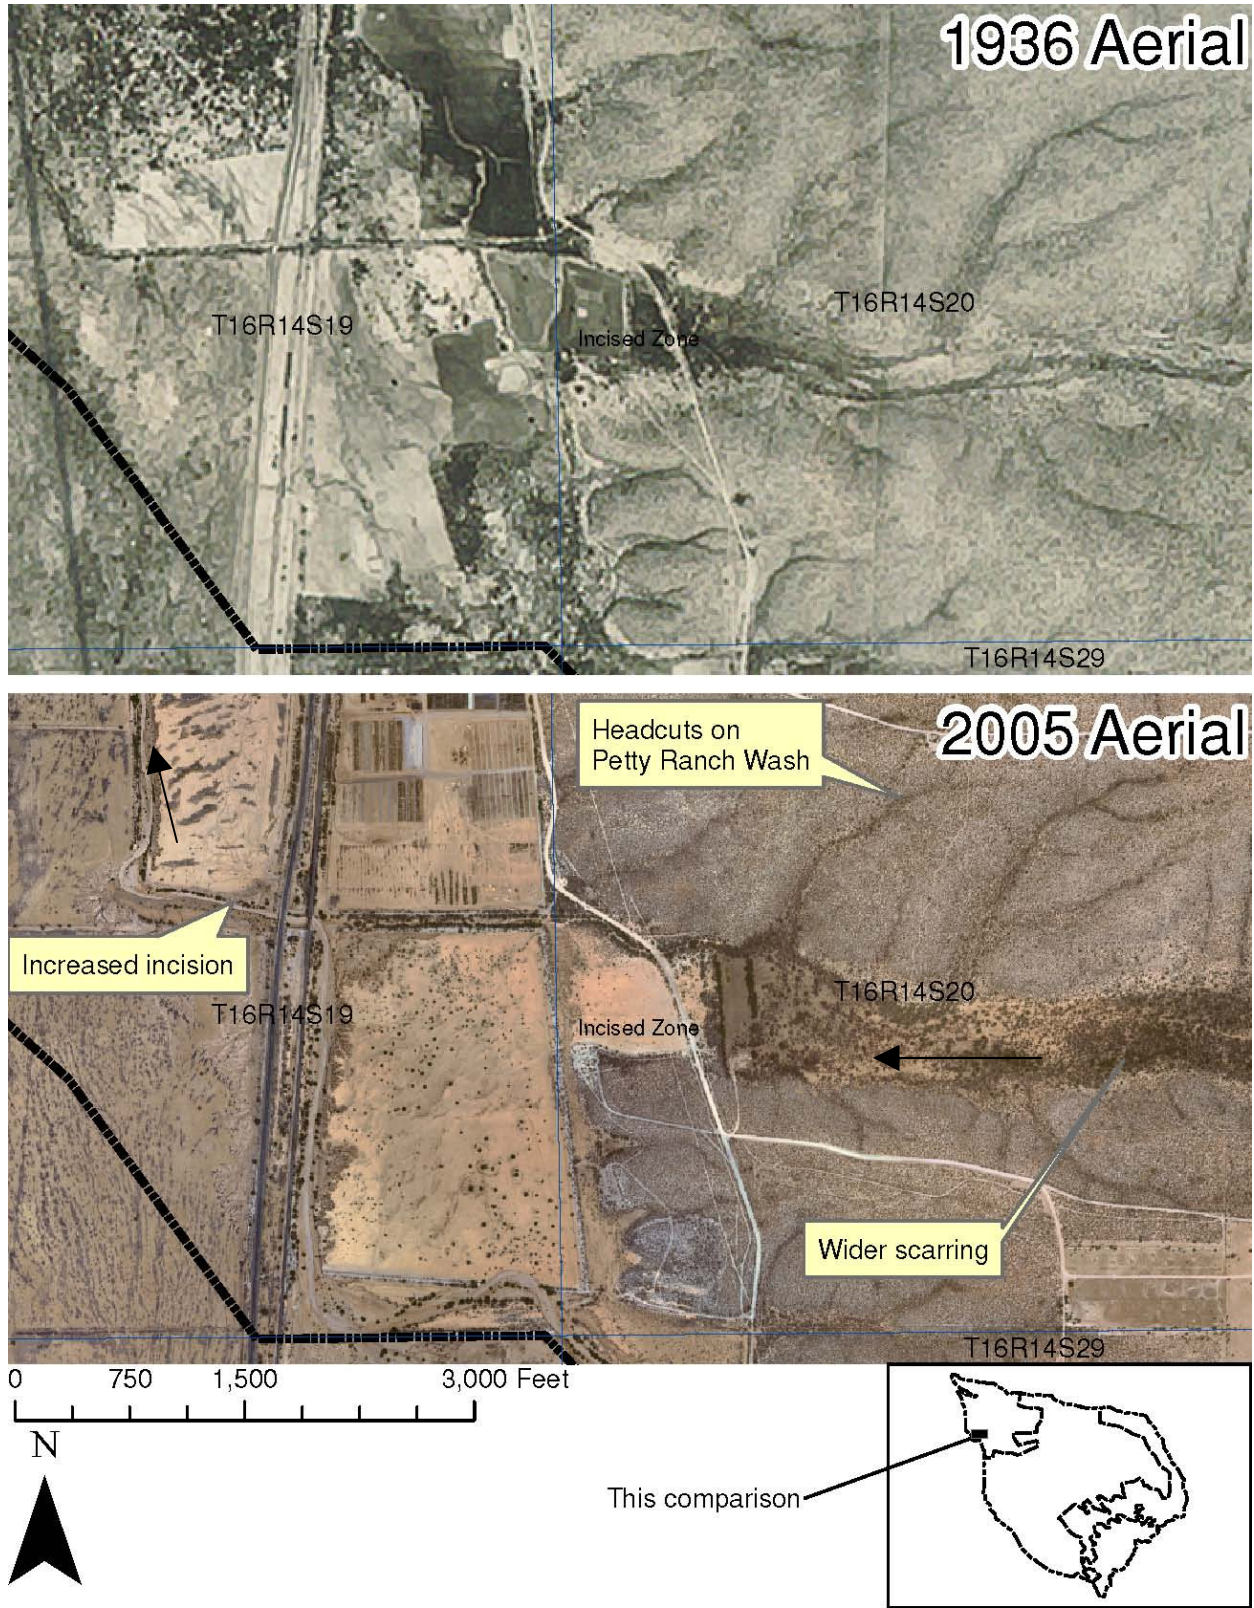
Figure 103 - Comparison of 1936 and current aerial images; station IZ04

Headcutting was found in the aerial comparisons. In Figure 103, the Petty Ranch Wash footprint is wider upstream of the road in the modern aerial. Some of this may be attributed to sedimentation upstream of the road crossing, but headcutting was observed in the field and it is also observed in the tributary gullies. Field ID points LM02-02 and LM02-03 showed vertical banks and vertical scour at the road crossing. Review of the modern aerial shows that the gullies draining to the Petty Ranch Wash have extended and additional gullies have developed. Also noteworthy is the erosion shown on Figure 89 which is located toward the top left (northwest) end of Figure 103. This widespread erosion does not appear in the 1936 aerial.

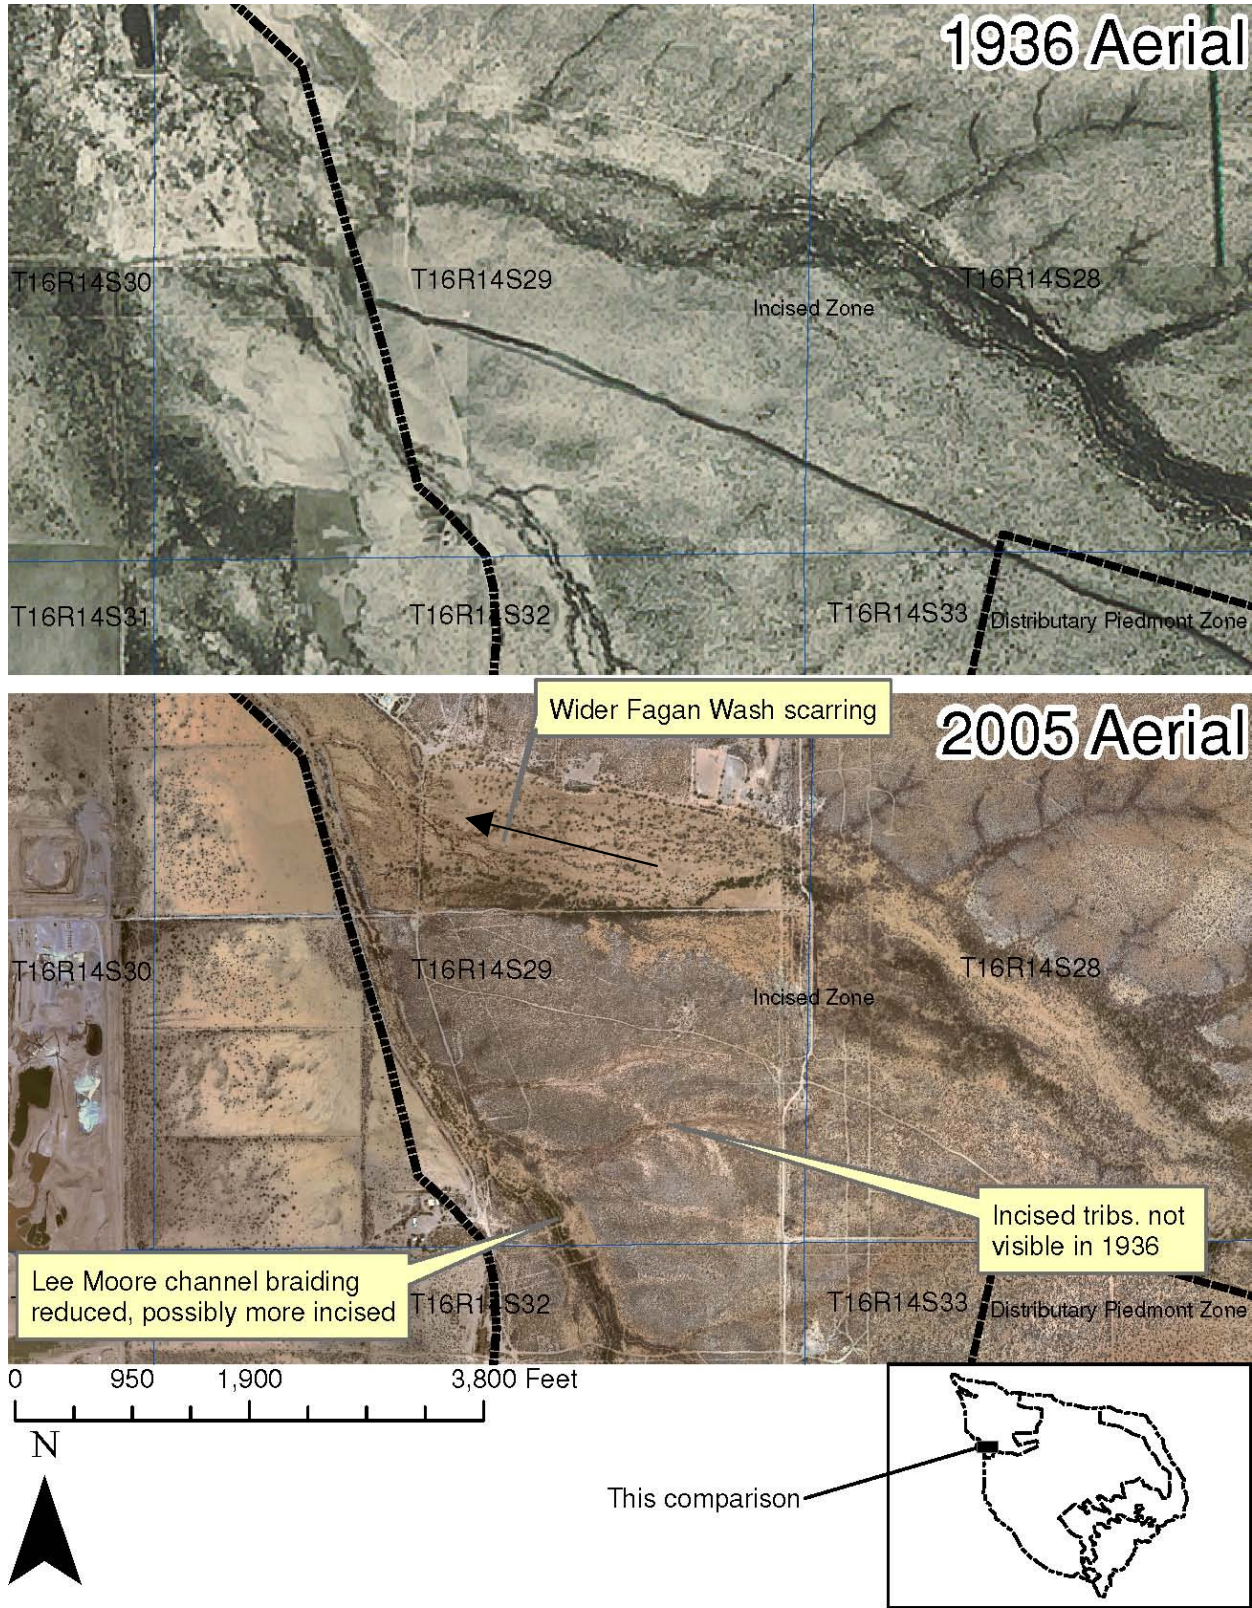
Figure 104 - Comparison of 1936 and current aerial images; station IZ05

Figure 104 shows a similar indication of a wider vegetated footprint upstream of the concrete low ford crossing (as shown on Figure 94) on the Fagan Wash near the confluence with the Lee Moore Wash. This figure also shows increased incision of the Lee Moore Wash; the channel is less braided and appears to be narrower. Furthermore, multiple incised tributaries have apparently developed since 1936 suggesting that the base level of this wash has been reduced, thus inducing headcutting up the tributaries. The wider footprint of the Fagan and Petty Ranch Washes may be due to expanded flooded widths in response to contractions in the system such as road crossings. Additionally, stagnant water was observed at these locations as a result of road and drainage structures. The local water table may be elevated enough to encourage increased vegetative growth.

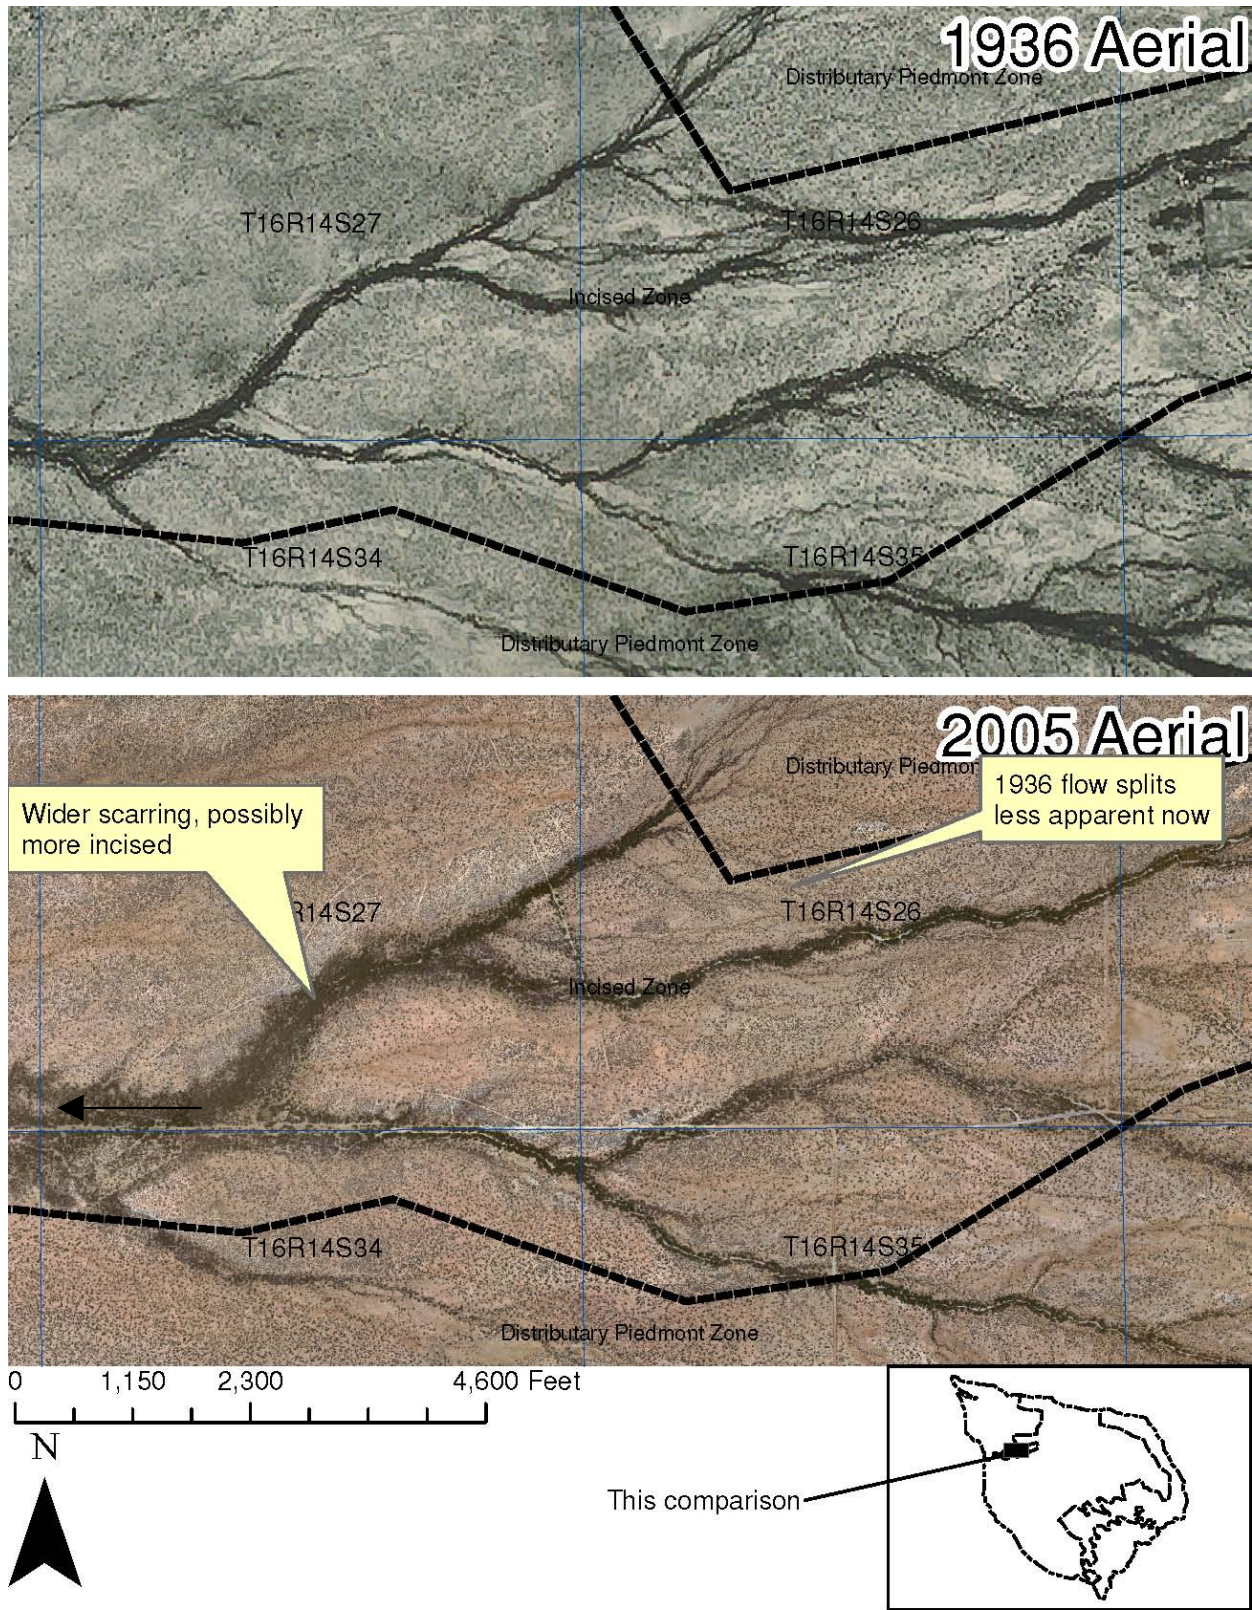
Figure 106 - Comparison of 1936 and current aerial images; station IZ07

Figure 106 shows a series of flow splits and confluences which may have migrated since 1936. The two major confluences appear to have migrated upstream or become wider (possibly as a result of incision). This phenomenon was observed in other locations during the course of this comparison. This figure also shows several locations where breakout flow paths are still visible

but less evident and slightly altered since 1936. (The breakout flow occurs from the main Qy channels across T5 terraces.) While avulsion from the main channel appears to be more limited in recent years, this may be in part due to the reduced runoff in the watershed due to the current drought. Therefore, the breakout flow paths may be more visible on the 1936 aerials because the vegetation was healthier at that time and/or overland flow has filled the breakout channels which have not scoured in recent years. Another explanation would be that if the channels have incised and downgraded, avulsion would be less likely to occur. Regardless, Figure 106 shows the potential for abandonment of flow paths which could lead to the carving of additional flow paths, vertical and/or lateral channel changes within the primary channels, and even the reestablishment of abandoned flow paths.

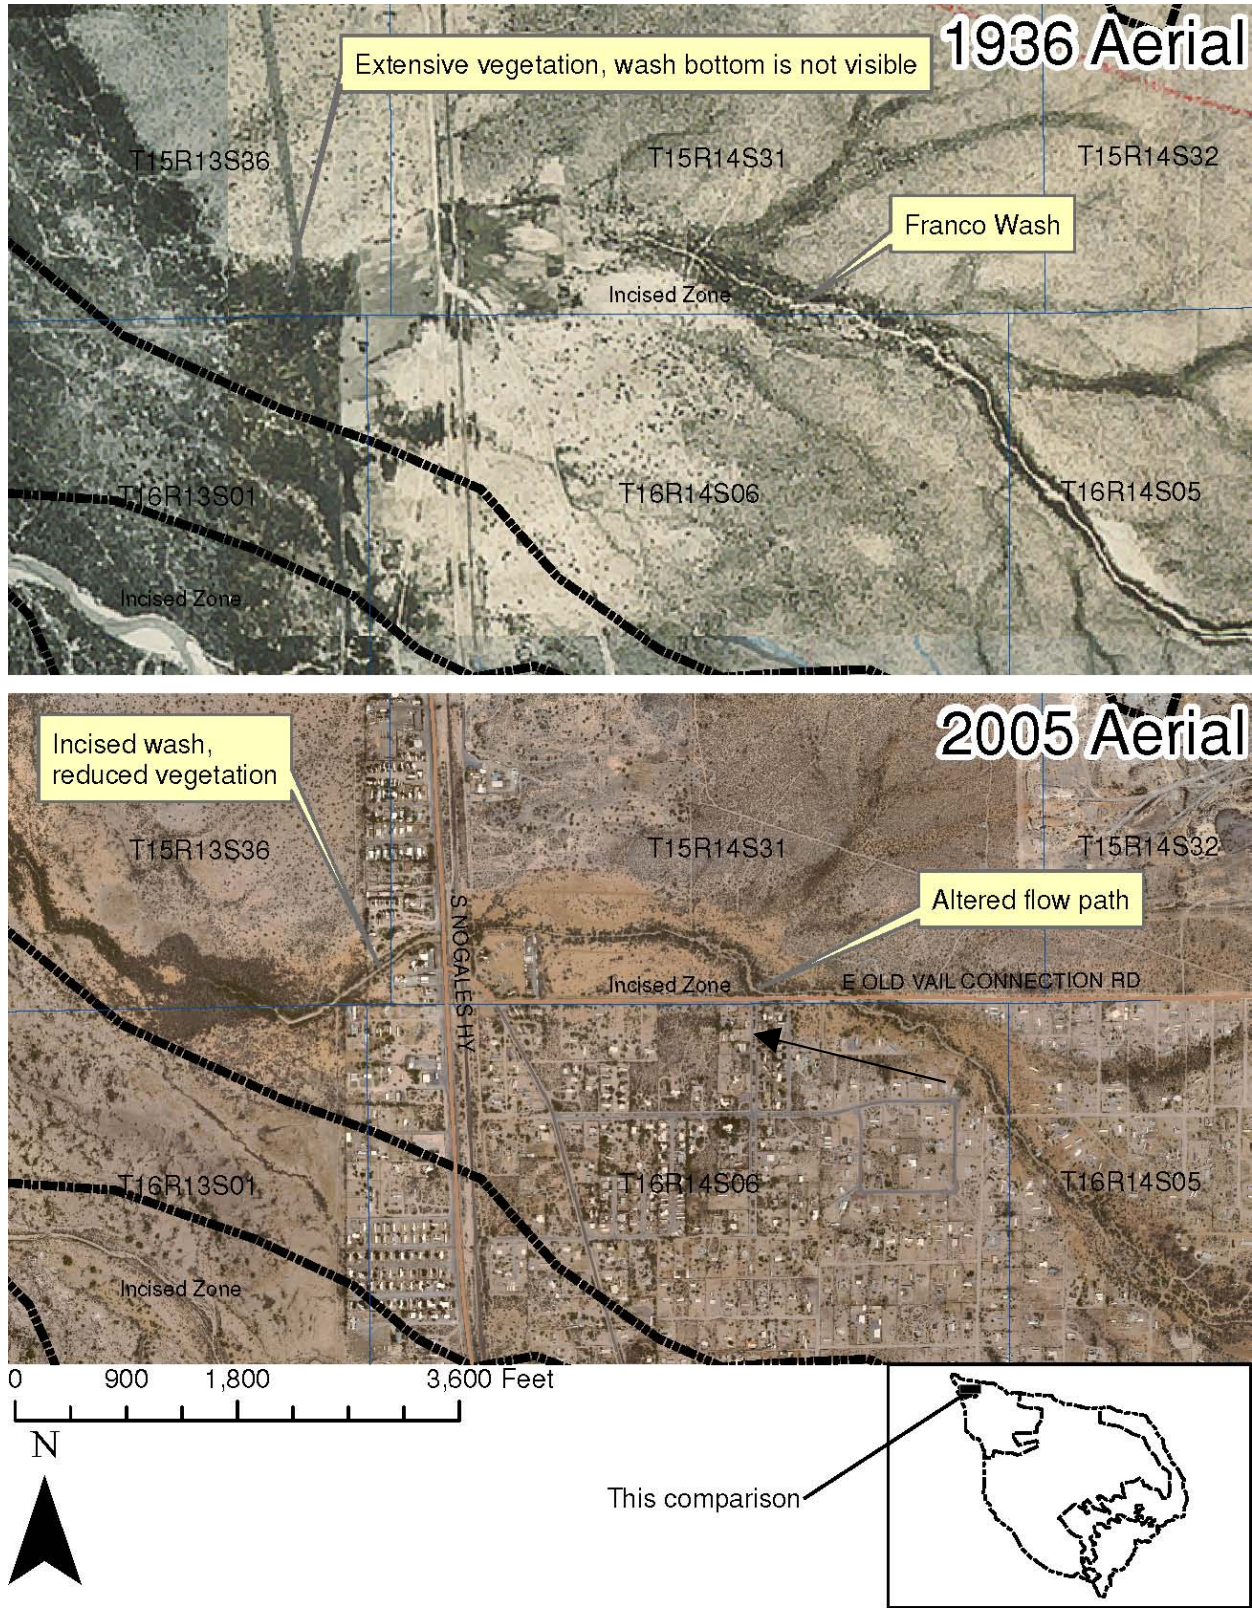
Figure 107 - Comparison of 1936 and current aerial images; station IZ08

Figure 107 shows the Franco Wash in the vicinity of the Nogales Highway. Obvious changes have occurred downstream of the Highway. The wash in 1936 appears to have terminated at the highway, becoming wide and shallow with substantial vegetative growth. The wash downstream of the highway currently is incised and vegetation on the overbanks is significantly reduced. These observations could be the results of an improved culvert crossing along the highway in conjunction with the downcutting of the Santa Cruz River. An additional observation was made where the wash crosses Old Vail Connection Road; the road has redirected the flow path locally but has not significantly impacted the wash beyond the road alignment.

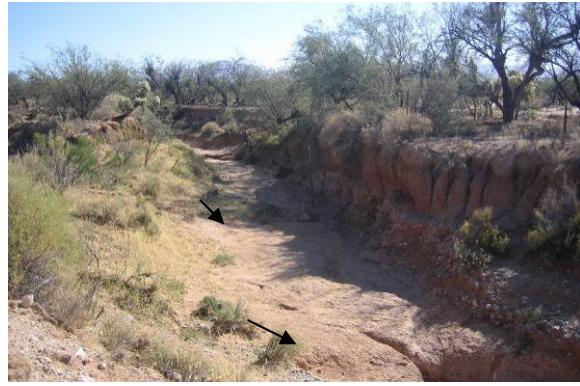
B - Upstream view of headcut, nick point in lower right of frame (LM03-59-01)

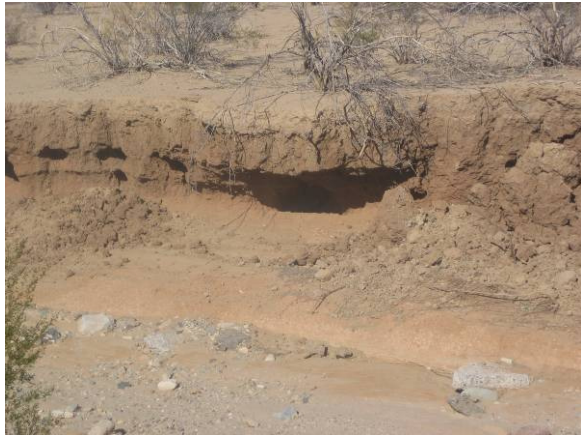
C - Widening and undercutting of terrace vegetation (LM03-51-01)

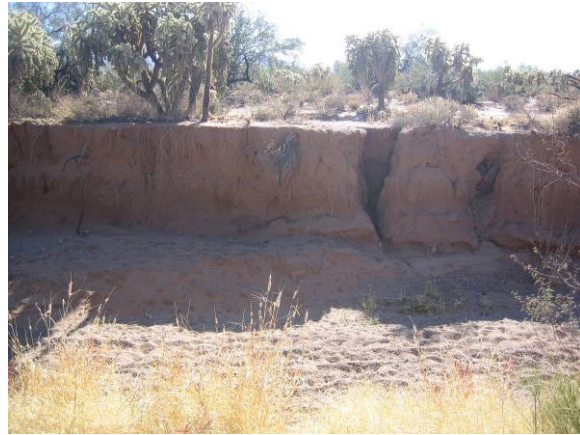
D - Vertical bank development and scouring of banks from inflow (LM03-64-01)

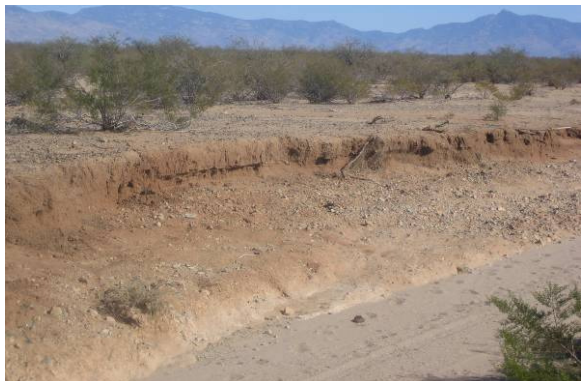
E - Lateral erosion and sloughing (LM03-50-01)

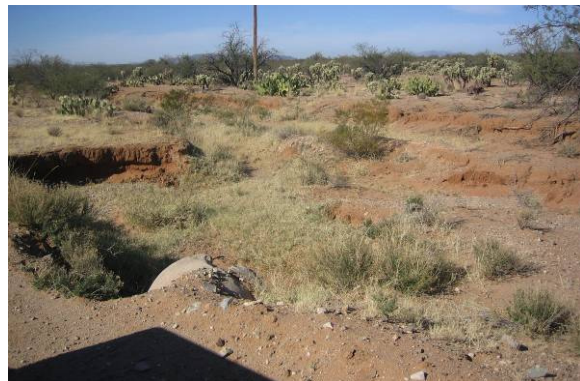
F - Headcut downstream of culvert outlet (LM03-56-01)
