# Performance Evaluation of Arizona's LTPP SPS-1 Project: Strategic Study of Flexible Pavement Structural Factors

Final Report 396-1  
February 2012

Nichols Consulting Engineers  
1885 South Arlington Avenue  
Suite 111  
Reno, Nevada 89509

Arizona Department of Transportation  
In cooperation with  
U.S. Department of Transportation  
Federal Highway Administration

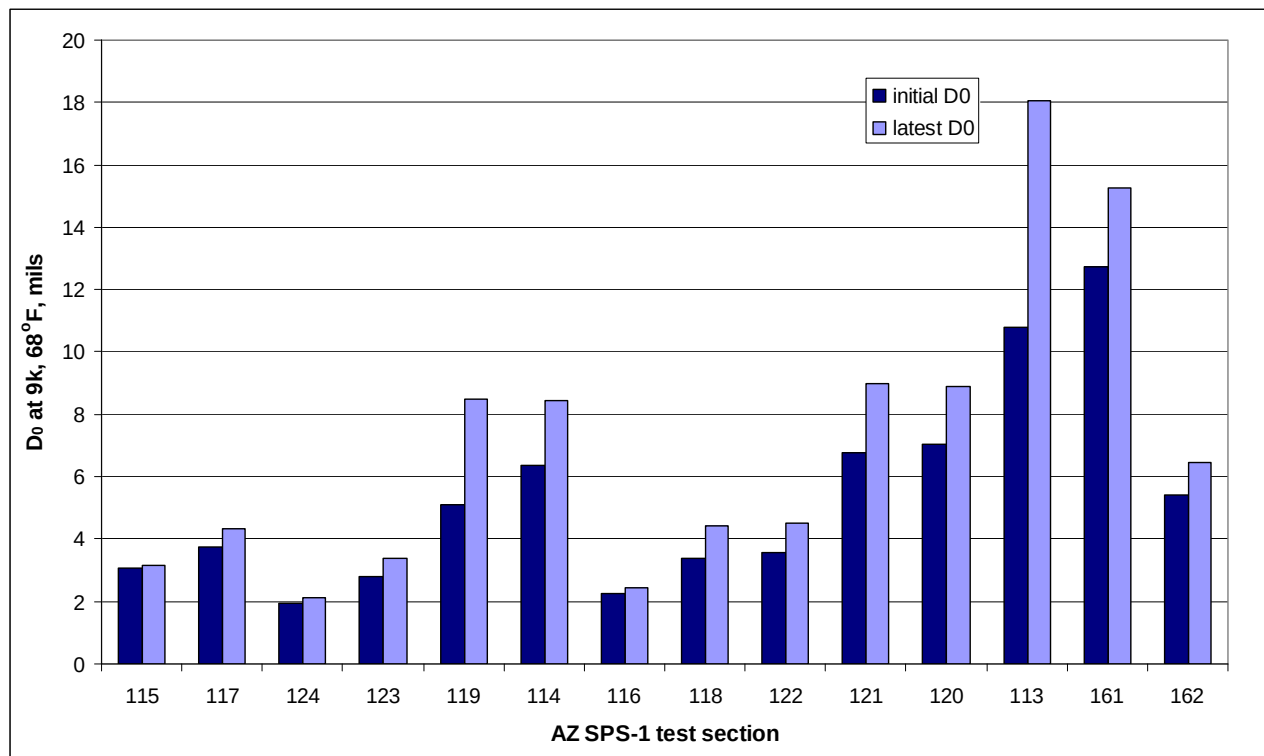
Figure 3. 1994 and 2004 average normalized maximum deflections by test section.

The normalized average maximum deflection is an indicator of the total stiffness of the pavement structure (surface and base) and the underlying subgrade. The increases in normalized average maximum deflection observed over time may thus be due to weakening of the pavement structure and/or weakening of the subgrade.

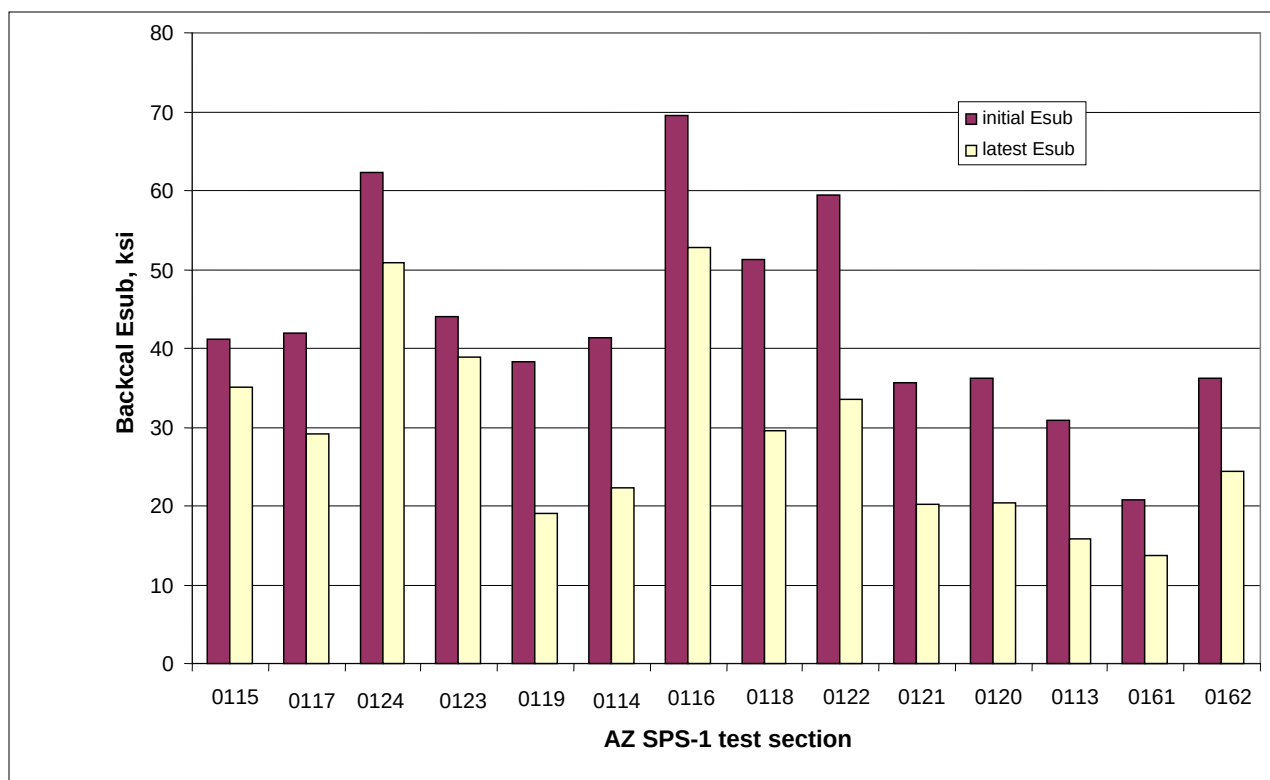
Figure 4. 1994 and 2004 backcalculated subgrade modulus by test section.

The overall average initial subgrade modulus for the site, backcalculated from the first round of deflection data in 1994, was about 43.5 ksi. The average subgrade modulus of each of the test sections declined between the first round of deflection testing in 1994 and the most recent round of deflection testing in 2004, as shown in Figure 4 and Table 5. The overall average subgrade modulus for the site, backcalculated from the last round of deflection data in 2004, was about 29 ksi.

This decrease in subgrade modulus over time is presumed to be due to a gradual increase and leveling off of the subgrade moisture content after construction. The fairly steady trend in decreasing subgrade moduli over time is illustrated by the values backcalculated for SMP test section 0113, shown in Figure 5 and Table 6.

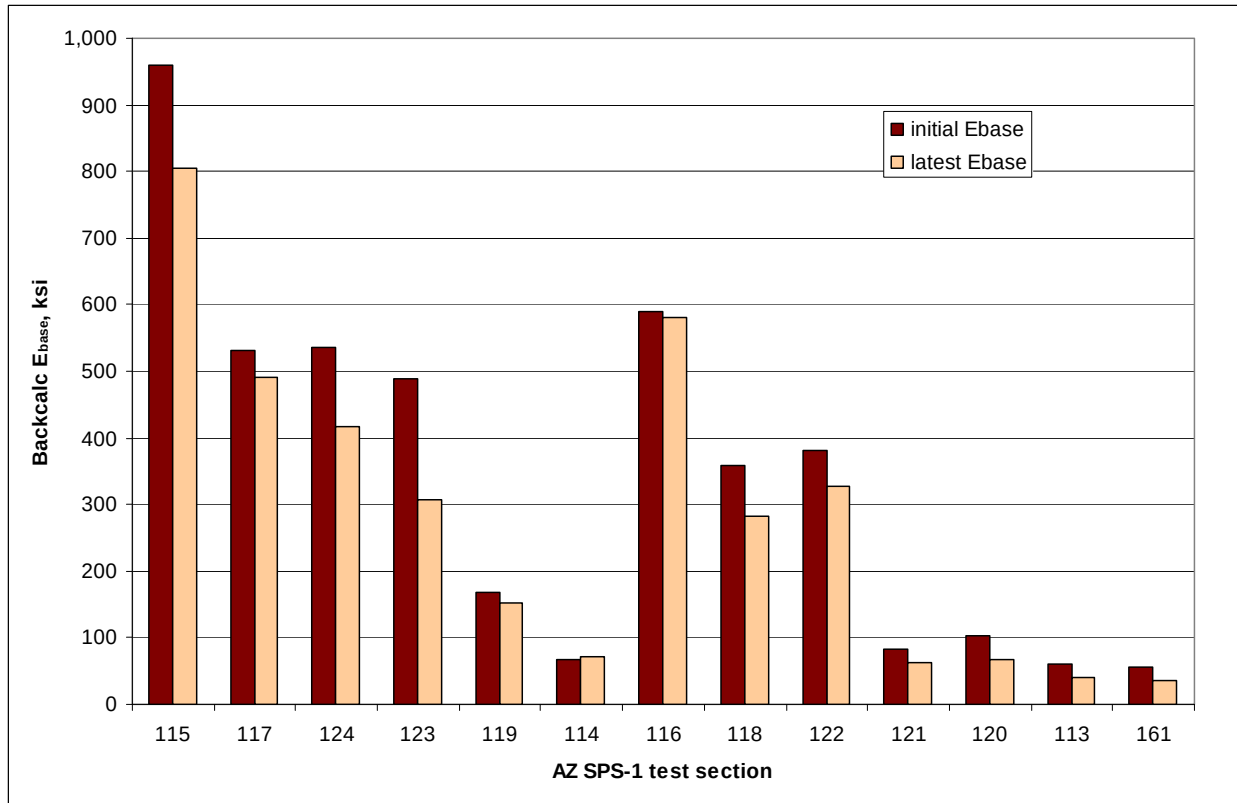
Figure 7. 1994 and 2004 backcalculated base modulus by test section.

The initial and latest average backcalculated base modulus values are shown by test section in Figure 7 and Table 8. All but one of the test sections showed a decrease in base modulus between 1994 and 2004. This effect may be coupled with the commensurate decrease in subgrade modulus. Whether an increase in moisture content in any unbound aggregate layers also played a role is difficult to say. For example, AC-over-aggregate test sections 0113 and 0161 experienced fairly large decreases in backcalculated base modulus, but AC-over-aggregate test section 0114 did not.

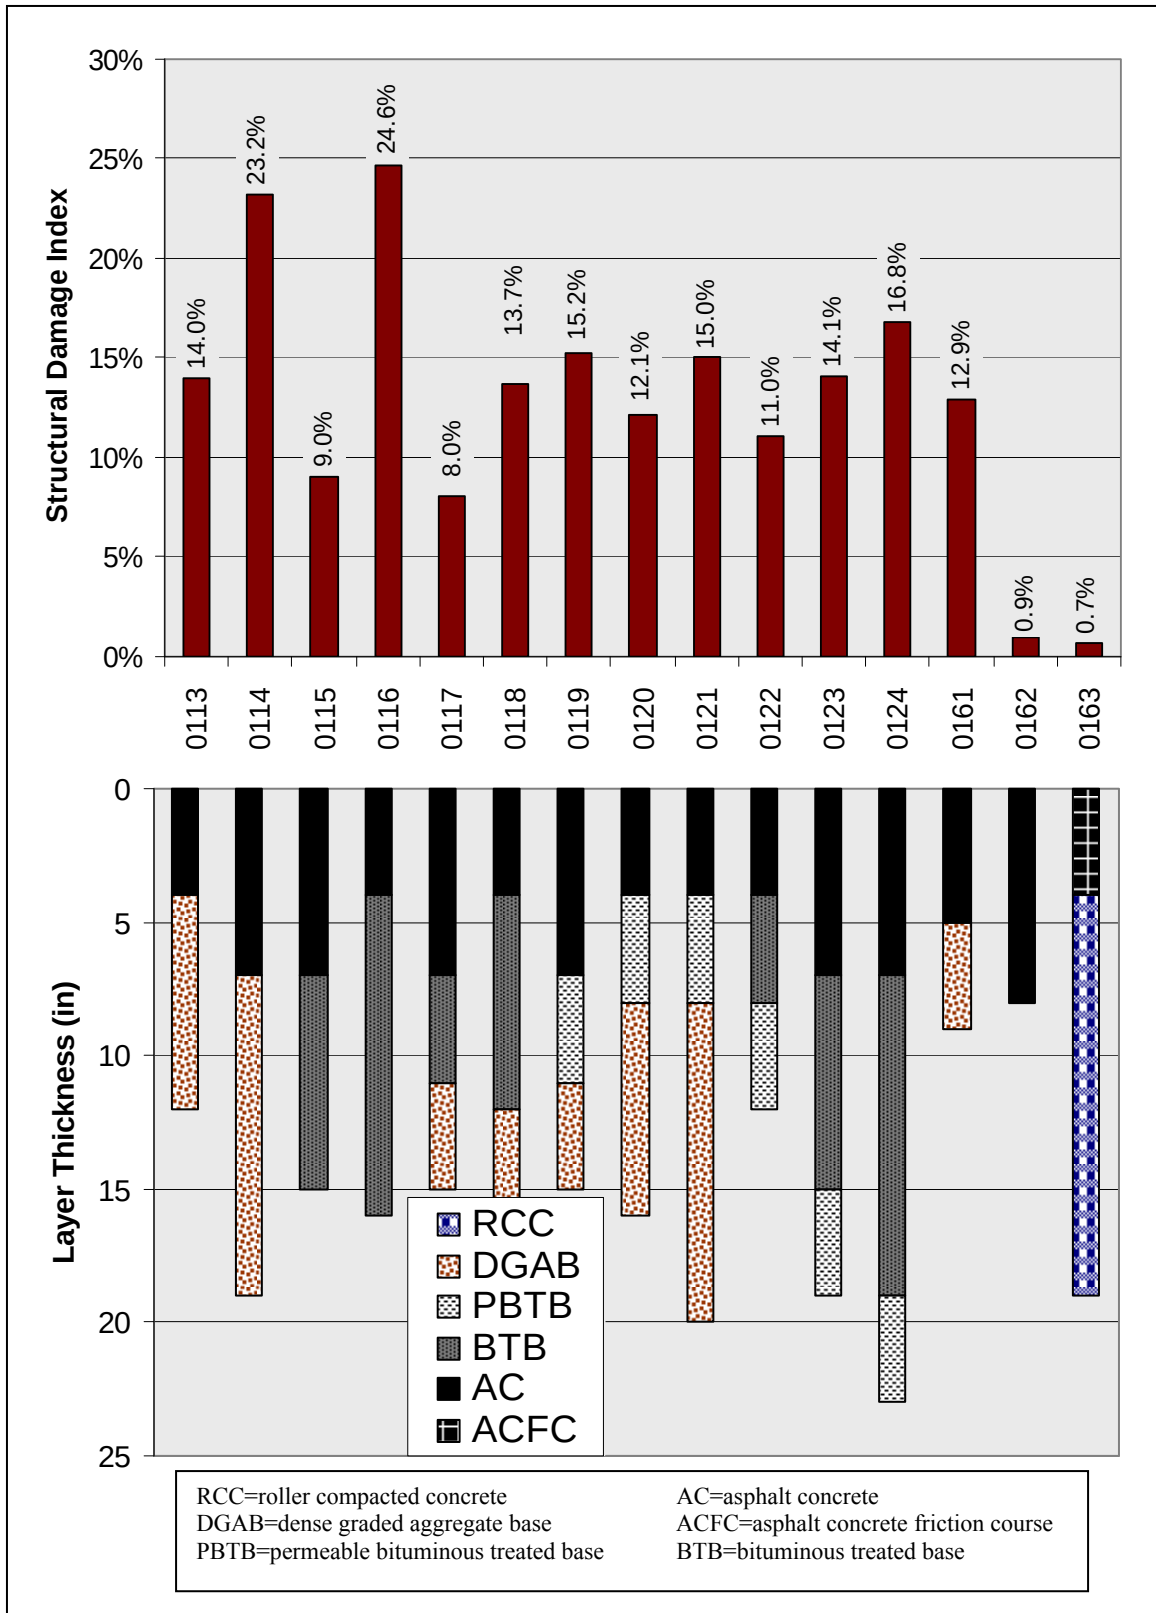
Figure 15. Structural Damage Index and pavement structure summary.

In-depth analyses and comparisons were conducted for all of the SPS-1 test sections. Figure 15 provides a summary of the structural damage index and pavement structure for each section while a summary of the environmental damage index and pavement structure can be found in Figure 16. Both damage indices reported are based on the data collected in March/April 2002 (just prior to the slurry seal).

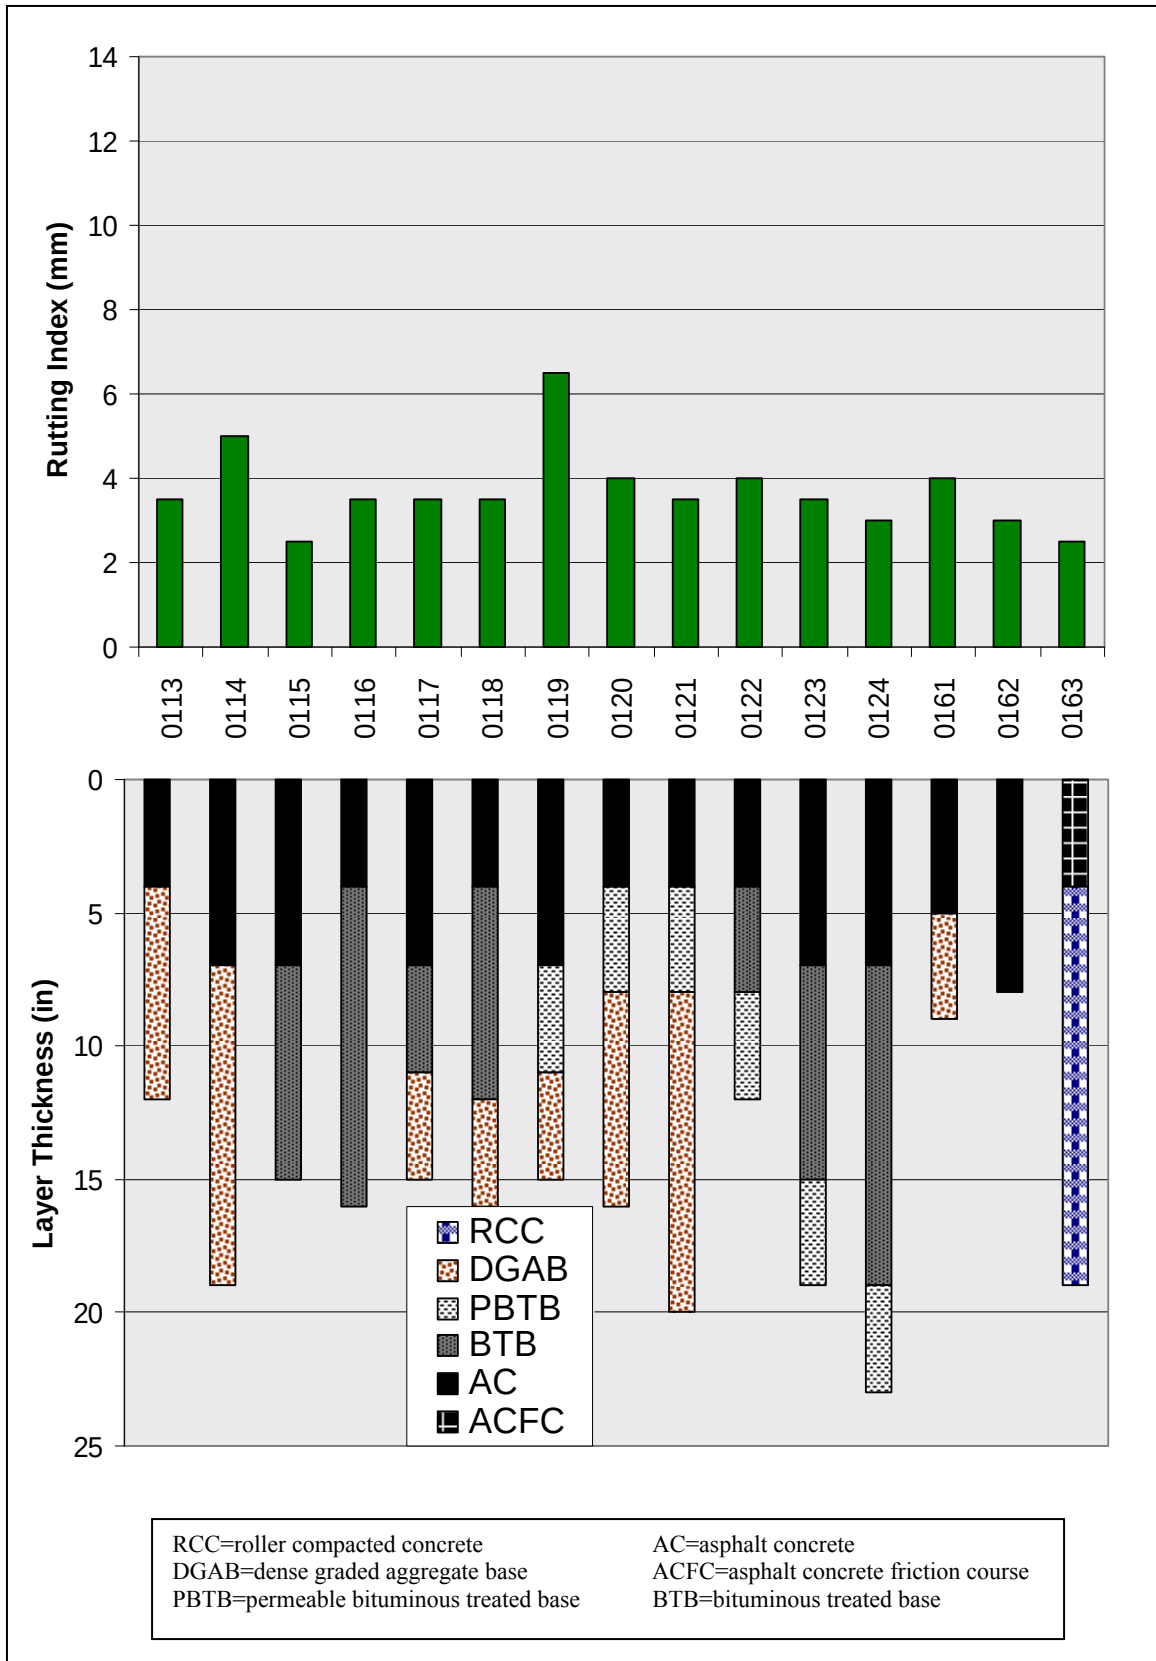
Figure 17. Rutting Index and pavement structure summary.

Figure 17 provides a summary of rutting and pavement structure for each section. Significant variation in rutting performance between the sections did not exist. All sections exhibited less than 7 mm of rutting after more than seven years in service, which is well below the level required to trigger improvements in most pavement management systems. Therefore, rutting was not the driving factor in the overall condition of the pavement.

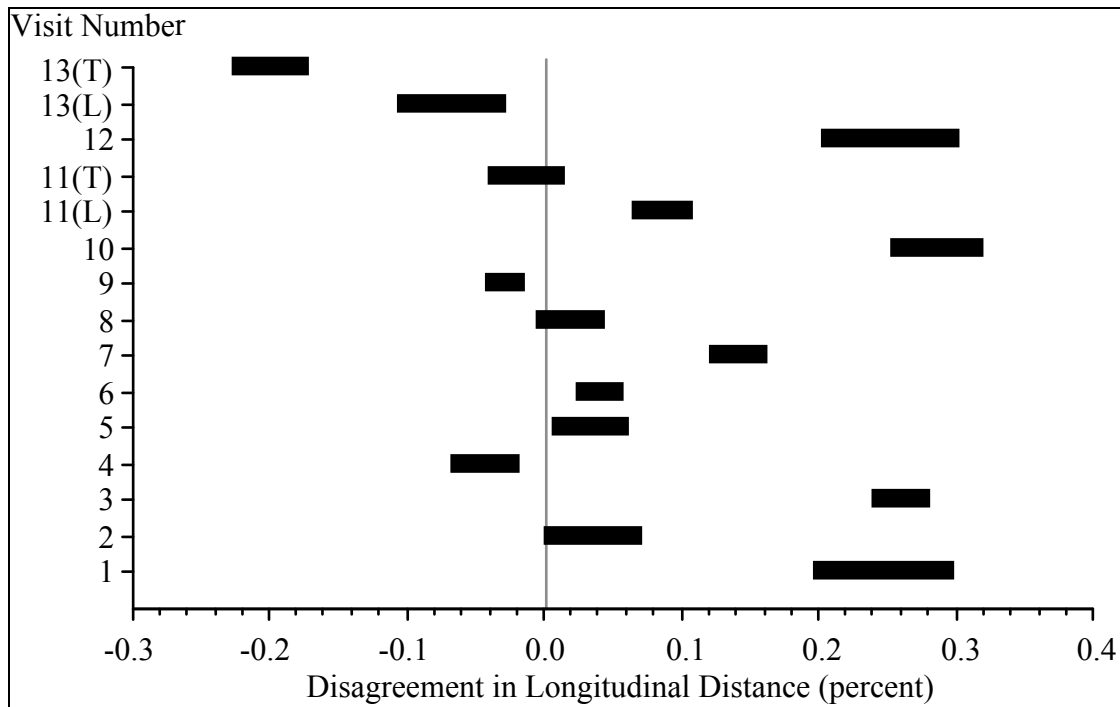
Figure 19. Consistency in longitudinal distance measurement.

Since the longitudinal distance measurement was based on the rotation of a drive wheel, the variations were most likely caused by variations in speed, lateral wander, and tire inflation pressure.<sup>11</sup> If tire inflation pressure were the dominant cause, the disagreement would grow more positive with each successive repeat measurement as the tire heated up and tire pressure increased. This is because the tire rolling radius would increase, and the profiler would register less wheel rotation for the same travel distance. This appeared to be the case for visits 03 through 08, but the effect was never greater than 0.05 percent of the overall distance. Note that the field procedures require the operator to warm up the tire prior to the measurements. That accounts for the high level of agreement among visits 03 through 13.

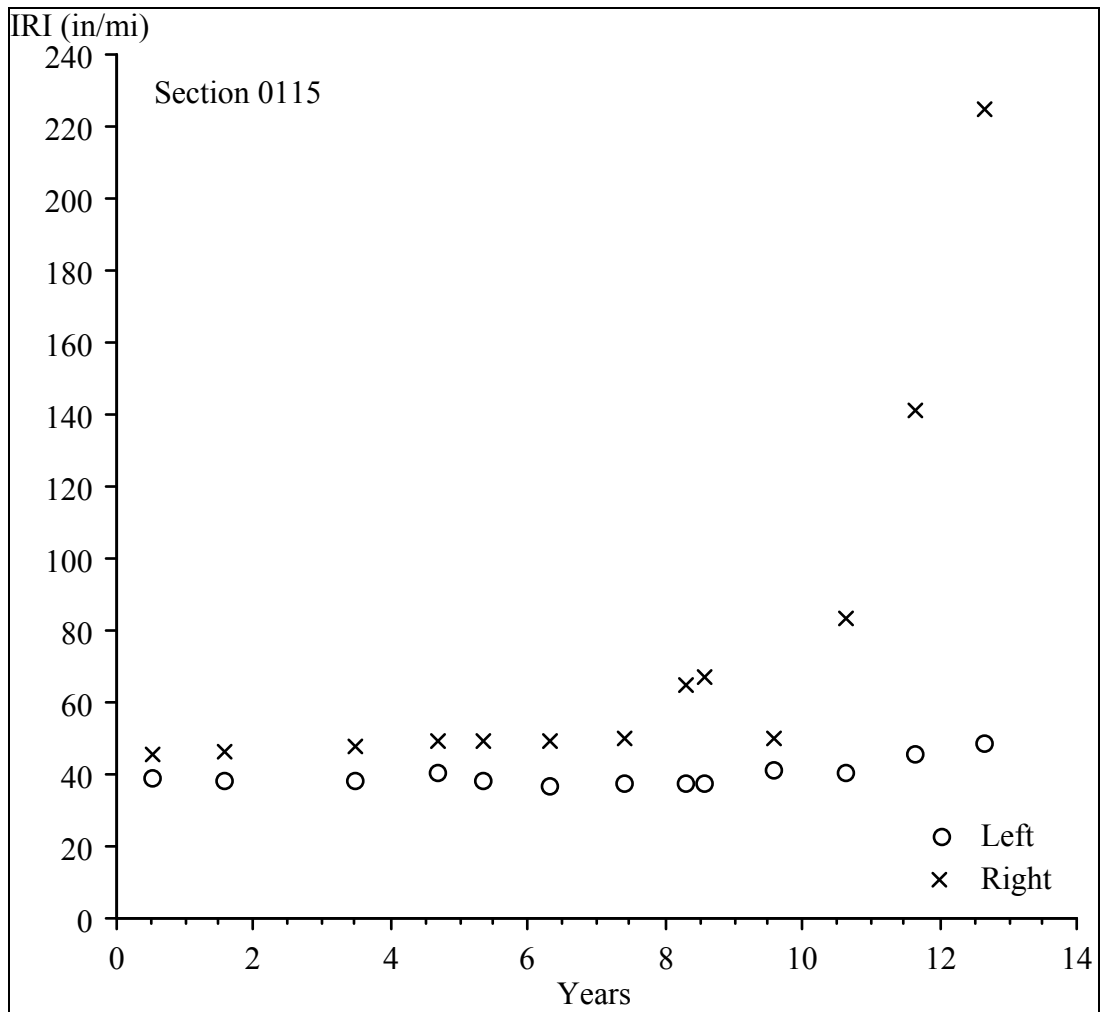
Figure 21. IRI progression, section 0115.

Section 0115: This section was very smooth on the left side throughout the entire monitoring period and was smooth on the right side through the first 10 visits. The roughness increased very aggressively on the right side over the last three visits because of longitudinal cracking. By the final visit the average IRI was 225 in/mi. However, the profile measurements of the right side were not very consistent with each other in the last three visits. This was because the profiler used height sensors with a narrow footprint and wandered above the cracks.

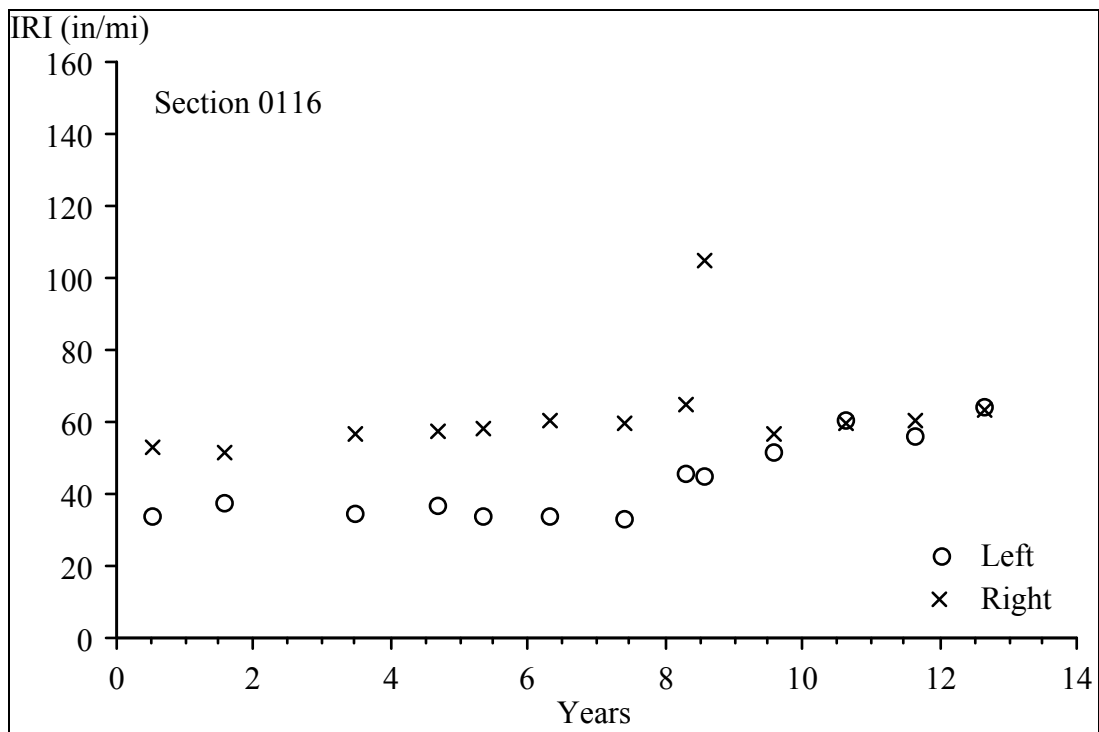
Figure 23. IRI progression, section 0116.

Section 0116: This section remained smooth over the entire monitoring period, with the exception of three small areas. In all three cases, deep dips appeared in the profiles that added significant roughness to the section. In August 2001 patches were placed over all three dips, but the patches were often at least as rough as the dips they replaced. One patch on the right side of the lane from 150 to 170 ft from the start of the section was so rough that it temporarily added more than 25 in/mi to the roughness of the entire section.

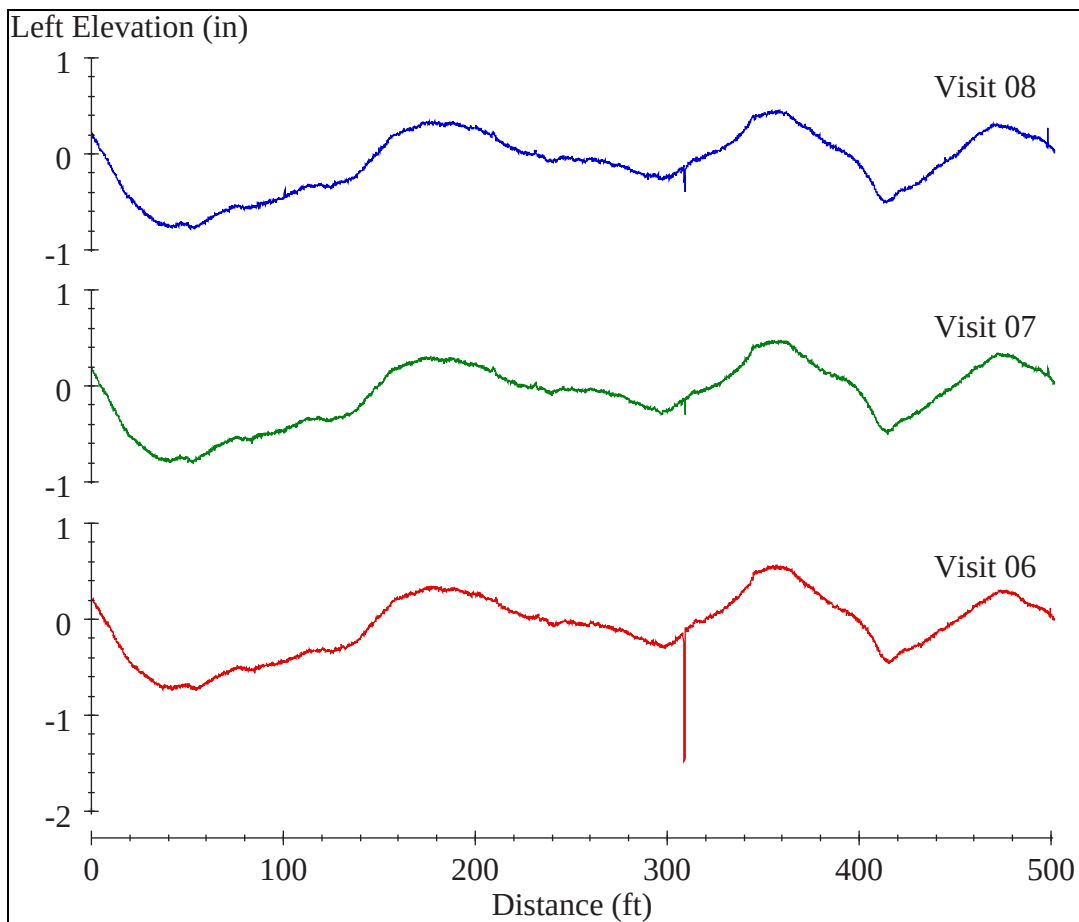
Figure 38. Raw profiles of section 0122.

A simple way to learn about the type of roughness that exists within a profile is to view the trace. However, certain key details of the profile are often not as obvious in a raw profile trace as they may be after the profile is filtered. For example, Figure 38 shows the left raw profile trace for three visits of section 0122. The plot shows that the long wavelength content, or the trend, in each plot is quite consistent with time. However, a narrow dip appears about 309 ft from the start of the section which is much more severe in visit 06 because the profile tracked directly over it.

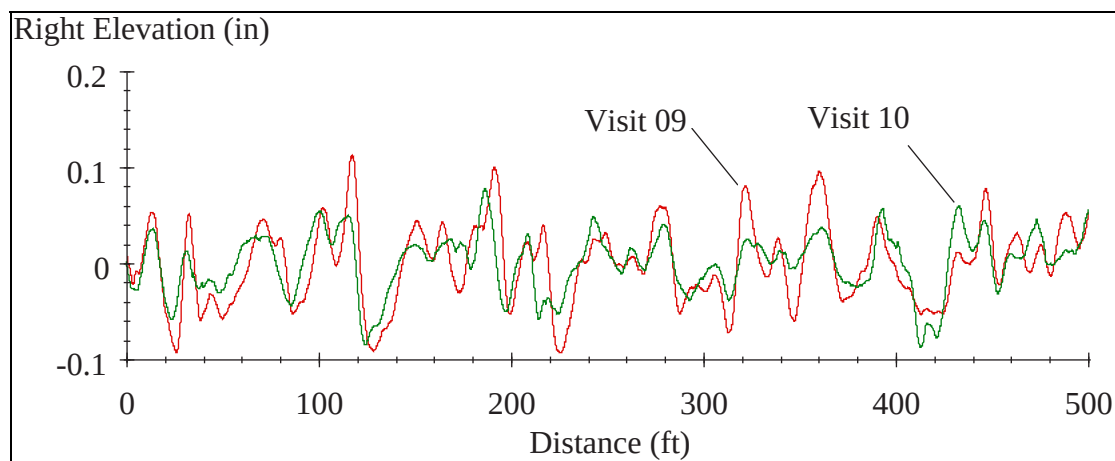
Figure 40. Medium wavelength profiles of section 0122.

Filtered profile plots also helped to characterize the effects of maintenance operations. For example, a slurry seal was applied to nine of the sections on the SPS-1 site in May 2002 (between visit 09 and 10). In most cases, this caused a complete change to the short wavelength profile plots and a significant change to the medium wavelength profile plots. Figure 40 shows an example of the change in the medium wavelength content on section 0122. Local peaks and troughs occur in roughly the same place before and after the slurry seal, but the shape and severity of bumps and dips are heavily altered. This, and the submerging of narrow dips at cracks under the seal, is the source of the change in roughness that occurred after the slurry seal.
