**Catalina Foothills Watercourse Studies:  
Technical Data Notebook for Hydrologic and Hydraulic Mapping of the  
Geronimo Wash and its Tributary,  
Pima County Arizona.**

FEMA FIRM Panel 04019C-1630 and 1635K

Pima County Regional Flood Control District  
97 E Congress Street  
Tucson Arizona, 85701

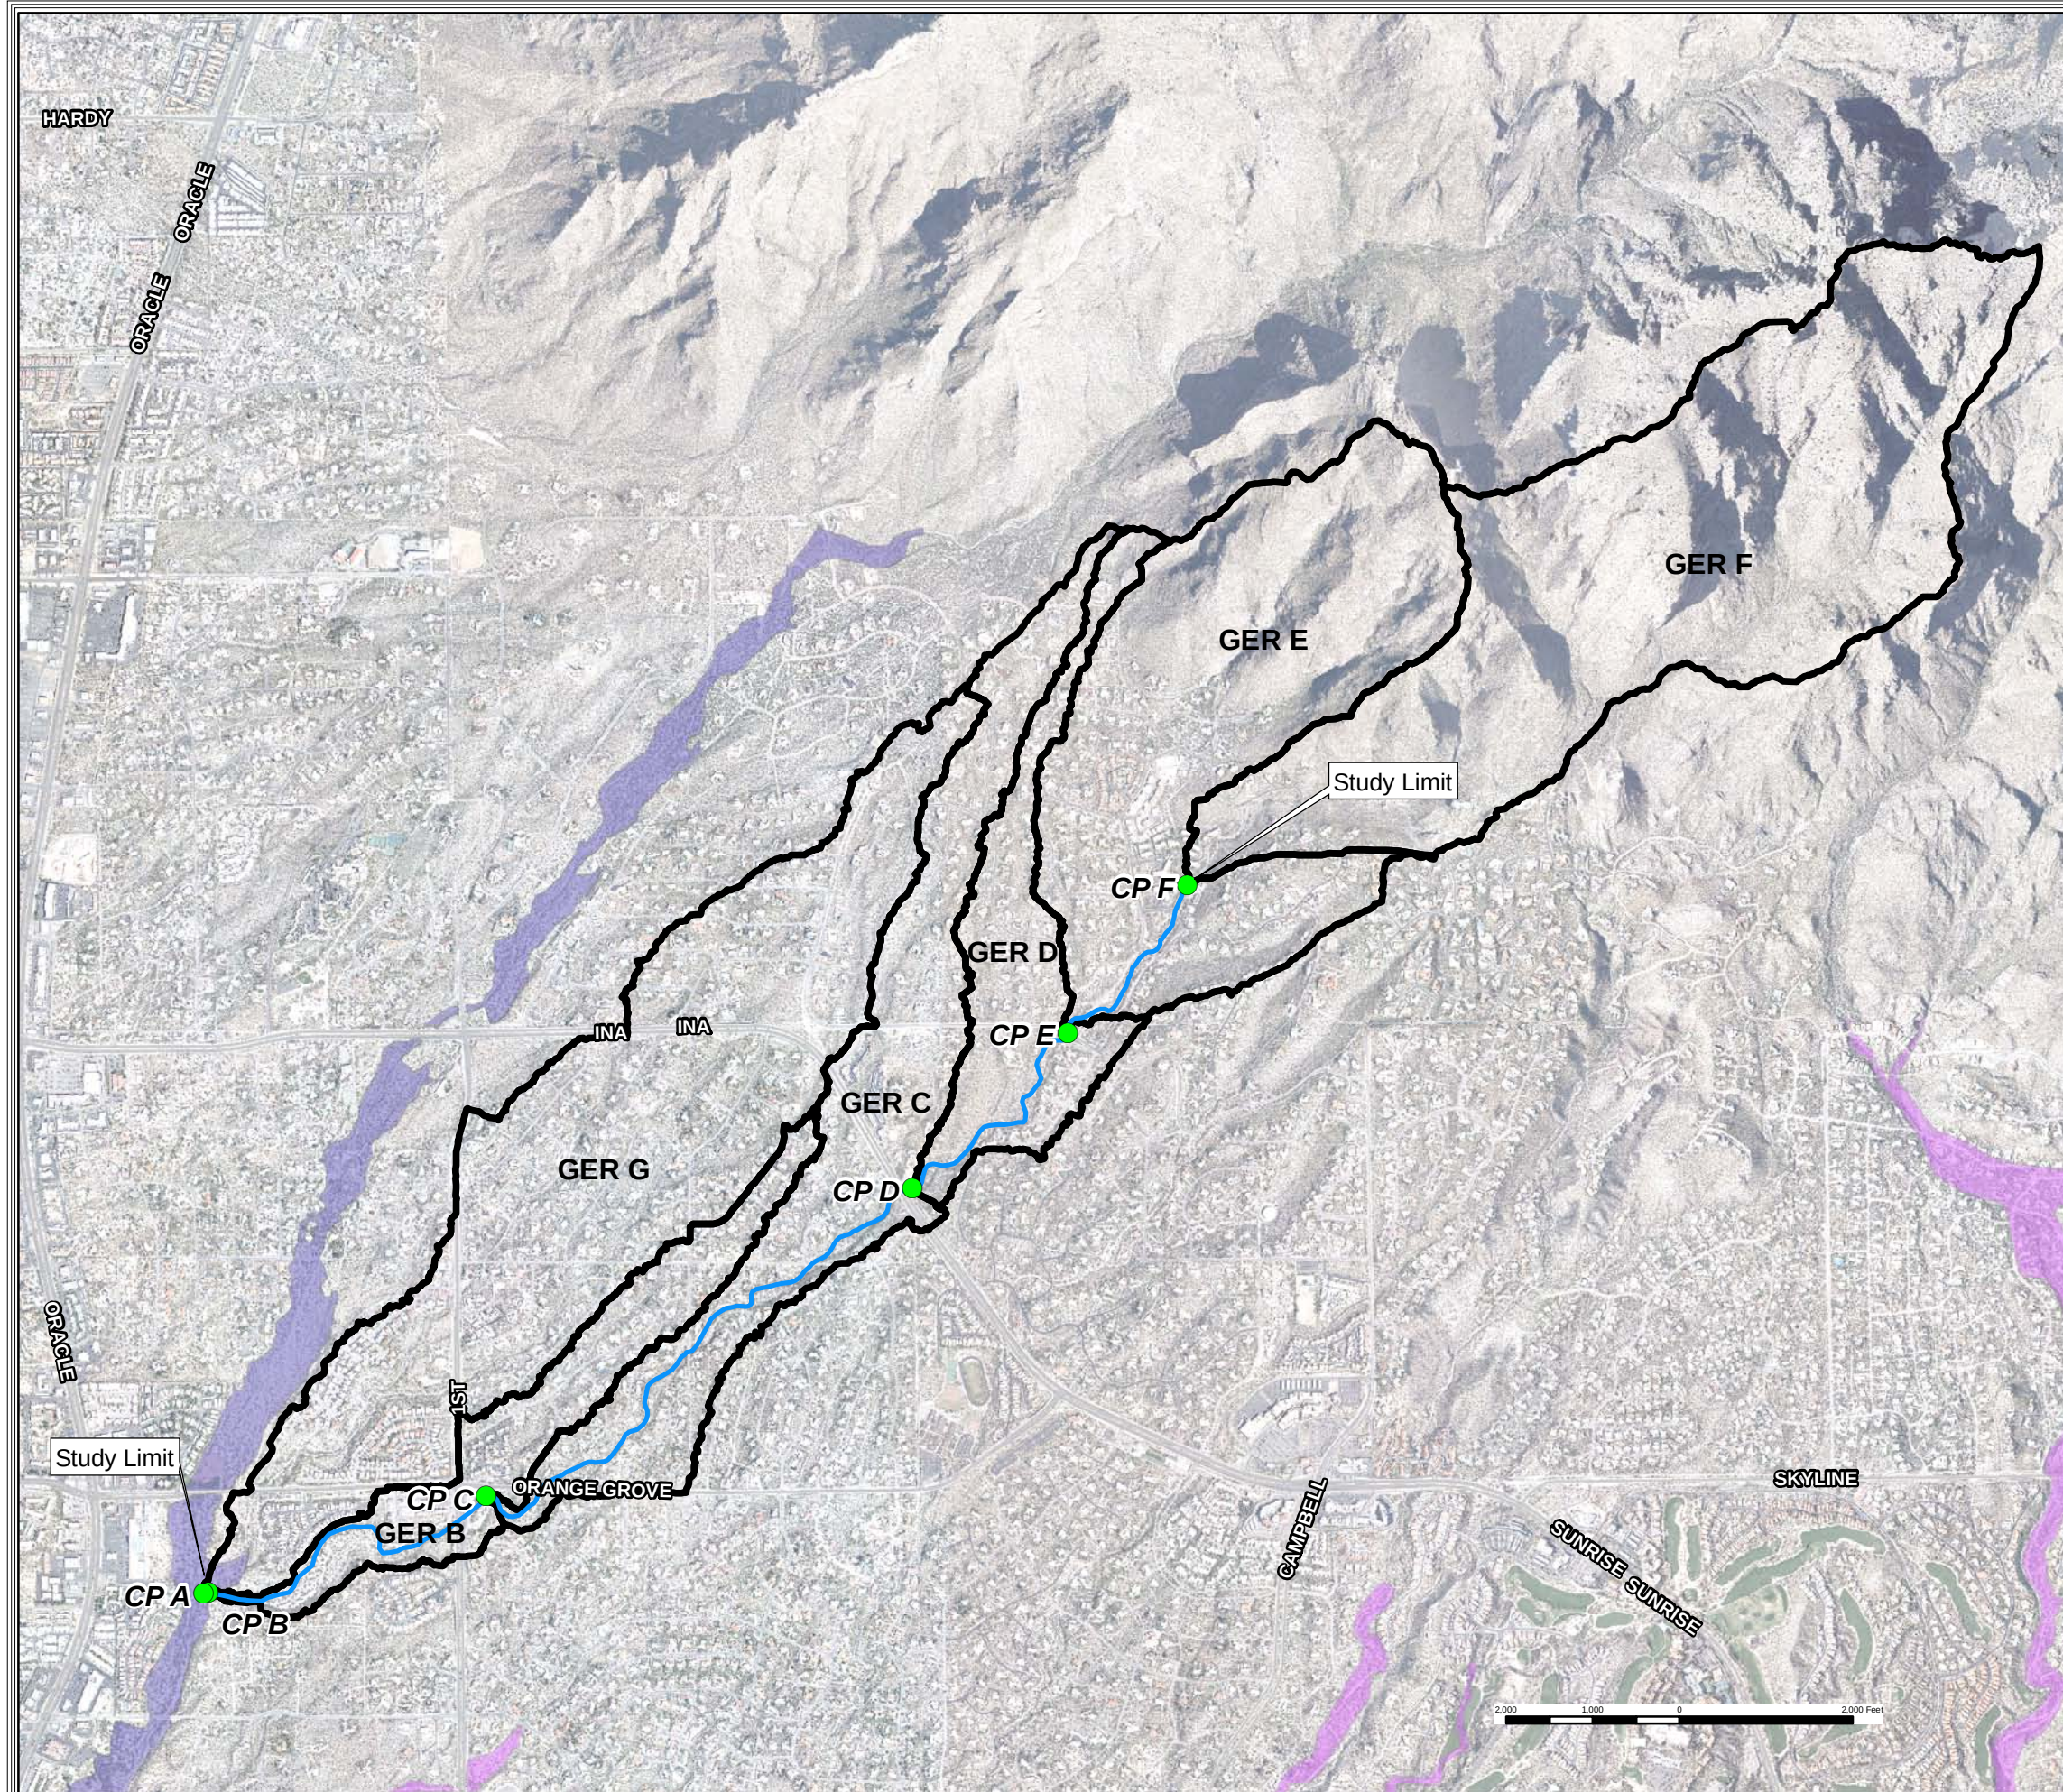
**Figure 1.2**  
**Study Limit**  
**Geronimo Wash**

- GER\_CP
  - River
  - ▭ Geronimo Subbasins
  - Existing FEMA Floodplain
    - ZONE A
    - ZONE AE
    - ZONE X - SHALLOW 100-YEAR
- 2008PAGclr01ft.ecw

The limits of this study are shown in Fig.1.2. The site includes Sections 32 of Township 1 South, Range 14 East, Sections 5, 6 and 7 of Township 13 South, Range 14 East, and Section 13 of Township 13 South, Range 12 East, Pima County, Arizona. The entire watershed of the Geronimo Wash is in FEMA Zone X, as shown on the current Flood Insurance Rate Map (FIRM) number 04019C-1630 and 1635K.

The watershed is 3.37 square mile. The study watershed was divided into five sub-basins (Fig.1.1). The upstream study limits is the north of Calle sin Desengano, while the downstream limit is the confluence with the Pima Wash (Fig.1.2).

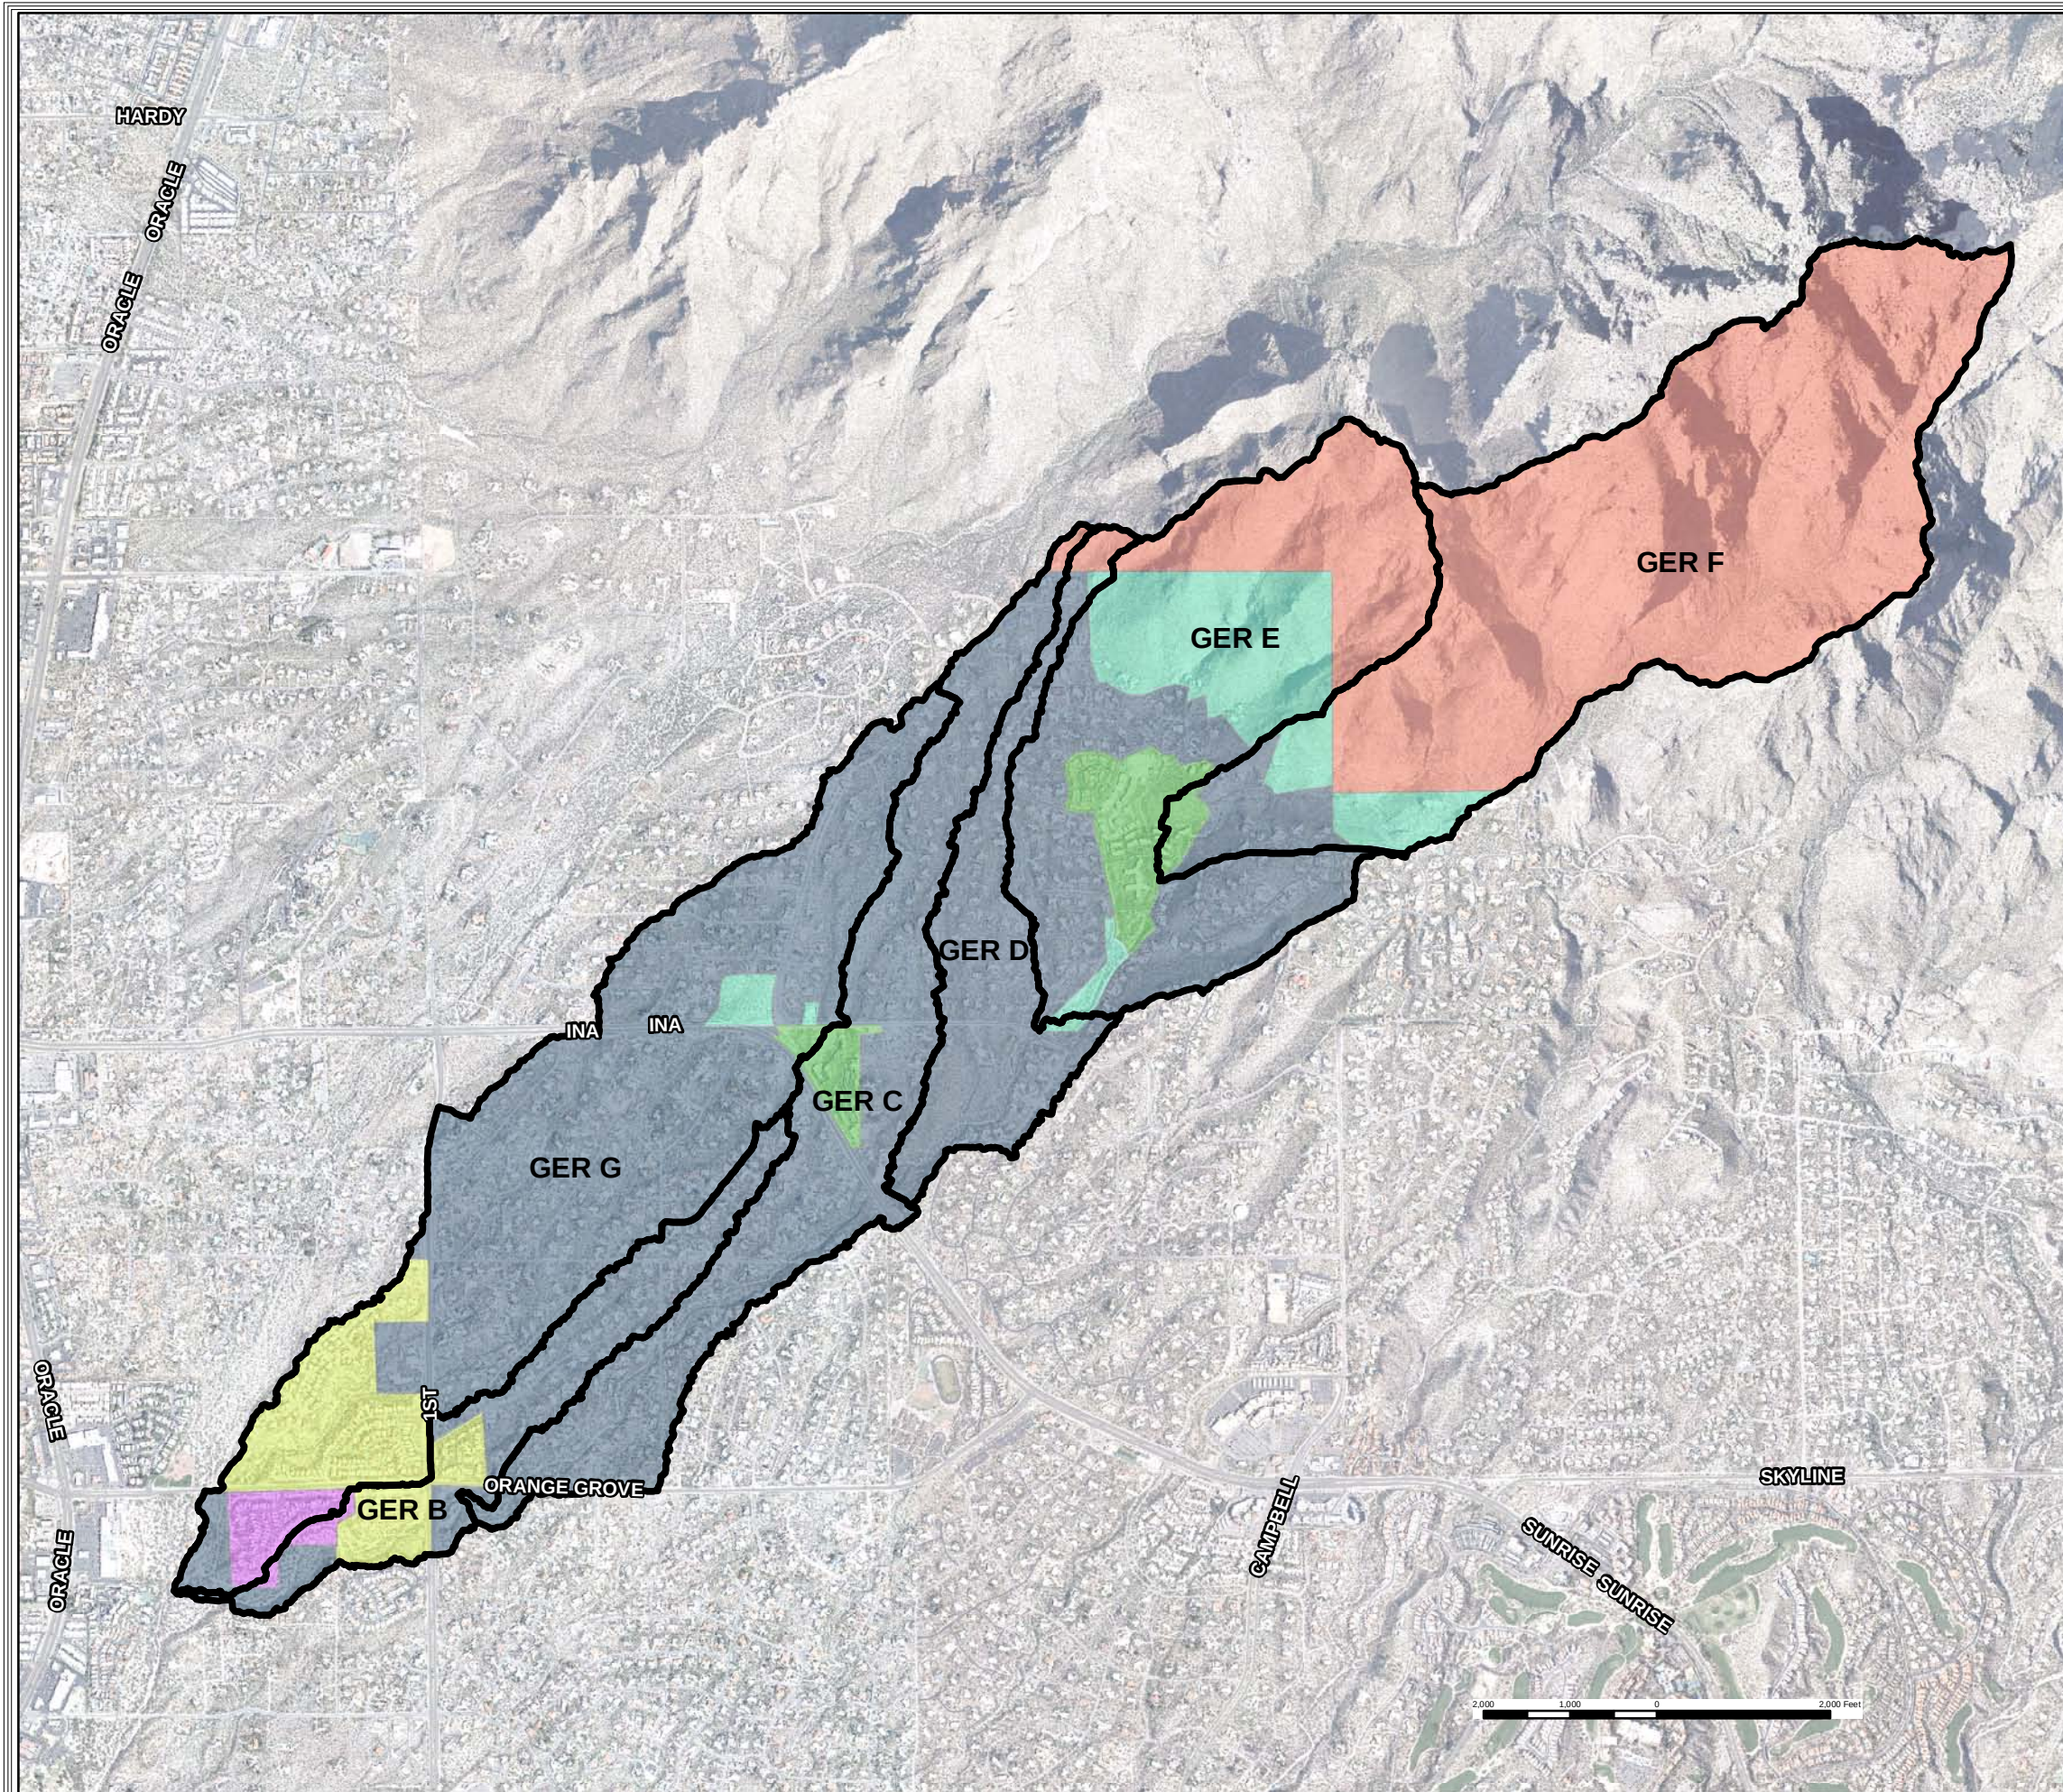
**Figure 1.3**  
**Zoning Classification**  
**Geronimo Wash**

**Pima County Zoning**

The watershed is 3.37 square mile. The study watershed was divided into six sub-basins (Fig.1.1). The study limits for the Geronimo Wash extends from a junction with the Pima Wash to the north of Calle sin Desengano (Fig.1.2). Major zoning classification of the watershed is CR-1 (Fig.1.3).

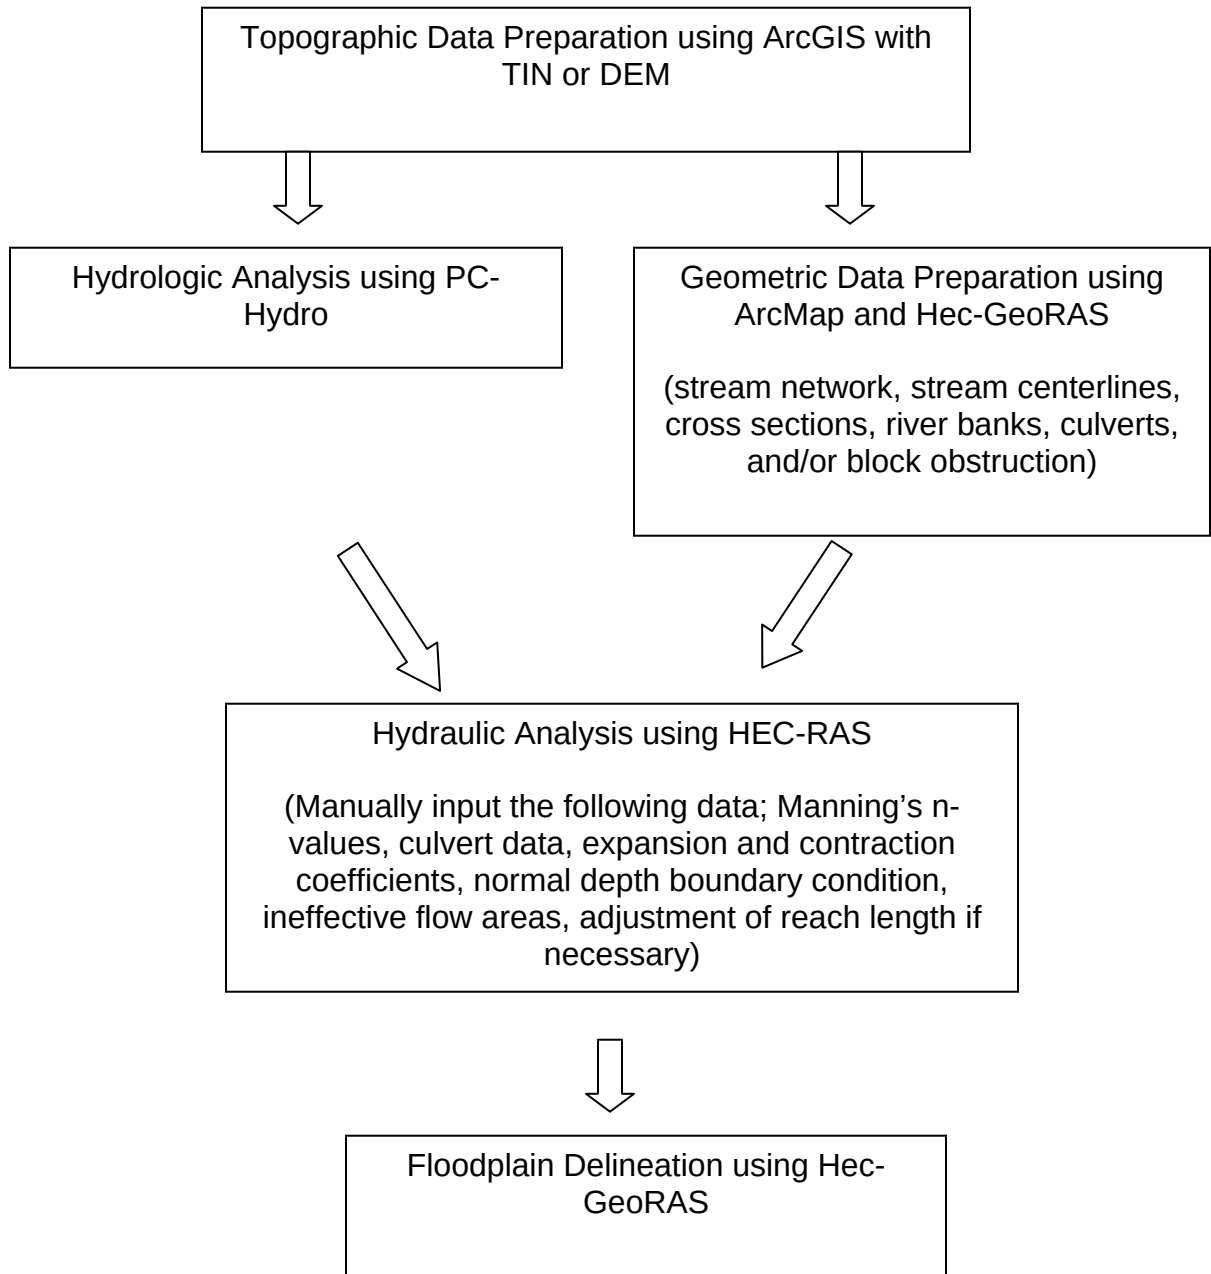
**Figure 4.1 – Flow Chart of Mapping Process**

The boundary of the watershed and internal sub-basins were determined using Hydrology function in ArcGIS with DEM derived from the 2008 Lidar. The sub-basins reflected predominant topographic, soils, cover and development conditions, so that the sub-basins would represent hydrologic response from the sub-basin. The locations of the stream centerline, cross-sections, culverts, and other physical attributes of the wash were determined by using the 2-ft interval contour map and 2008 aerial photo.

Methods are summarized in Table 4.1. The data processing methods are summarized in Fig. 4.1.

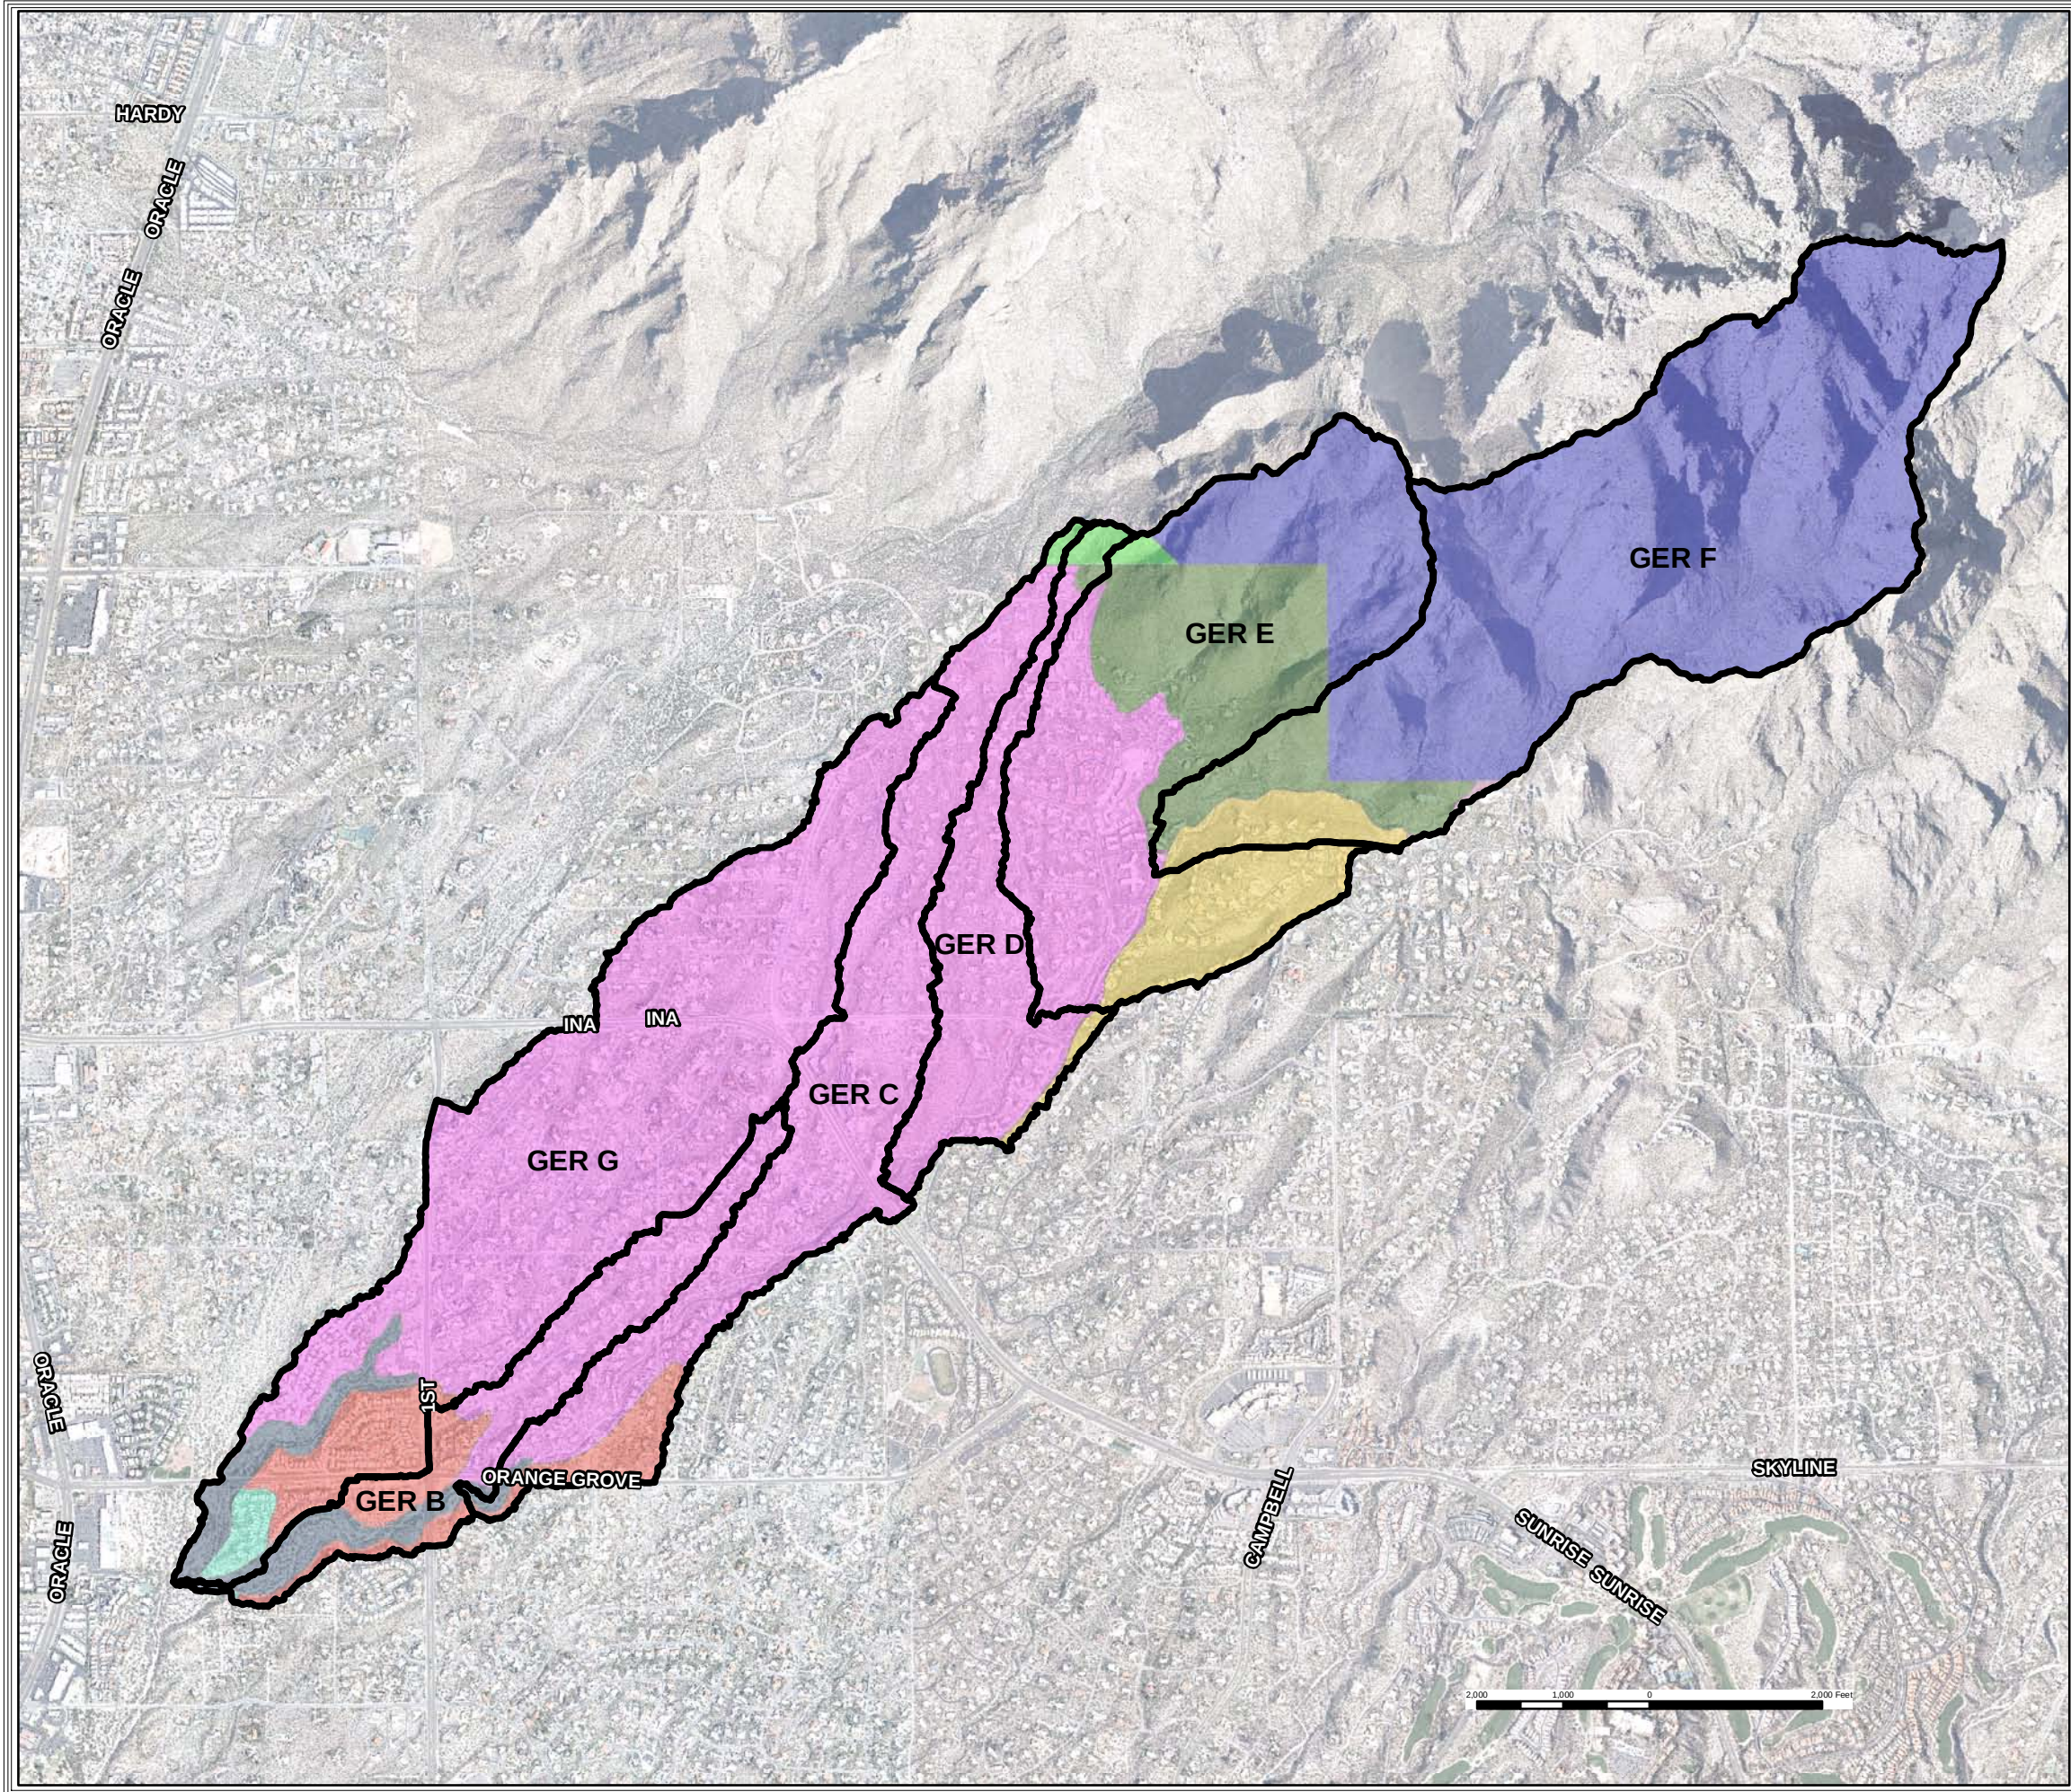
Figure 4.2  
Soil Classification Map  
Geronimo Wash

- GERONIMO SUBBASINS
- Soil Group: A (100%), ARIZO-RIVERWASH COMPLEX, 0 TO 3 PERCENT SLOPES
- Soil Group: B (100%), PINALENO VERY COBBLY SANDY LOAM, 1 TO 8 PERCENT SLOPES
- Soil Group: B (100%), PINALENO-STAGECOACH COMPLEX, 5 TO 16 PERCENT SLOPES
- Soil Group: B (82%) C (18%), PINALENO-STAGECOACH-PALOS VERDES COMPLEX, 10 TO 35 PERCENT SLOPES
- Soil Group: C (47%) D (53%), PANTANO-GRANOLITE COMPLEX, 5 TO 25 PERCENT SLOPES
- Soil Group: C (50%), D (50%)
- Soil Group: D (100%), CELLAR-LAMPSHIRE-ROCK OUTCROP COMPLEX, 15 TO 60 PERCENT SLOPES
- Soil Group: D (100%), CELLAR-LEHMANS COMPLEX, 5 TO 25 PERCENT SLOPES

A hydrologic soils group map for the study watershed is presented in Fig.4.2. The study watershed is mostly covered with Desert brush. Hydrologic Soil Groups B and D are the dominant soil types in the Geronimo Wash watershed. The SCS Curve Number was determined using maps obtained from NRCS (<http://soildatamart.nrcs.usda.gov/>) as a basis for preparing a Hydrologic Soil Group Map for Pima County. The CN charts in the PC Hydro Manual (Arroyo Engineering, 2007) were the basis for CN selection. A vegetation cover density of 30% was used to select the SCS Curve Number for the hydrologic calculation of the mountainous watersheds. Impervious cover percentage from 5-15%, were selected based on lot size, the fraction of the sub-basin that is developed and the tables in the PC Hydro manual. Sub-basin characteristics are summarized in Table 4.2 The detail of the CN calculation is included in Appendix D.

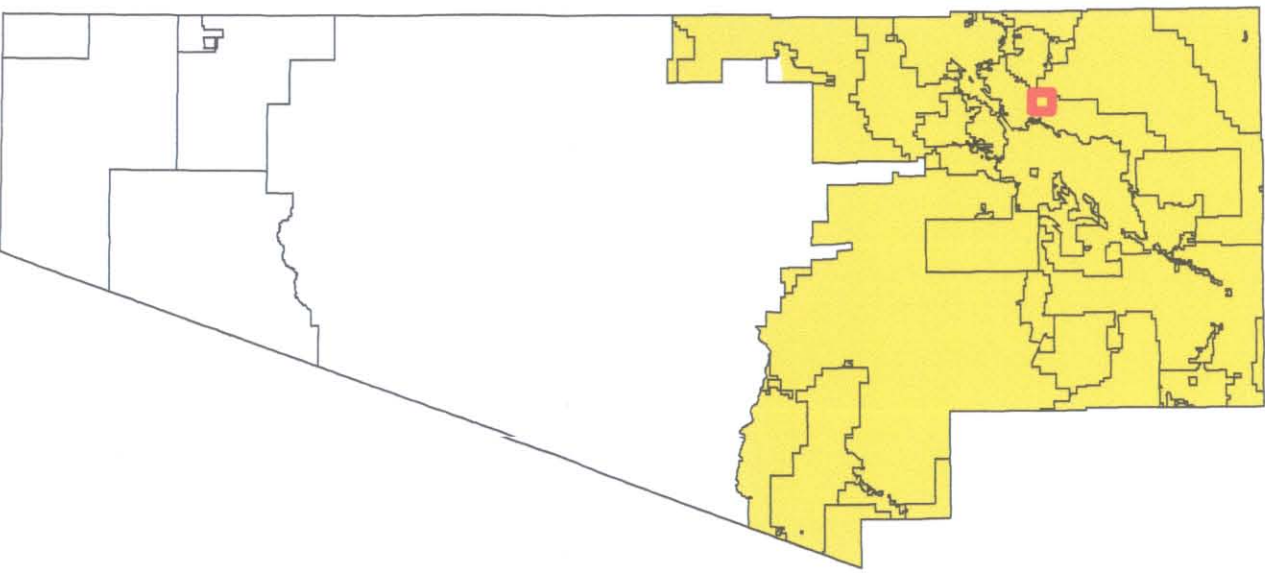
- GER\_CP
- GER\_Xsection
- GER\_subbasins
- Geronimo\_contours10ft
- replace\_terrain
- 100-yr floodplain
- 500-yr floodplain

Note: On this scale 100 and 500yr floodplains  
appear coincident on much of the map,  
because the floodplains tend to be confined.

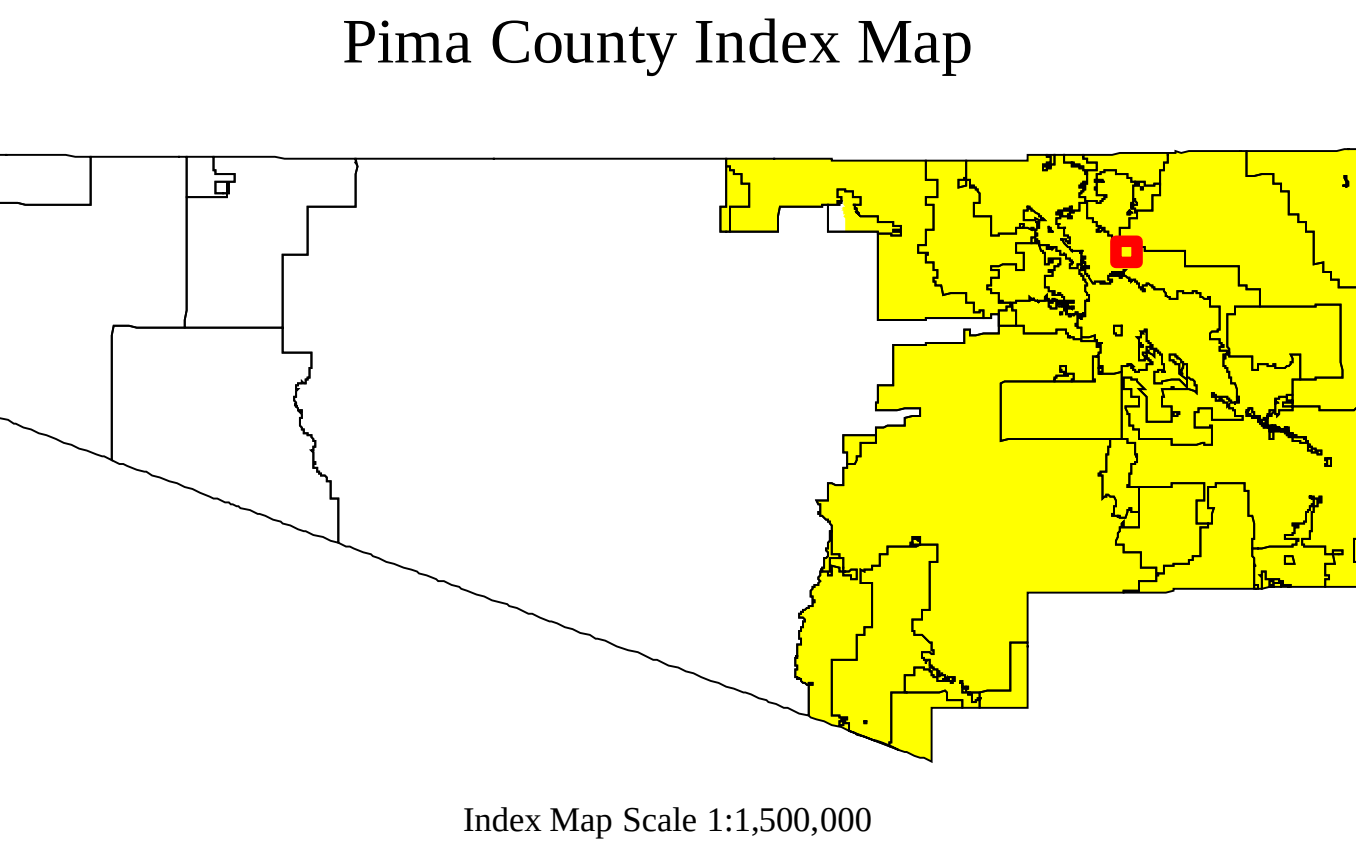
# Exhibit 2

- GER\_CP
  - ▭ Geronimo Subbasins
  - ▭ Prpoosed 100-yr floodplain
  - ▭ LOMR Case Studies
  - ▭ FIRM - Flood Insurance Rate Map
  - ▭ Township, Range, Section
  - Existing FEMA Floodplain
  - ▭ ZONE A
  - ▭ ZONE X - SHALLOW 100-YEAR
- 2008PAGclr01ft.ecw
