ARIZONA WATER ATLAS

VOLUME 6

WESTERN PLATEAU PLANNING AREA

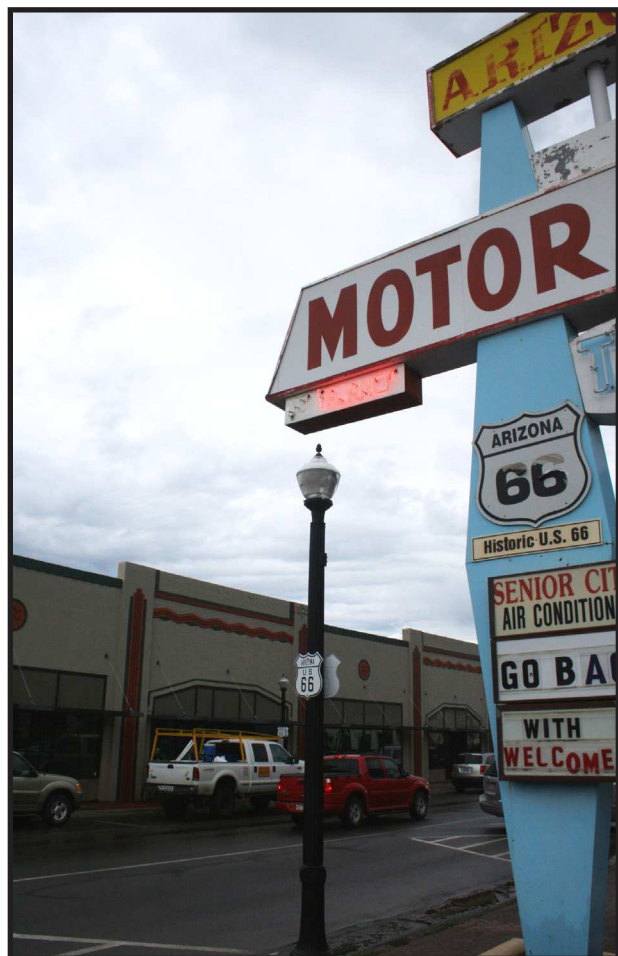
City of Williams. At Williams, three of four water system wells are drilled to depths exceeding 3,500 feet bls.

are between 2,740 and 2,875 feet. Water in the deepest of the Williams wells is of poor quality with elevated metal concentrations, including arsenic, and high corrosivity (City of Williams, 2007).

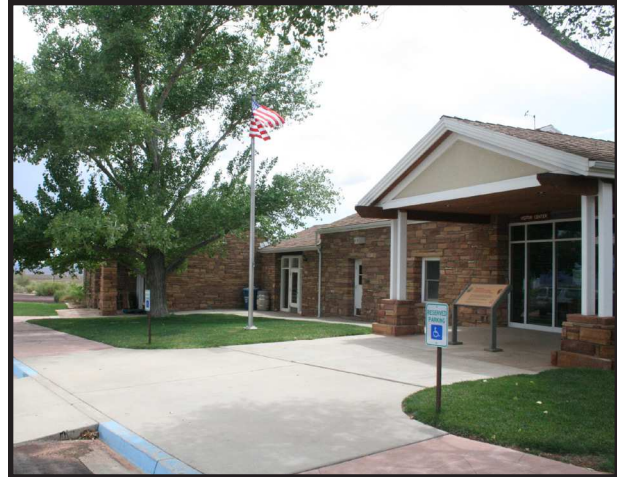
Pipe Springs National Monument. Water bearing units in this area include alluvium, Navajo Sandstone, the Kayenta and Moenave formations and the Shinarump Formation

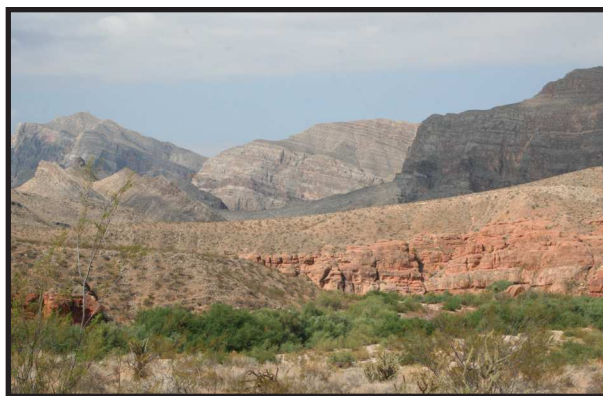
Virgin River Mountains and Virgin River Valley. Principal aquifers are basin fill in the Virgin River Valley and Beaver Dam Wash, and the Muddy Creek Formation.

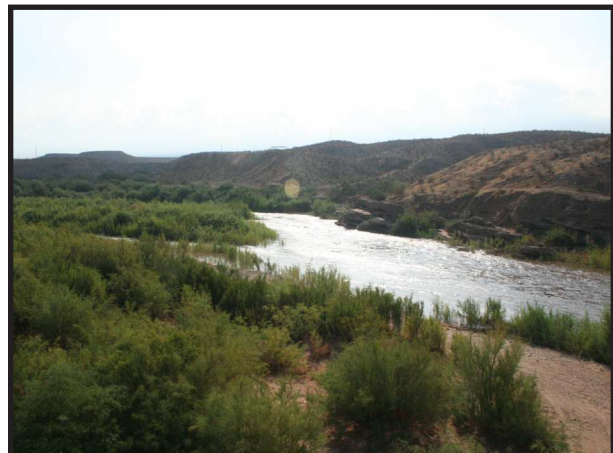
Virgin River near Littlefield. Average annual flow in the Virgin River above the Narrows gage is about 92,600 acre-feet.

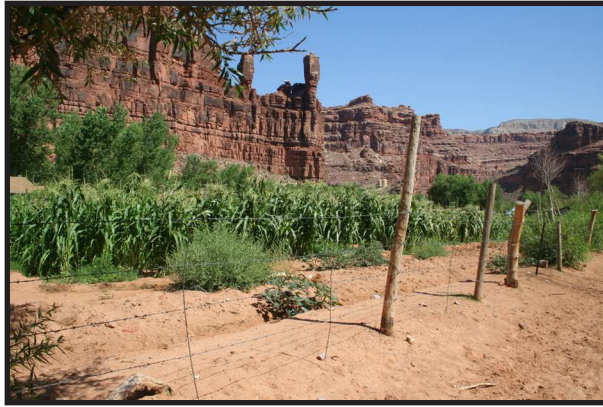
Agriculture in Havasu Canyon. Surface water is used as both a municipal and agricultural supply on the Havasupai Reservation.

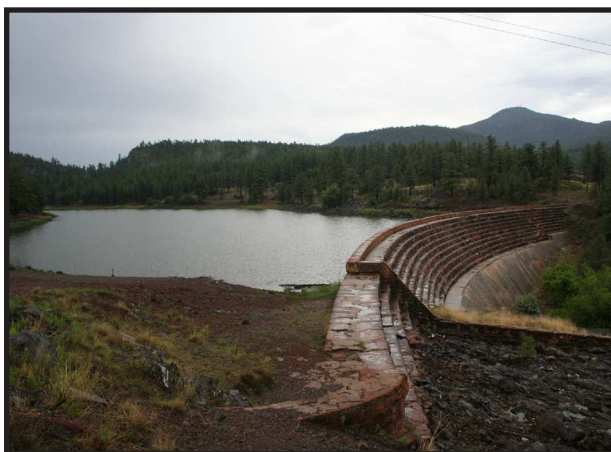
Santa Fe Reservoir, City of Williams. City of Williams historically relied on surface water stored in five small reservoirs. Since 1999, the city has drilled four wells to supplement surface water supplies.
